Duquesne Light Company

**Subject: Beaver Valley Power Station, Unit No. 2
Docket No. 50-412, License No. NPF-73
Request for Relief for a Non-Code
Repair on the Supply Pipe for 2HVP*CLC265B**

Request for Relief for a Non-Code
Repair on the Supply Pipe for 2HVP*CLC265B

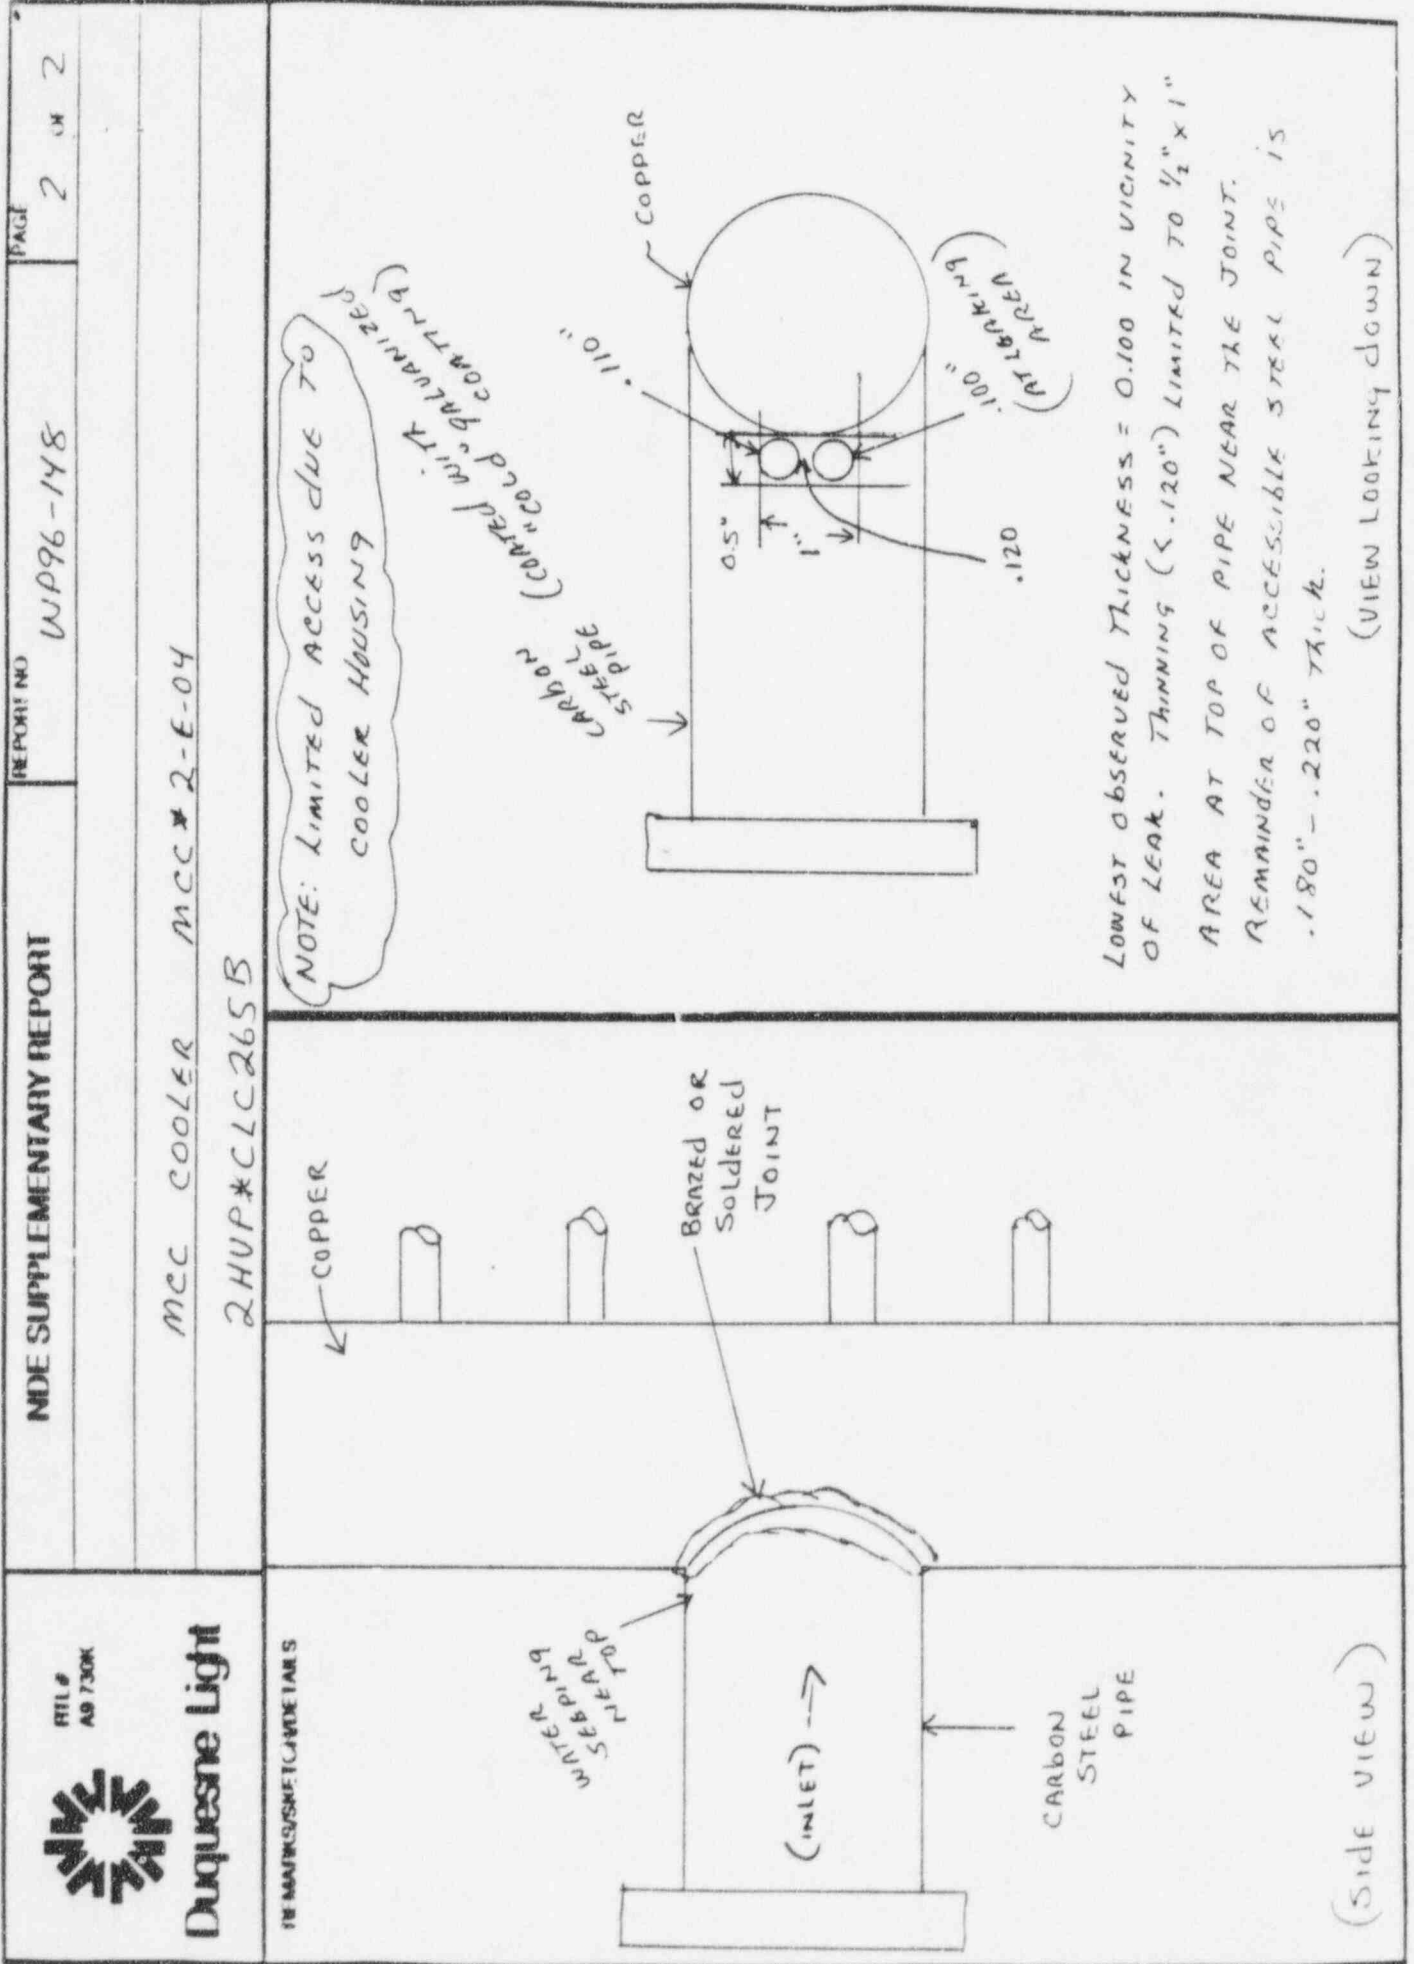
FIGURE 1

On June 8, 1996, during Beaver Valley Unit 2 (BV-2) power operation, a pinhole leak was discovered on the supply nozzle for the MCC*2-E04 Cubicle Cooler 2HVP*CLC265B. The pinhole leak was located near the top of the carbon steel pipe near the brazed joint where the nozzle attaches to the copper header of the cooler (See Figure 1). The pinhole was seeping water at a rate of approximately four (4) drops per minute.

The inlet pipe nozzle was ultrasonically (UT) scanned to determine the extent of wall thinning (see Figure 1). The lowest thickness that could be obtained at, and in the vicinity of the pinhole leak was 0.100 inches. The pinhole was of insignificant size to allow for UT detection due to technique limitations and is suspected to be an inside surface pit. The visual inspection of the area of leakage could not discern a surface defect, thereby leading to the conclusion that the actual through-wall defect is small and localized.

The most likely root cause of the minor through-wall leak on the carbon steel piping section is localized pitting. This root cause determination is based on the following information: 1) the cooling fluid for the cooler is service water, 2) pitting has been experienced in the Service Water System, 3) the localized nature of the defect as characterized by ultrasonic (UT) thickness measurements, and 4) the lack of vibration loads and low nozzle stress loads. When this section of piping is removed from service for repair or replacement, the affected area will be examined to further ascertain the root cause.

The flaw was evaluated using the "through-wall flaw" approach provided by Enclosure 1 of Generic Letter 90-05. The Code required minimum wall thickness for the supply pipe for 2HVP*CLC265B was determined to be 0.082 inches based upon the design Code, ASME III, 1974 Edition, Winter 1974 Addenda. The pipe was fabricated with carbon

Using the "through-wall flaw" methodology, the maximum length of a flaw with a wall thickness less than 0.082 inches was determined to be 0.960 inches with a corresponding value of "K" equal to 34,745 psi (in)^{0.5}. The UT examination did not identify any areas below the Code required minimum wall thickness of 0.082 inches. The actual pinhole could not be seen visually or detected ultrasonically. Therefore, the actual flaw size is less than 0.960 inches and the "through-wall flaw" approach criteria is satisfied.

The pipe flaw will be removed and repaired or replaced in accordance with ASME Code Section XI requirements no later than the completion of the Sixth Refueling Outage (2R06) which is the next scheduled outage exceeding 30 days. This outage is scheduled to begin on August 30, 1996.

A UT examination of the supply pipe for 2HVP*CLC265B will be performed monthly. These UT examinations will continue until the piping is isolated from service to be repaired or replaced in accordance with Code requirements. The results of the periodic UT examinations will be evaluated to ensure that the piping is acceptable for continued service.
