LICENSEE EVENT REPORT (LER)

Facility Name (1) Quad Cities Unit One	Docket Number (2) 0   5   0   0   0   2   5   4	Page (3) 1   of   0   4
---	--	----------------------------

Title (4)  
The Technical Specification Required Pressure Was Not Met During Local Leak Rate Testing Due To A Procedural Deficiency

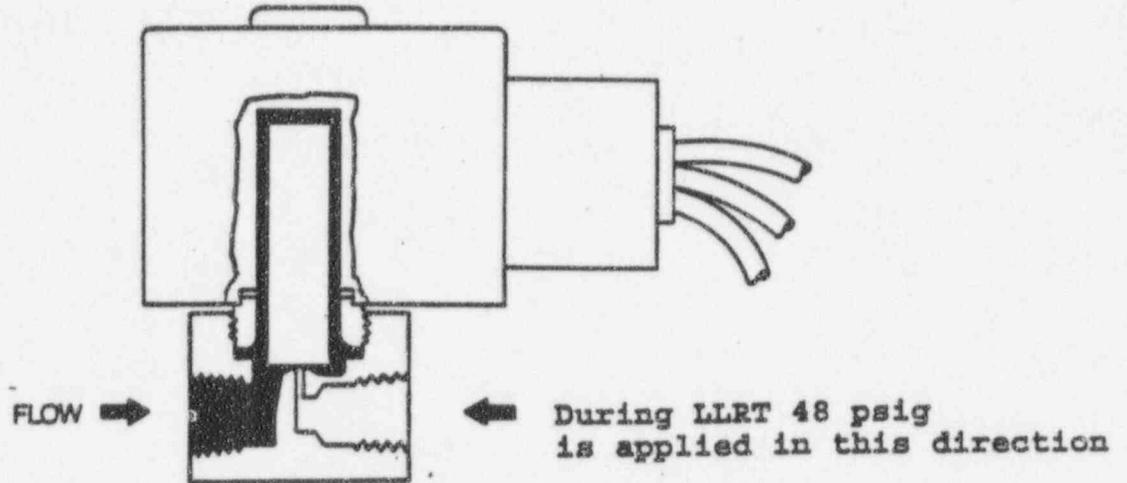
ATTACHMENT B

QCTS 0600-34 is currently performed when the CAM panel is in standby mode, which places the solenoids in a de-energized (closed) condition. When testing CAM check valves 1(2)-2498-8A/B, 11A/B, 14A/B, and 17A/B (which are internal to CAM panels 2251(2)-81A/B), the fittings at the calibration gas bottles are disconnected to provide a vent path. Solenoid valves [SOL] SO 1(2)-2498-6A/B, 9A/B, 12A/B, and 15A/B are also part of the same vent path (refer to Attachment A). During the performance of QCTS 0600-34, at least 48 psig of air pressure is applied to the outlet port of the solenoid (refer to Attachment B).

The Station performed a bench test to determine the force required to lift the solenoid core (to provide vent path) on a spare 2-way solenoid valve. The spare was identical to the solenoid currently installed in the 2251(2)-81A/B CAM panels. The test was performed at 50 psig. Based upon this test data, it was determined the solenoid valve produced a resulting back pressure of 35 psig. The net effect being that the check valves were tested at approximately 15 psig and not the Tech Spec required 48 psig.

The root cause of the event is a procedure deficiency, in that it did not ensure an appropriate vent path during the procedural valve line up.

1. Problem Information Form (PIF) 96-2053 was written as a result of the IN 96-13 review.
2. Panels 2251-81A/B and 2252-81A/B were leak rate tested on June 8, 1996 and June 12, 1996, respectively. The panels were tested using a revised procedure (QCTS 0600-34 PFC 2540) that ensured a vent path to atmosphere. (Refer to Attachment C). The panels tested satisfactory.
3. A review of the entire series of LLRT procedures (QCTS 0600 series) determined this was the only procedure with a improper vent path.
4. The LLRT Test Director training Lesson Plan was revised to ensure the trainees understand the need for an obvious (and direct) vent path, and reasons why a test will be invalidated if an appropriate vent path does not exist. A discussion of this LER was included.

1. Procedure QCTS 0600-34 will be revised to ensure an appropriate vent path exists when leak rate testing the 2251(2)-81A/B panels (NTS #2541809600801 Support Engineering). Due October 1, 1996.
