Subject: LaSalle County Station Units 1 and 2
Confirmatory Action Letter
NRC Docket Nos. 50-373 and 50-374

March 5, 1985

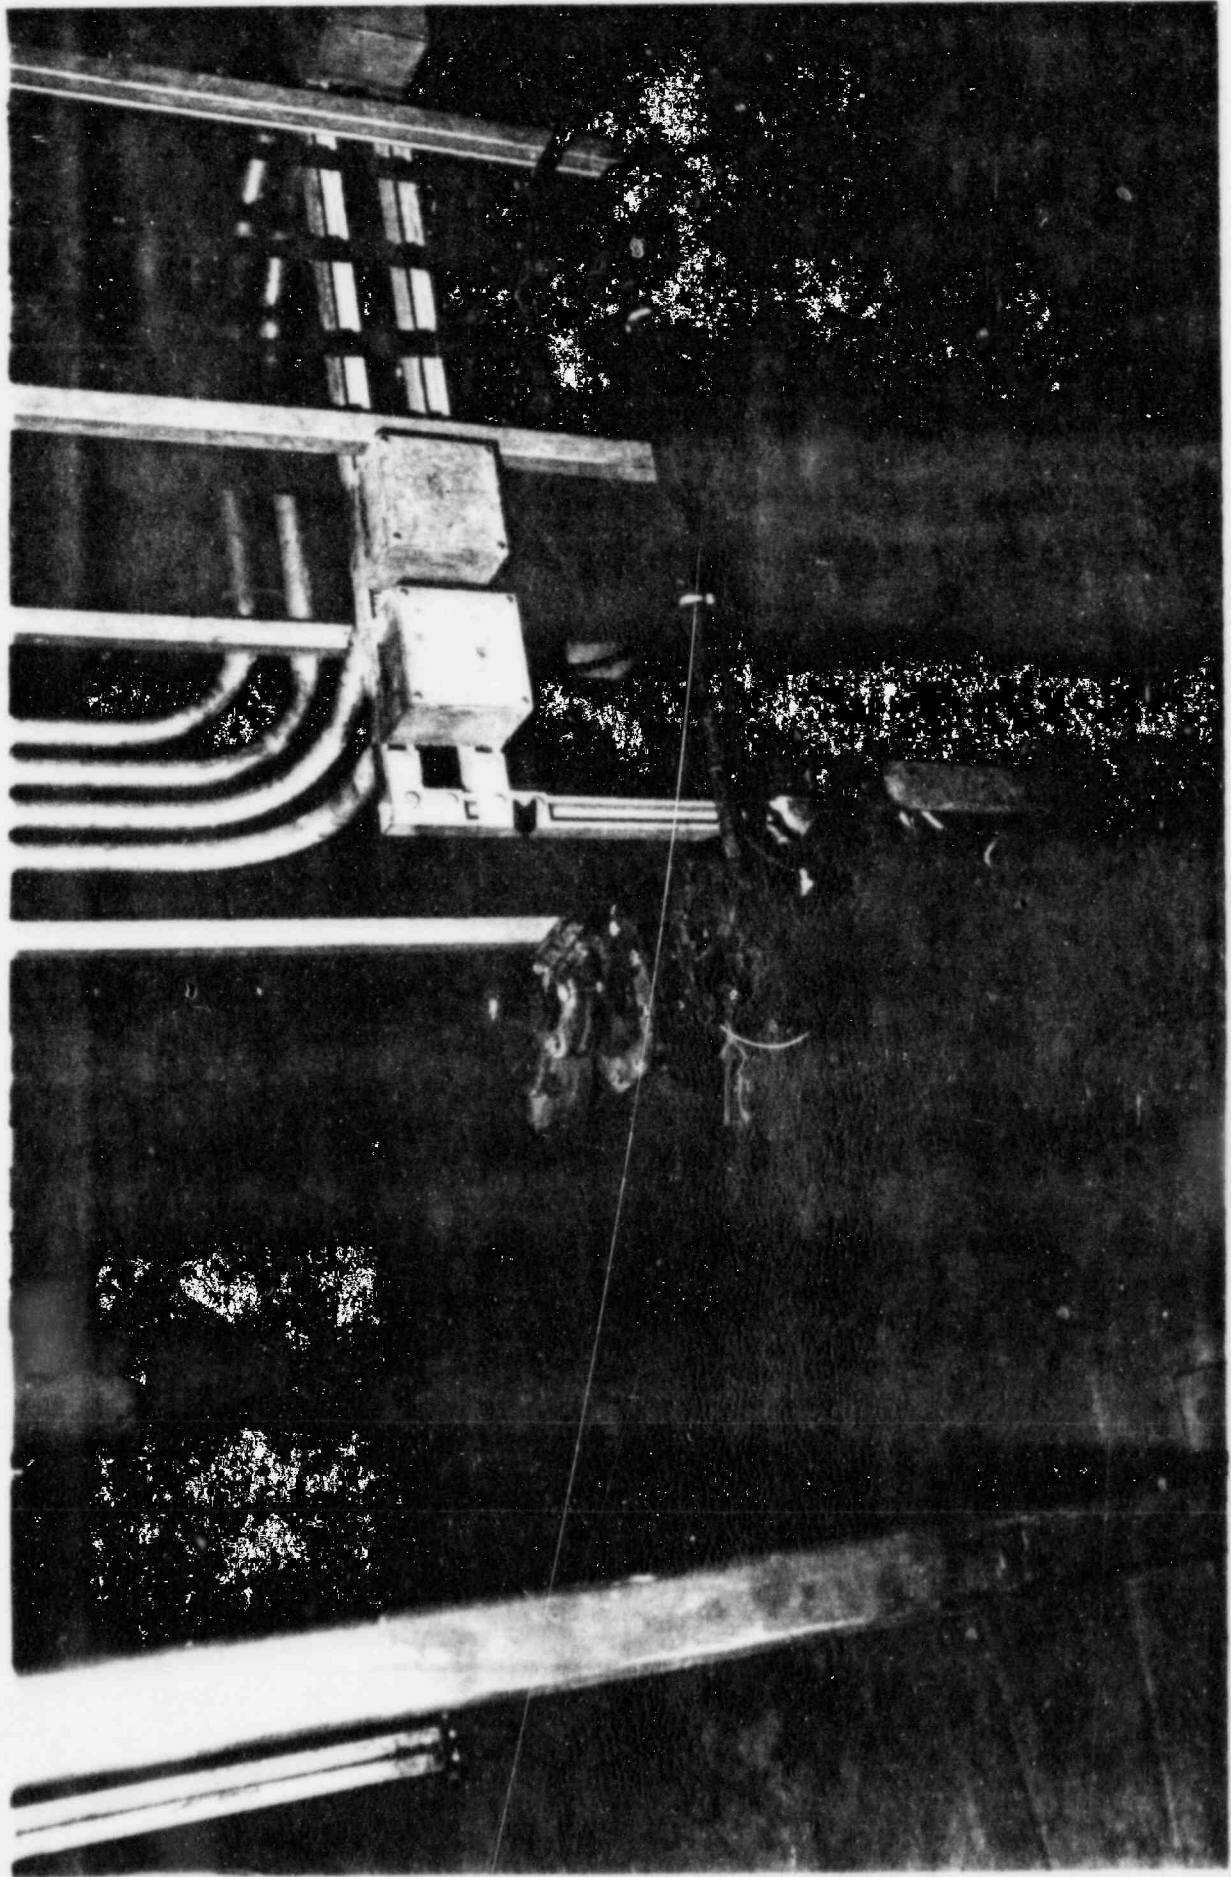
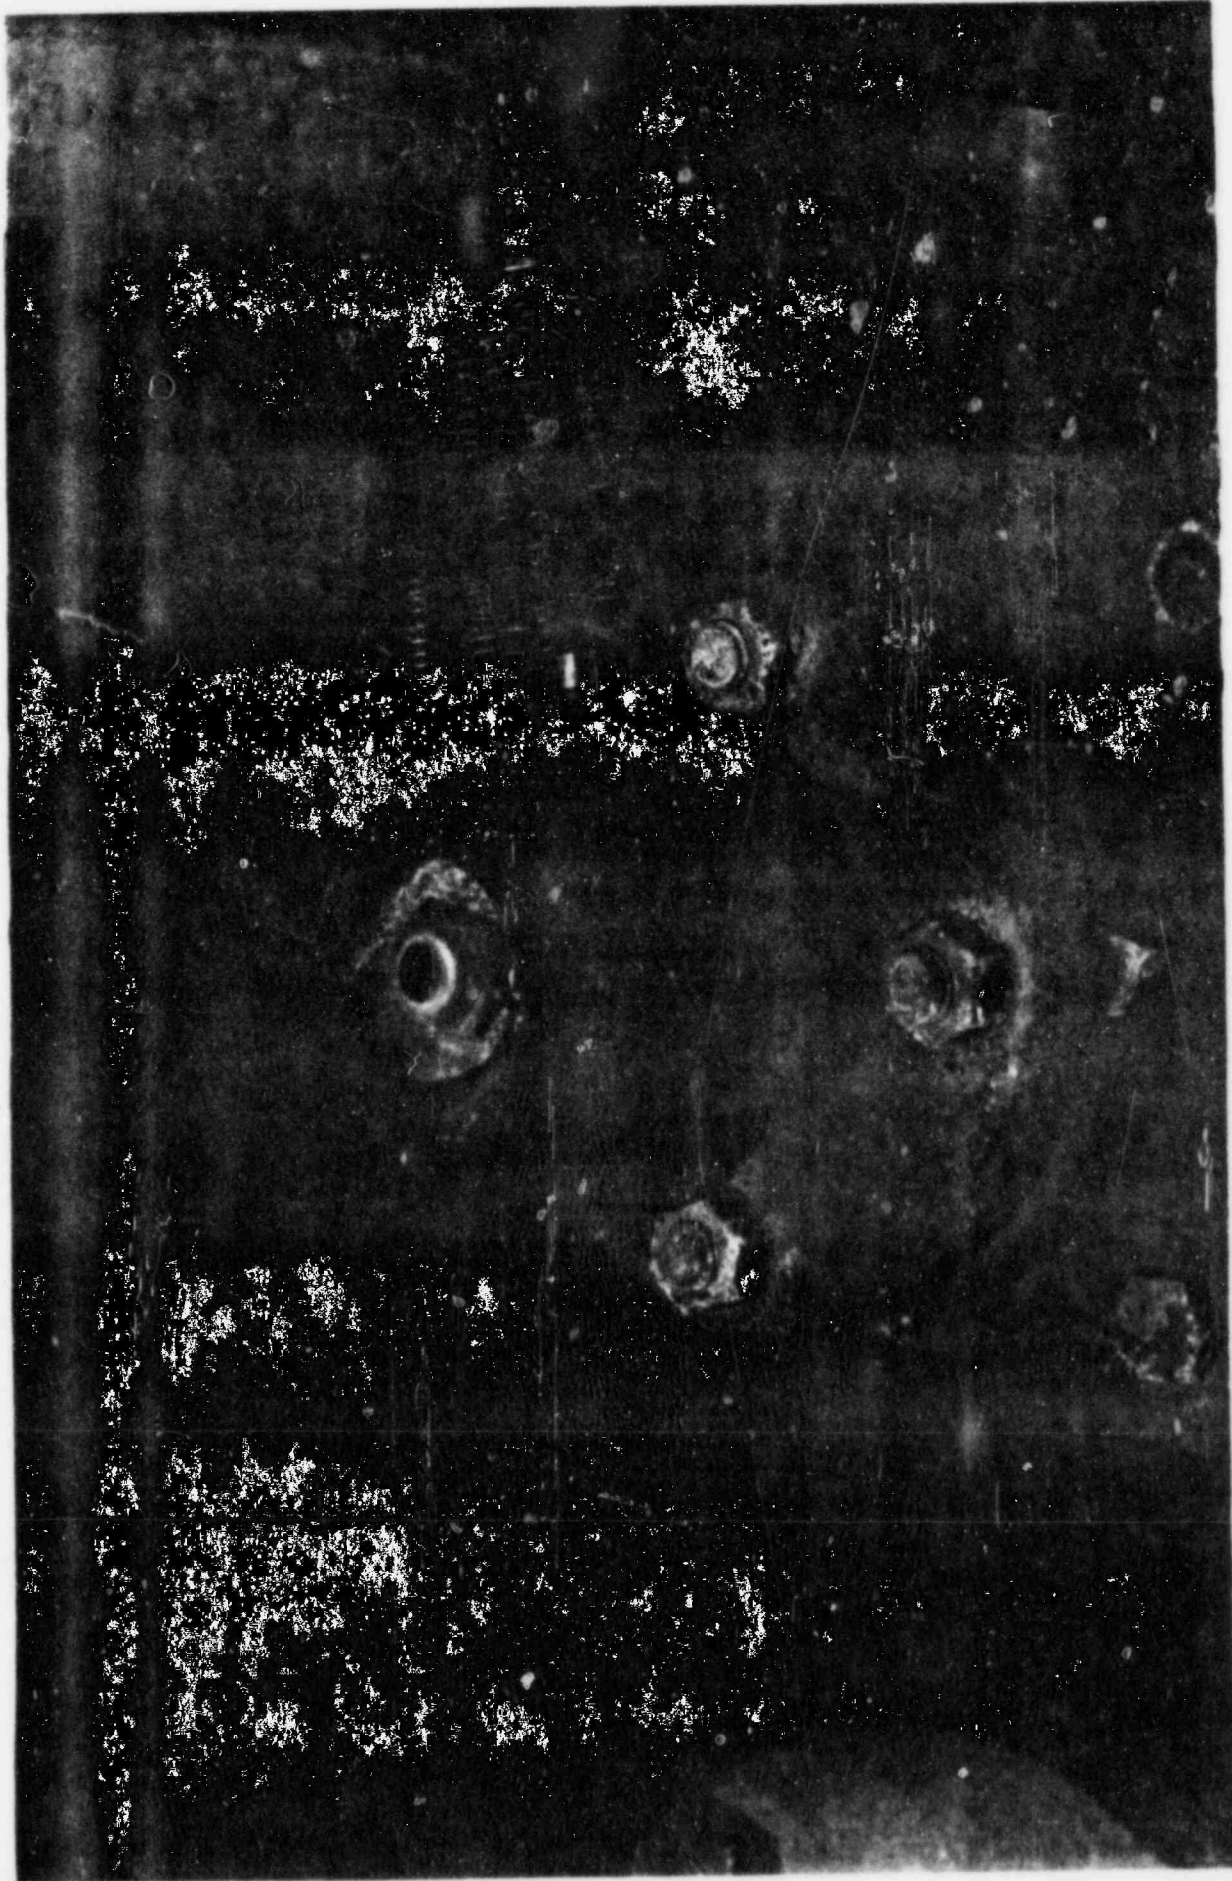
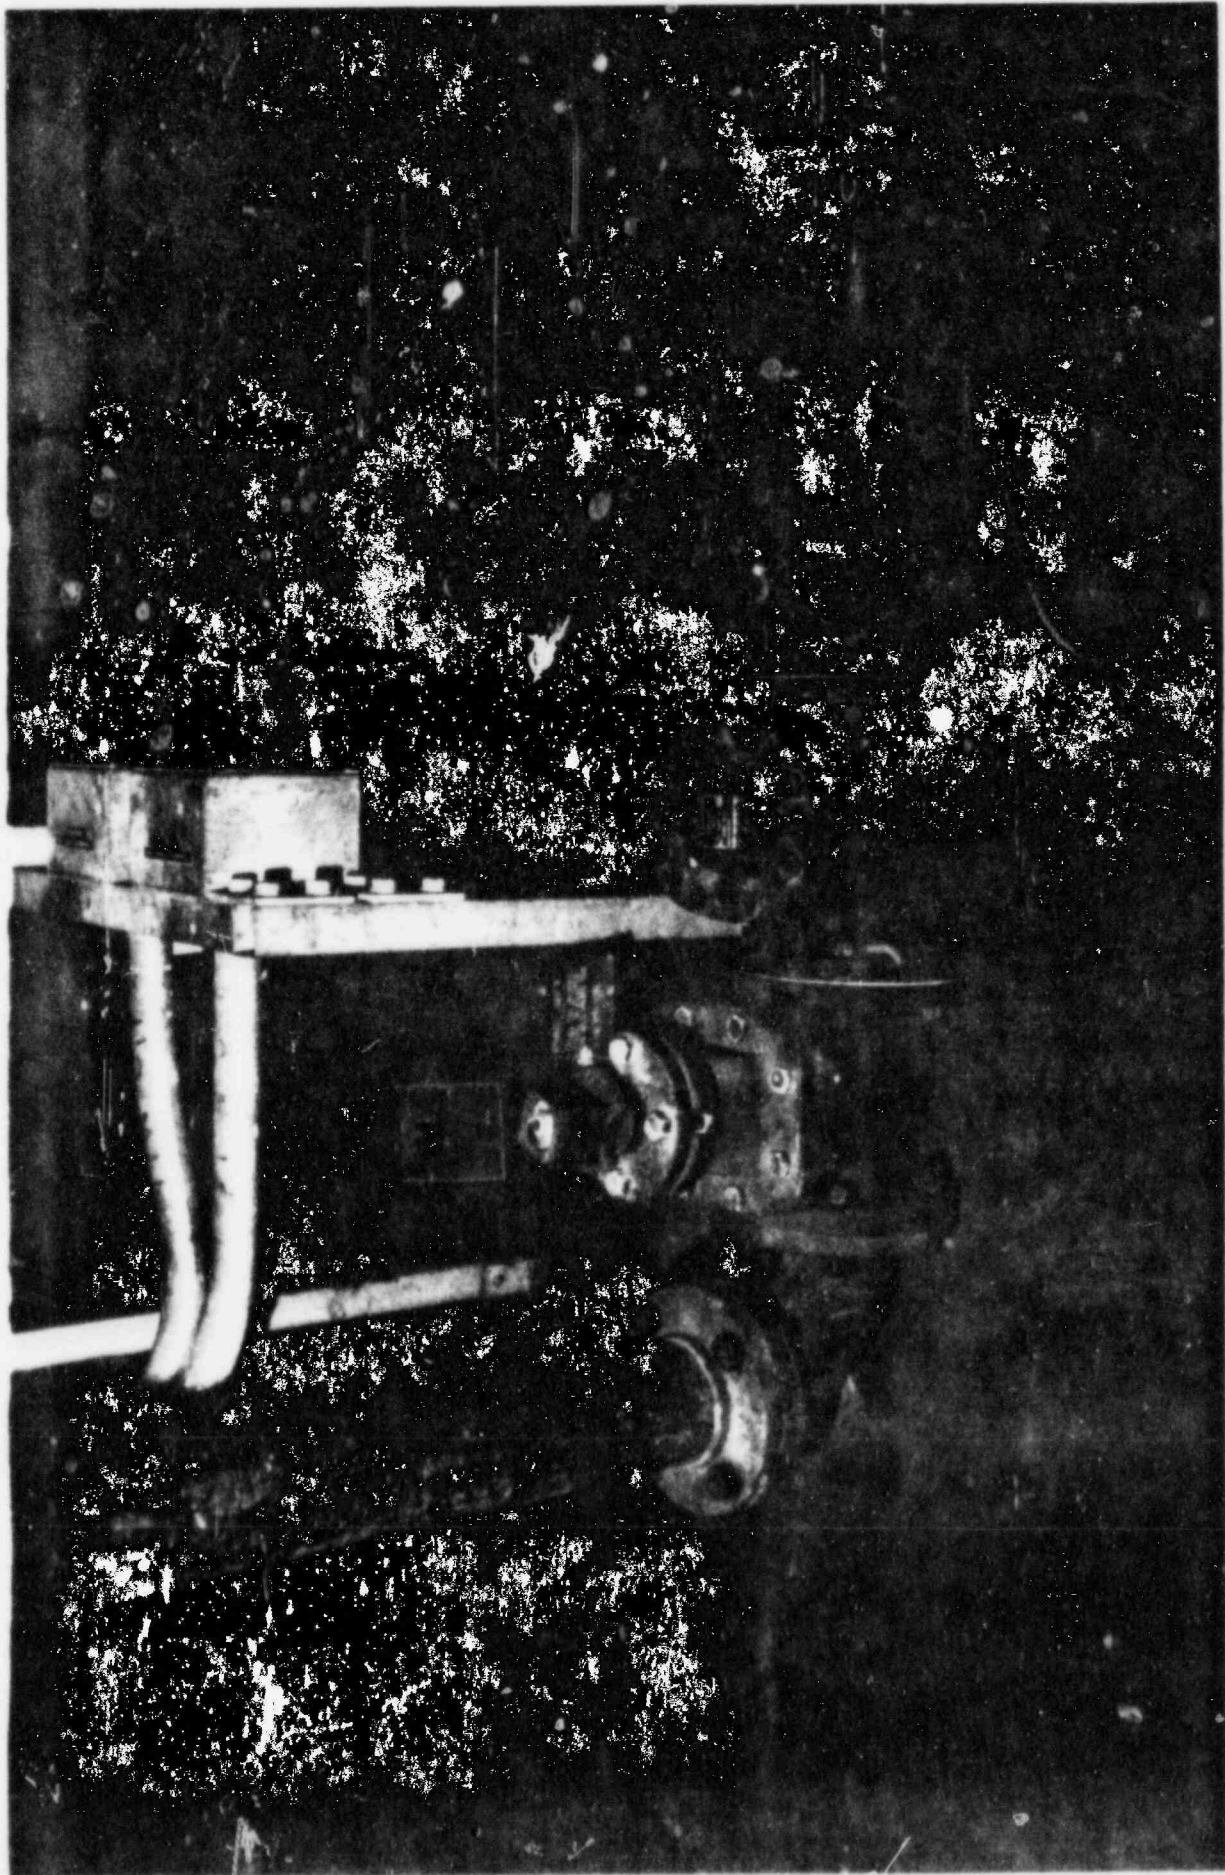
At approximately 1200 hours on 2/16/85, it was discovered that the Wastewater Treatment Facility Equalization Tank Discharge Valve was closed. The event was discovered by the Radwaste Coordinator following up on a report by the "B" Operator that the integrator had not changed during her rounds. No authorized activities were discovered that could have resulted in this valve being in the closed position.

LSCS EVENT #1 WWTF DISCHARGE VALVE OT W002A

LSCS EVENT #1 WWTF DISCHARGE VALVE OTW002A

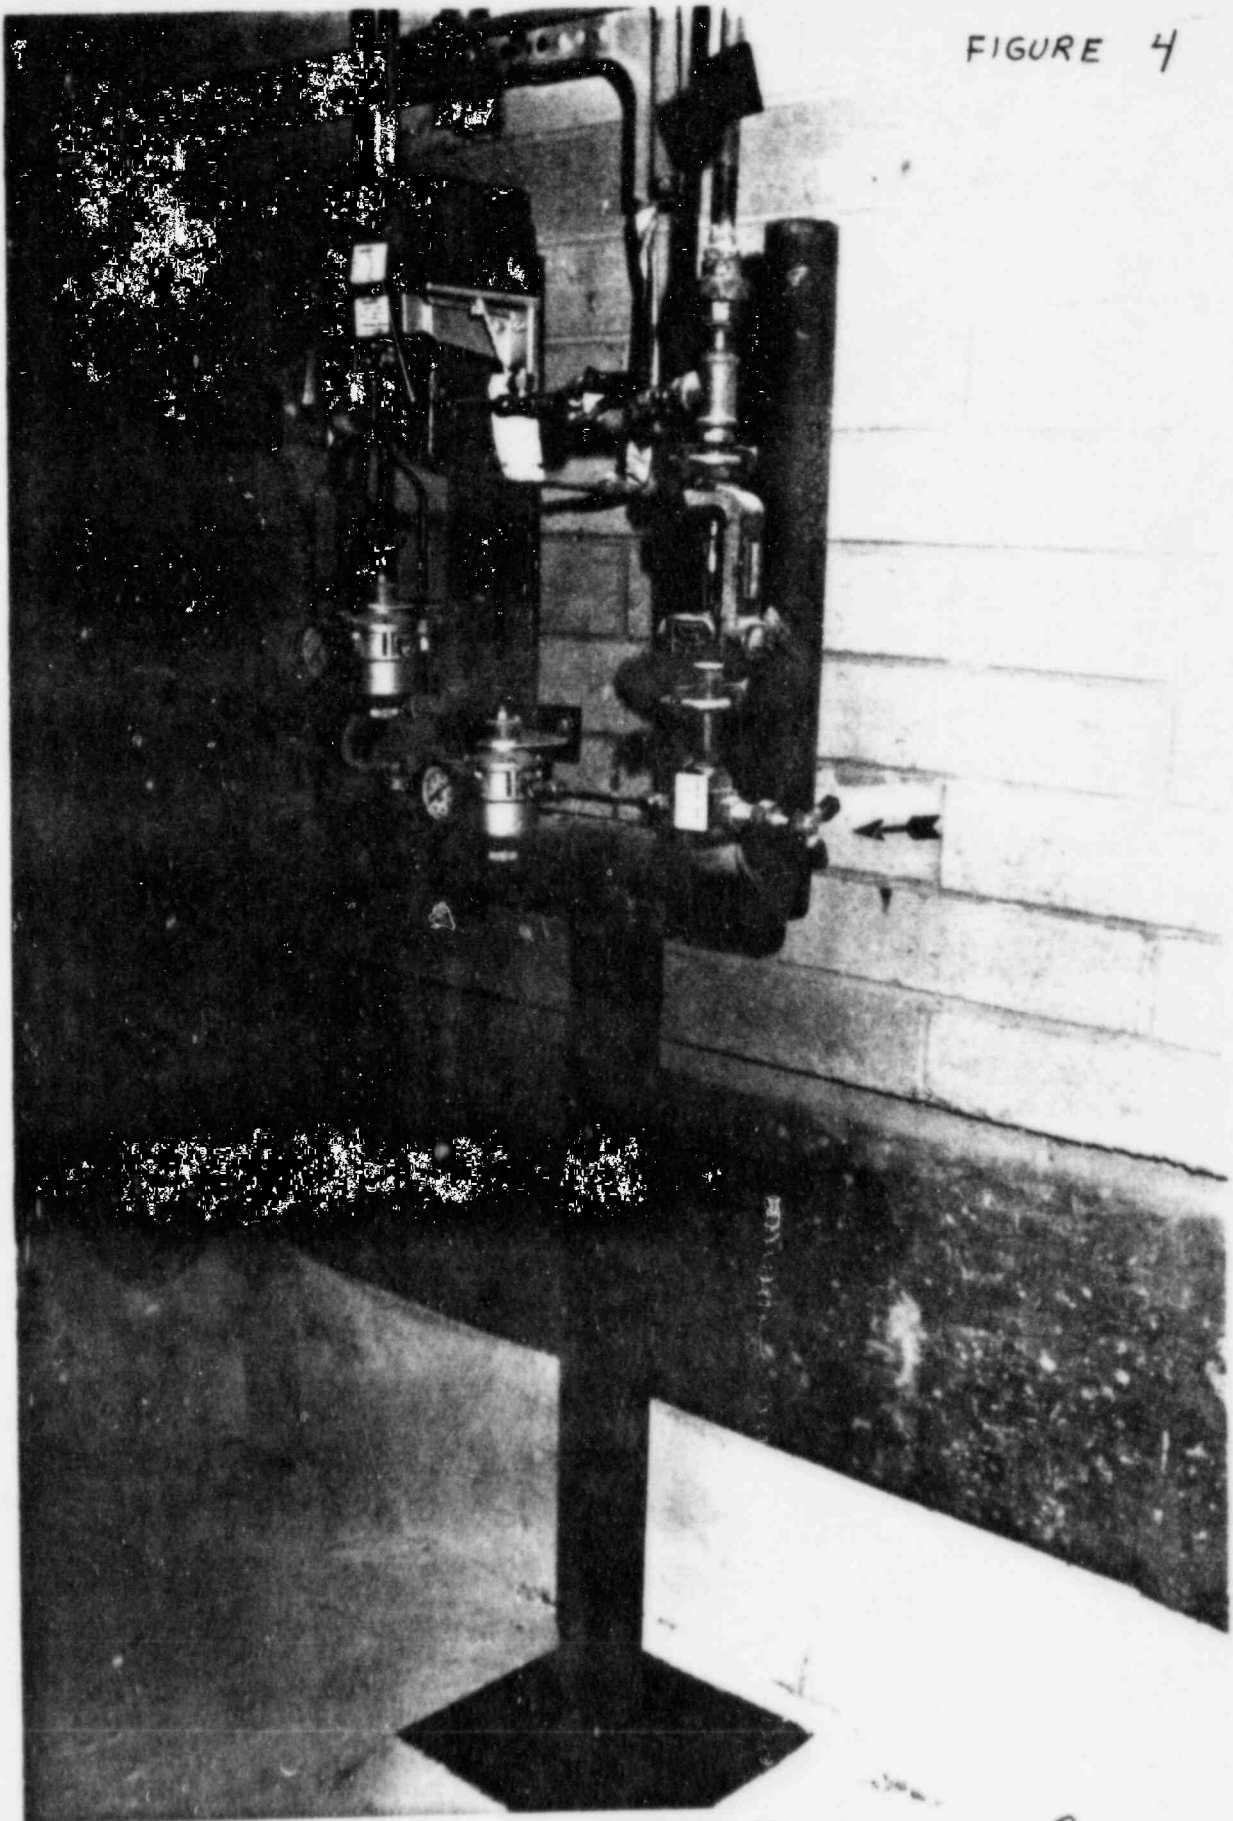
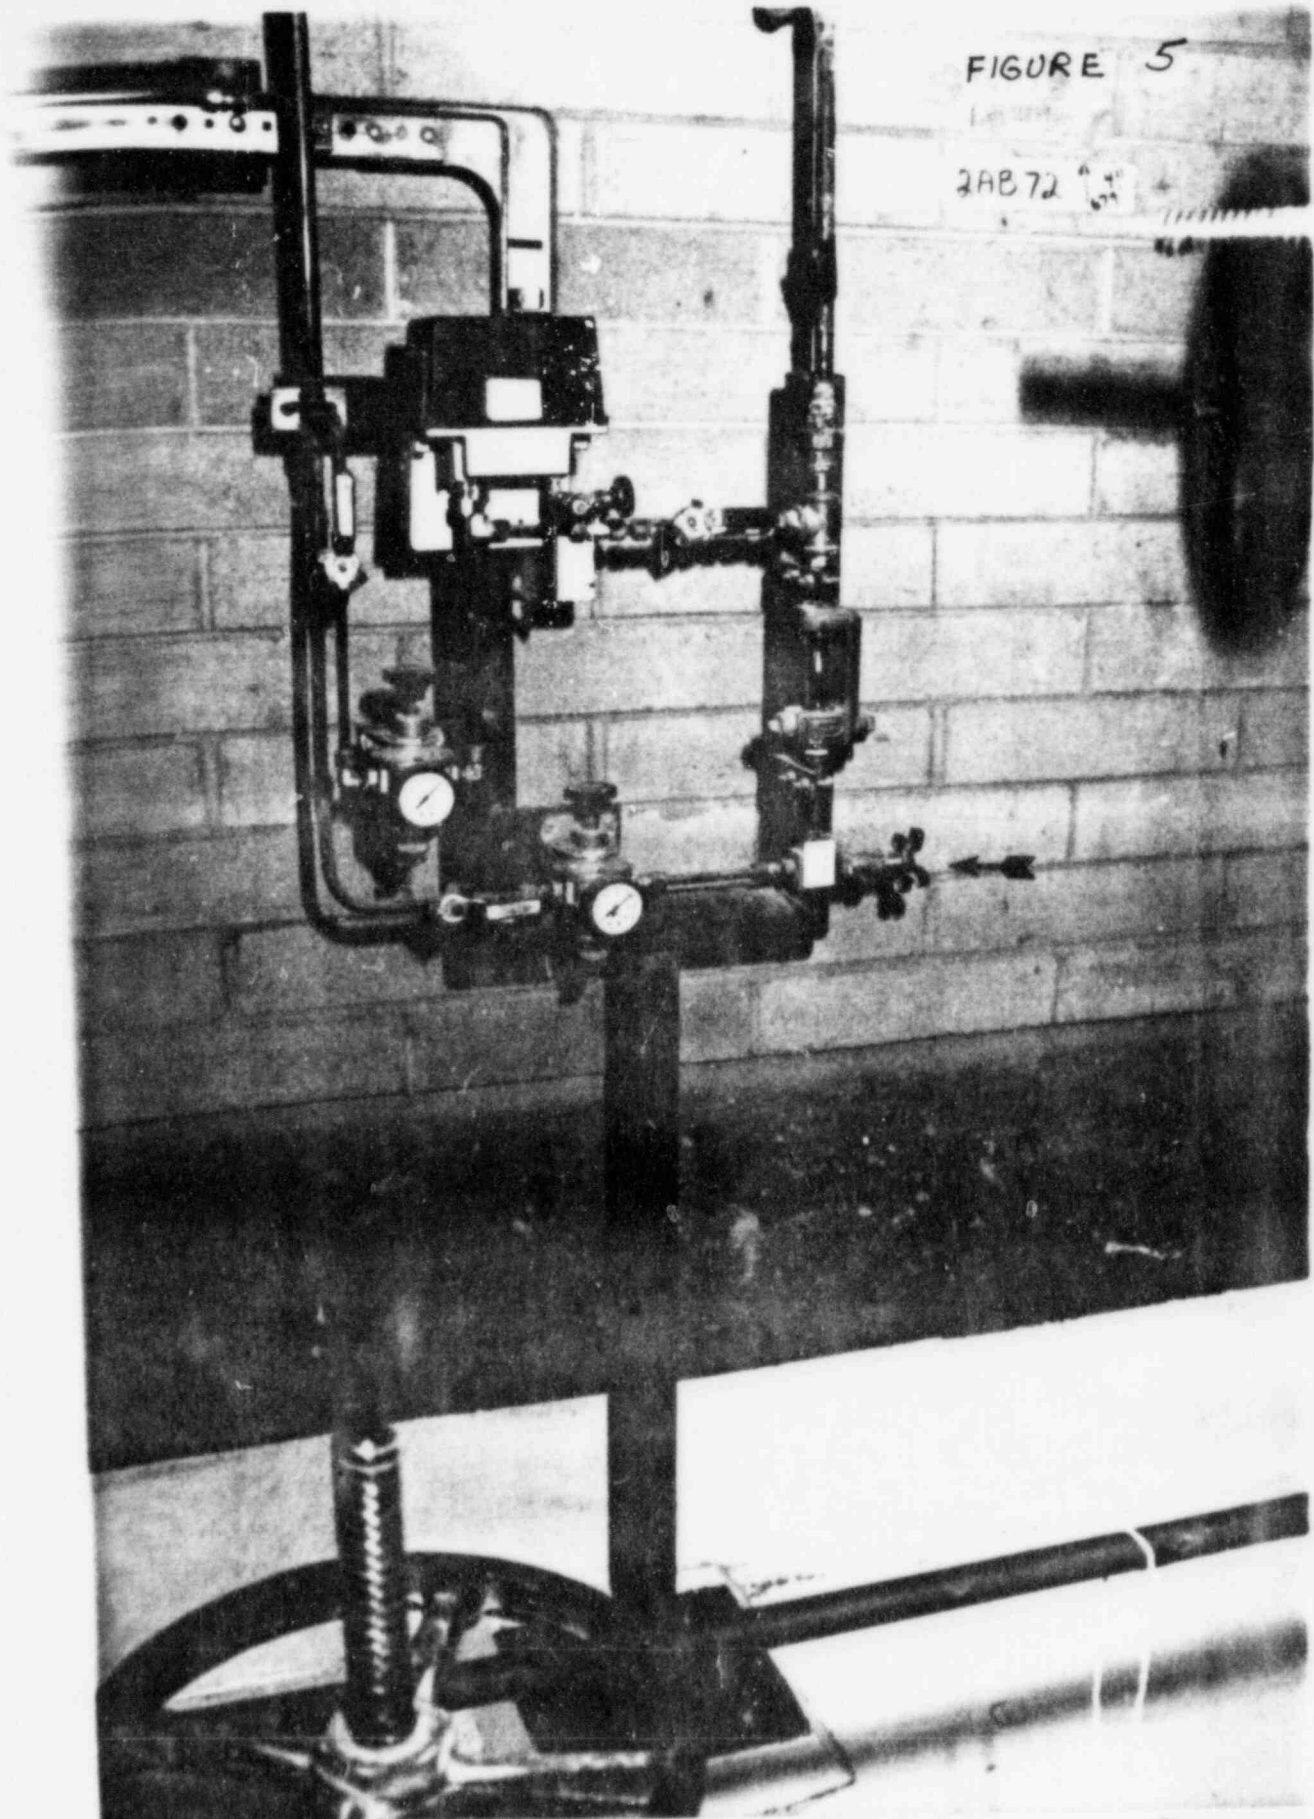
At 1900 hours on 2/16/85, the Radwaste Operator noted that level indication for the 2A Floor Drain Concentrator Feed Tank mysteriously dropped from 100" to 0" indicated level. Investigation by the Radwaste Foreman determined that the air supply to the bubbler valve was closed. This tank was not feeding at the time and this event therefore, had no impact on Radwaste operations.

Investigation revealed that stationmen had been cleaning in the area approximately two hours prior to the event, and that the valve could have been closed by someone inadvertently bumping the valve. However, this is unlikely since experimentation determined that level indication is lost 5 to 10 minutes after the valve is closed. The time frames involved do not place the stationmen in the area when the valve was closed.

Another possible cause is that a foreign material became lodged in the valve, blocking flow, and became dislodged when the operator adjusted the valve. The valve involved is a needle valve and due to close tolerances could easily be clogged by foreign particles. Experienced operating personnel state that this type of valve requires periodic adjustments to maintain proper level indication.

LSCS EVENT #2 2WFO3TA INDICATING BUBBLER

LSCS EVENT #2

2WFO3TA INDICATING BUBBLER
