Subject: LaSalle County Station Units 1 and 2
Confirmatory Action Letter
NRC Docket Nos. 50-373 and 50-374

March 5, 1985

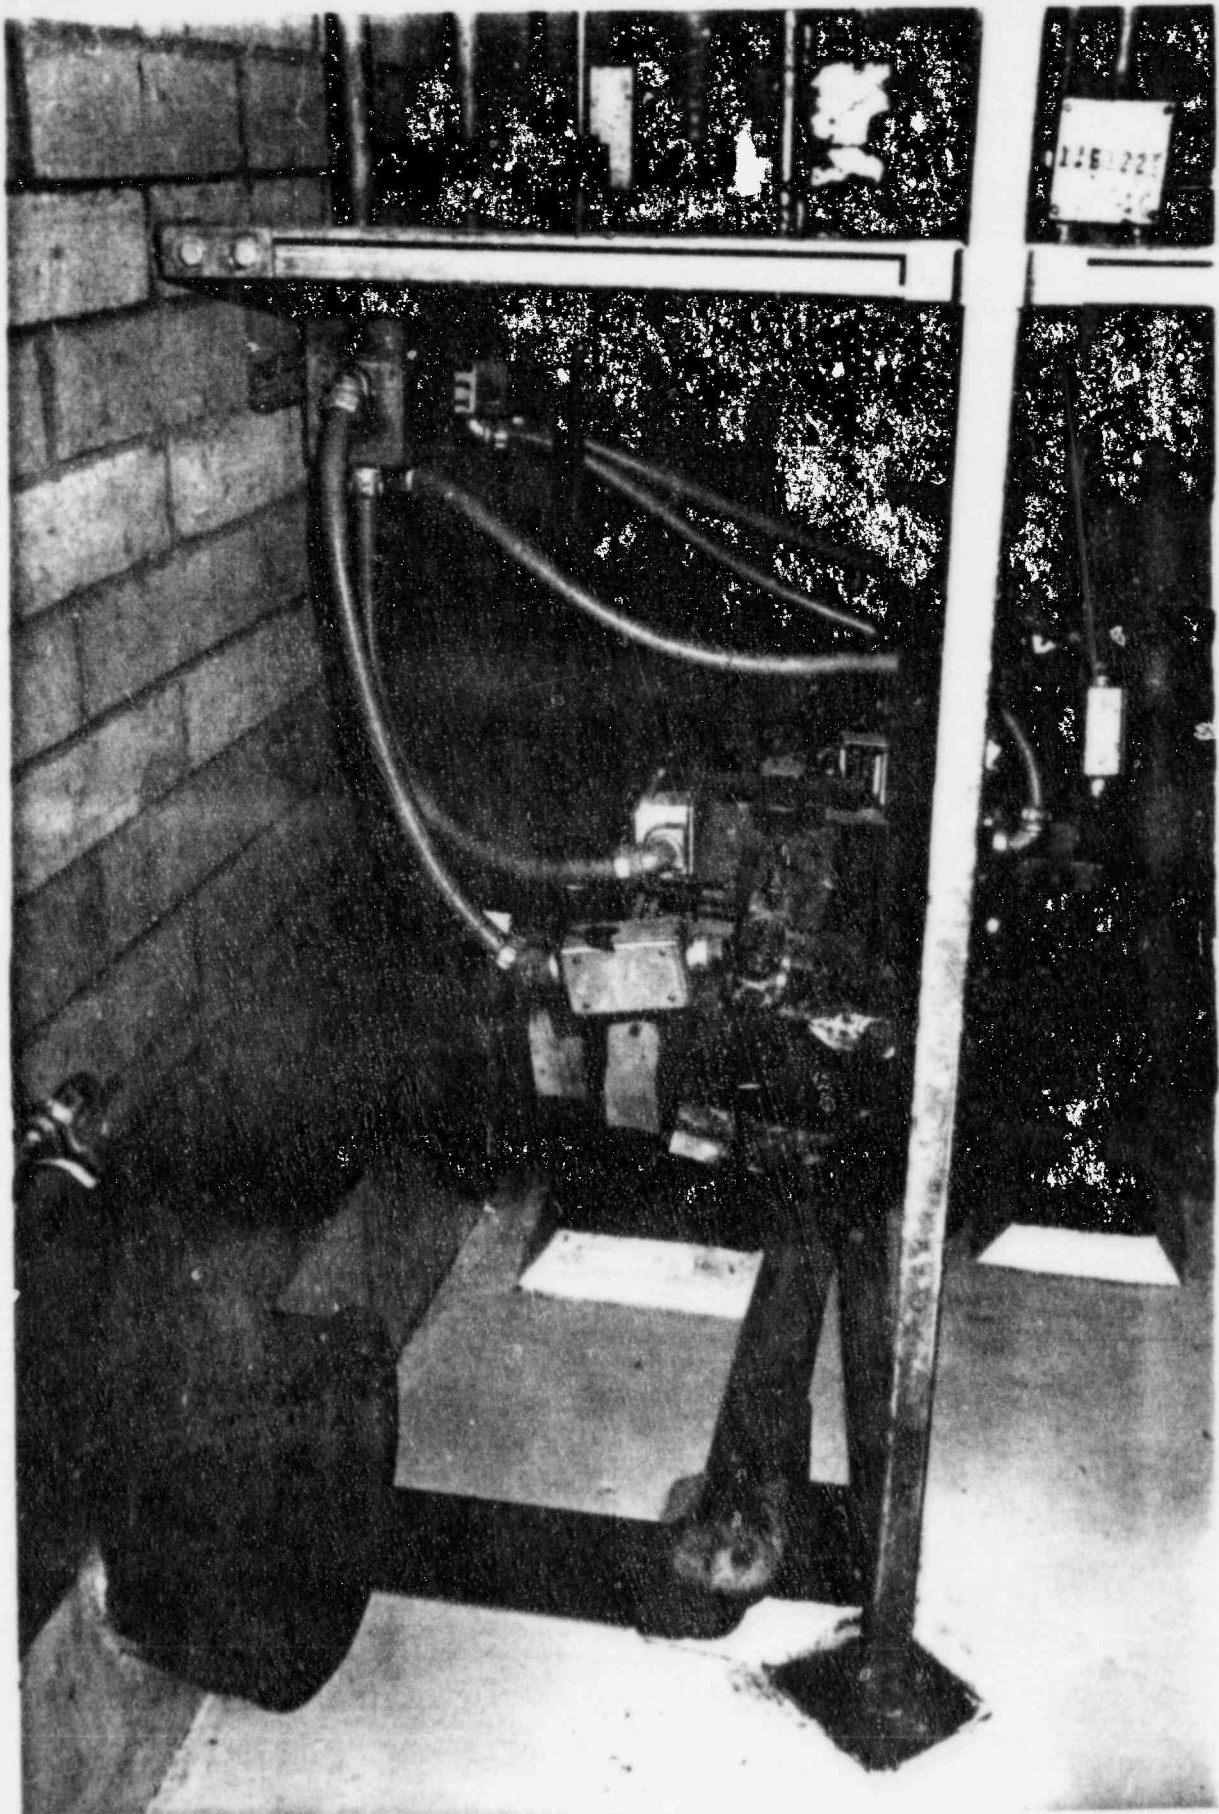
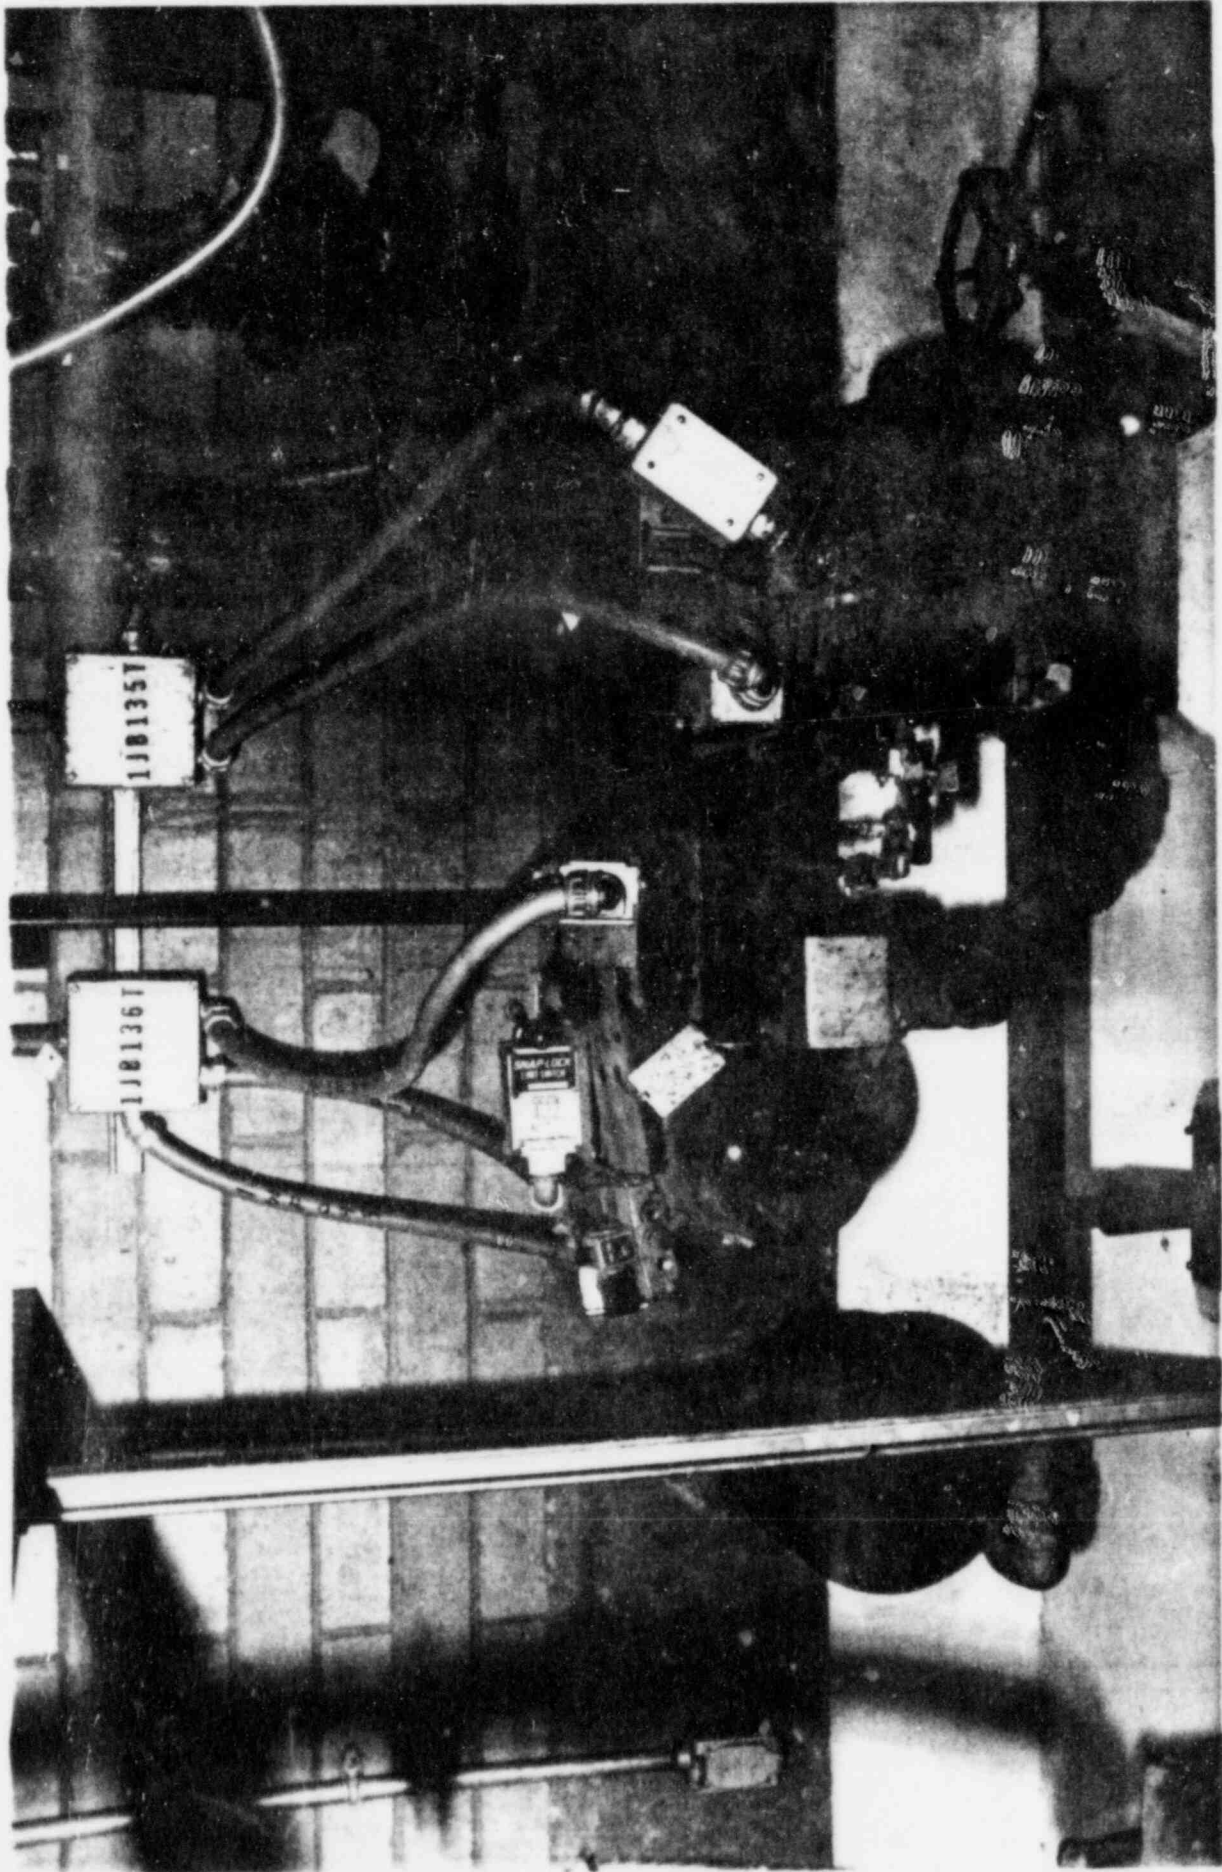
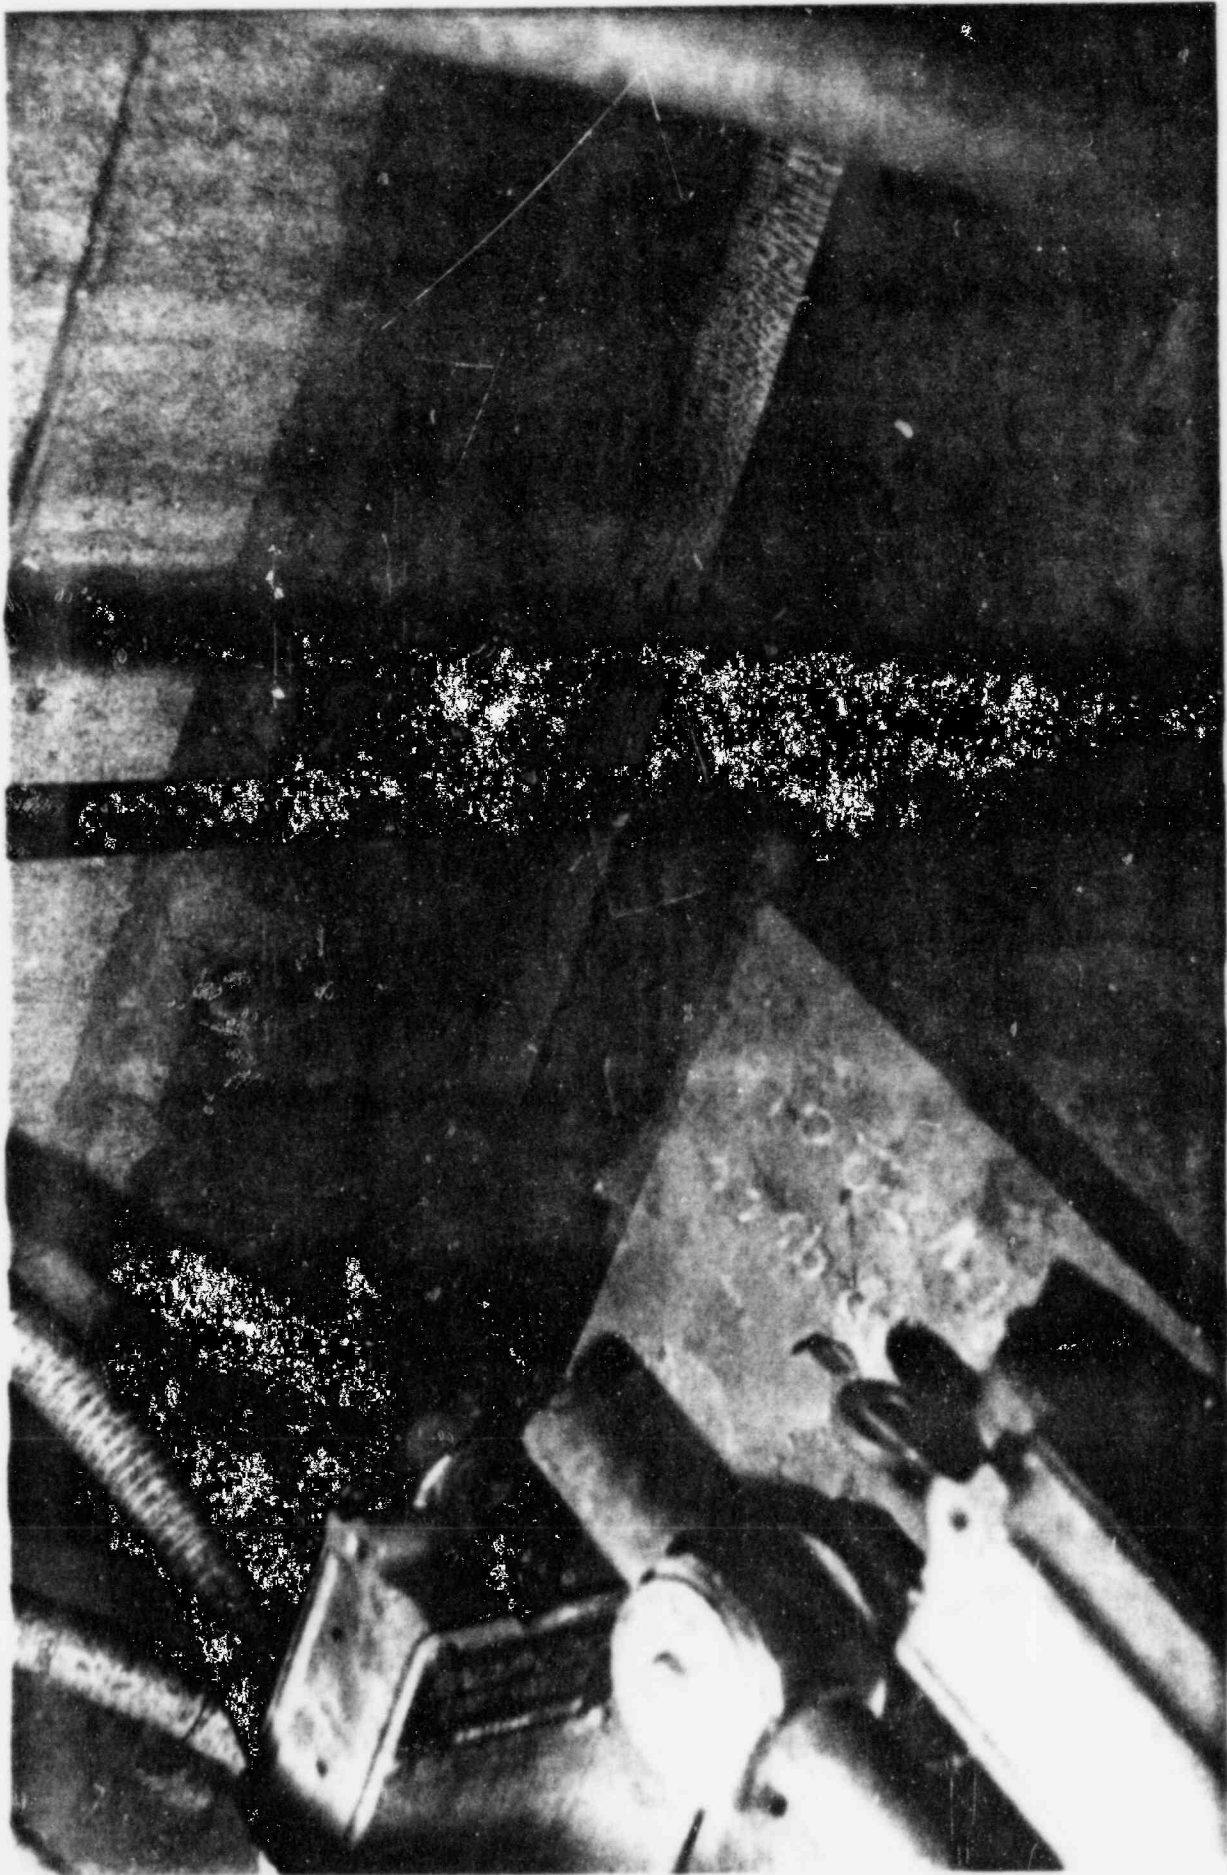
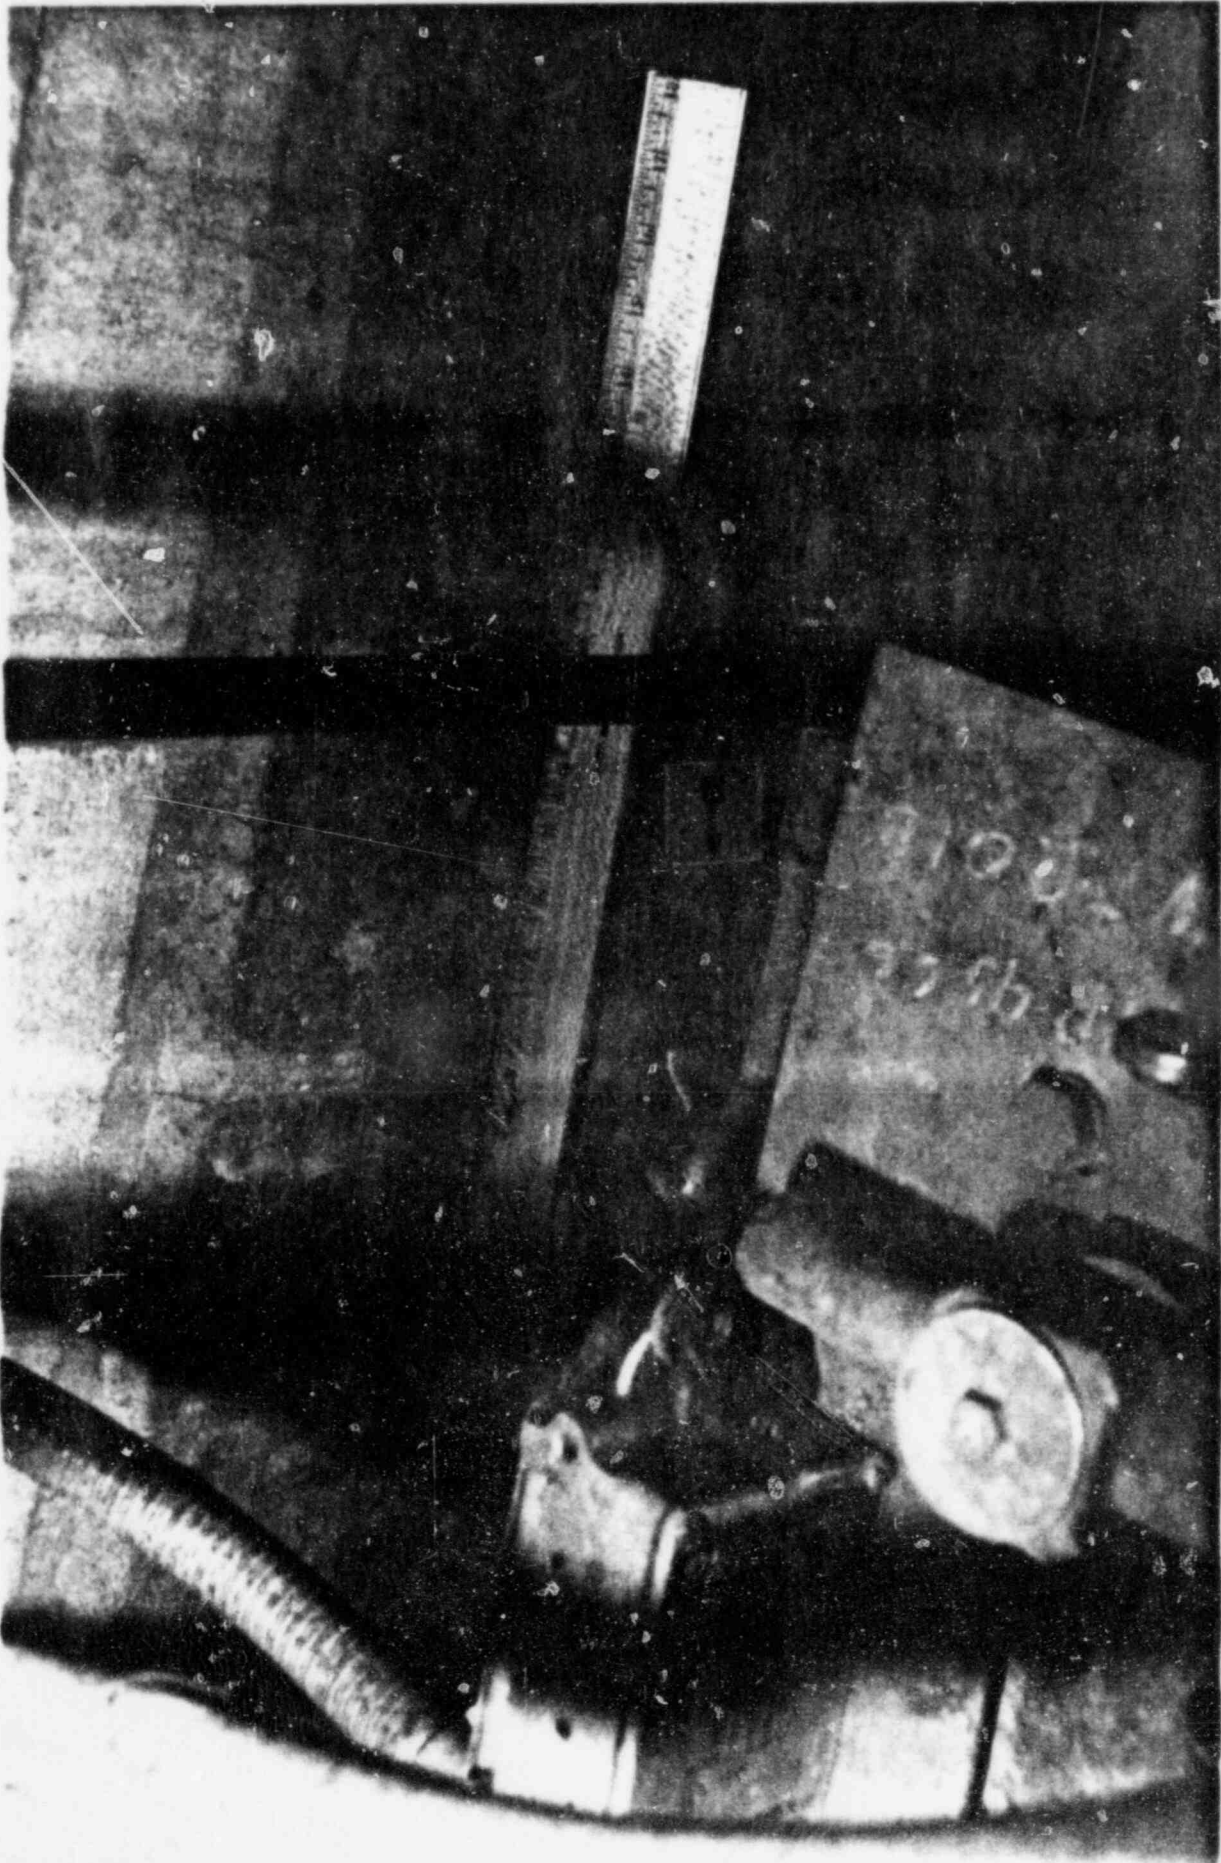
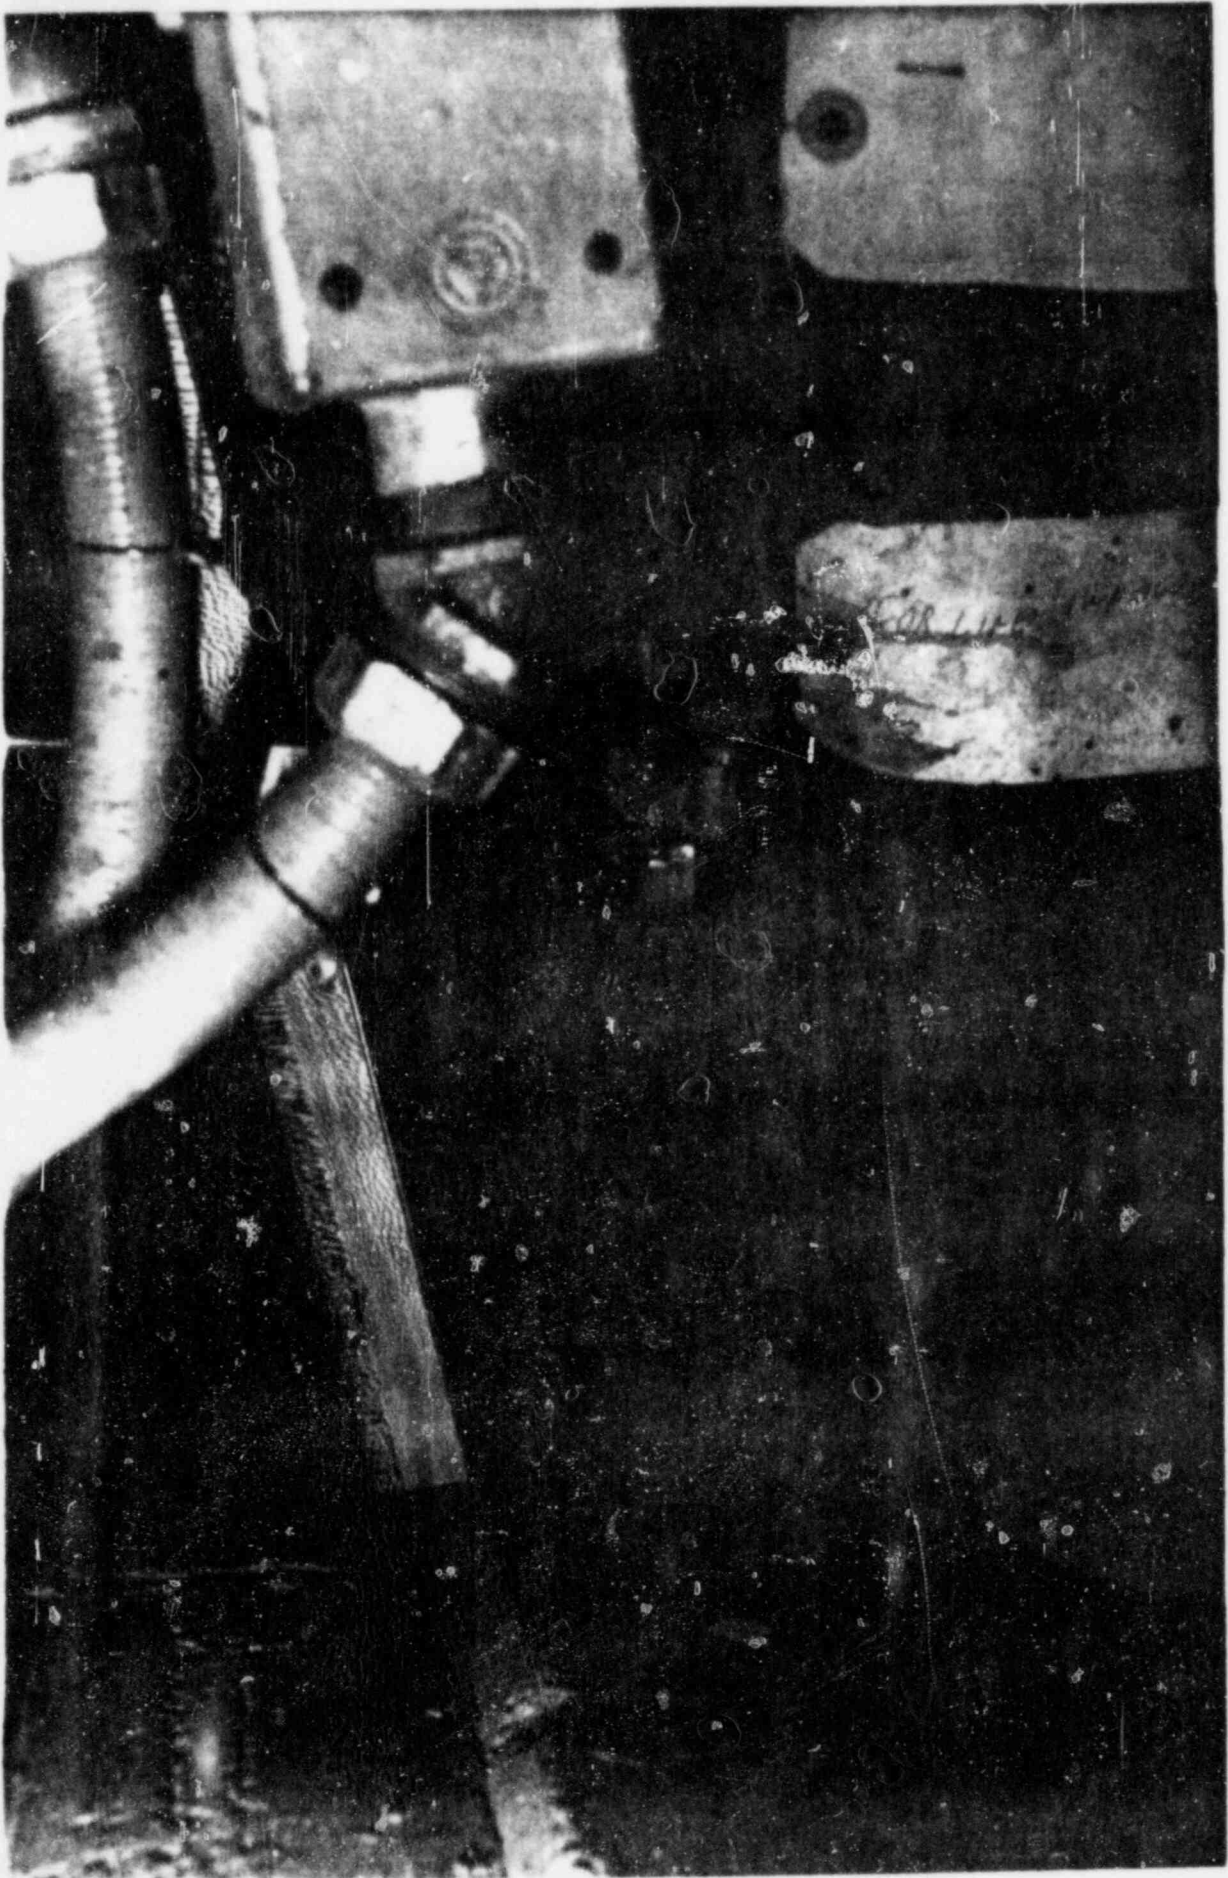
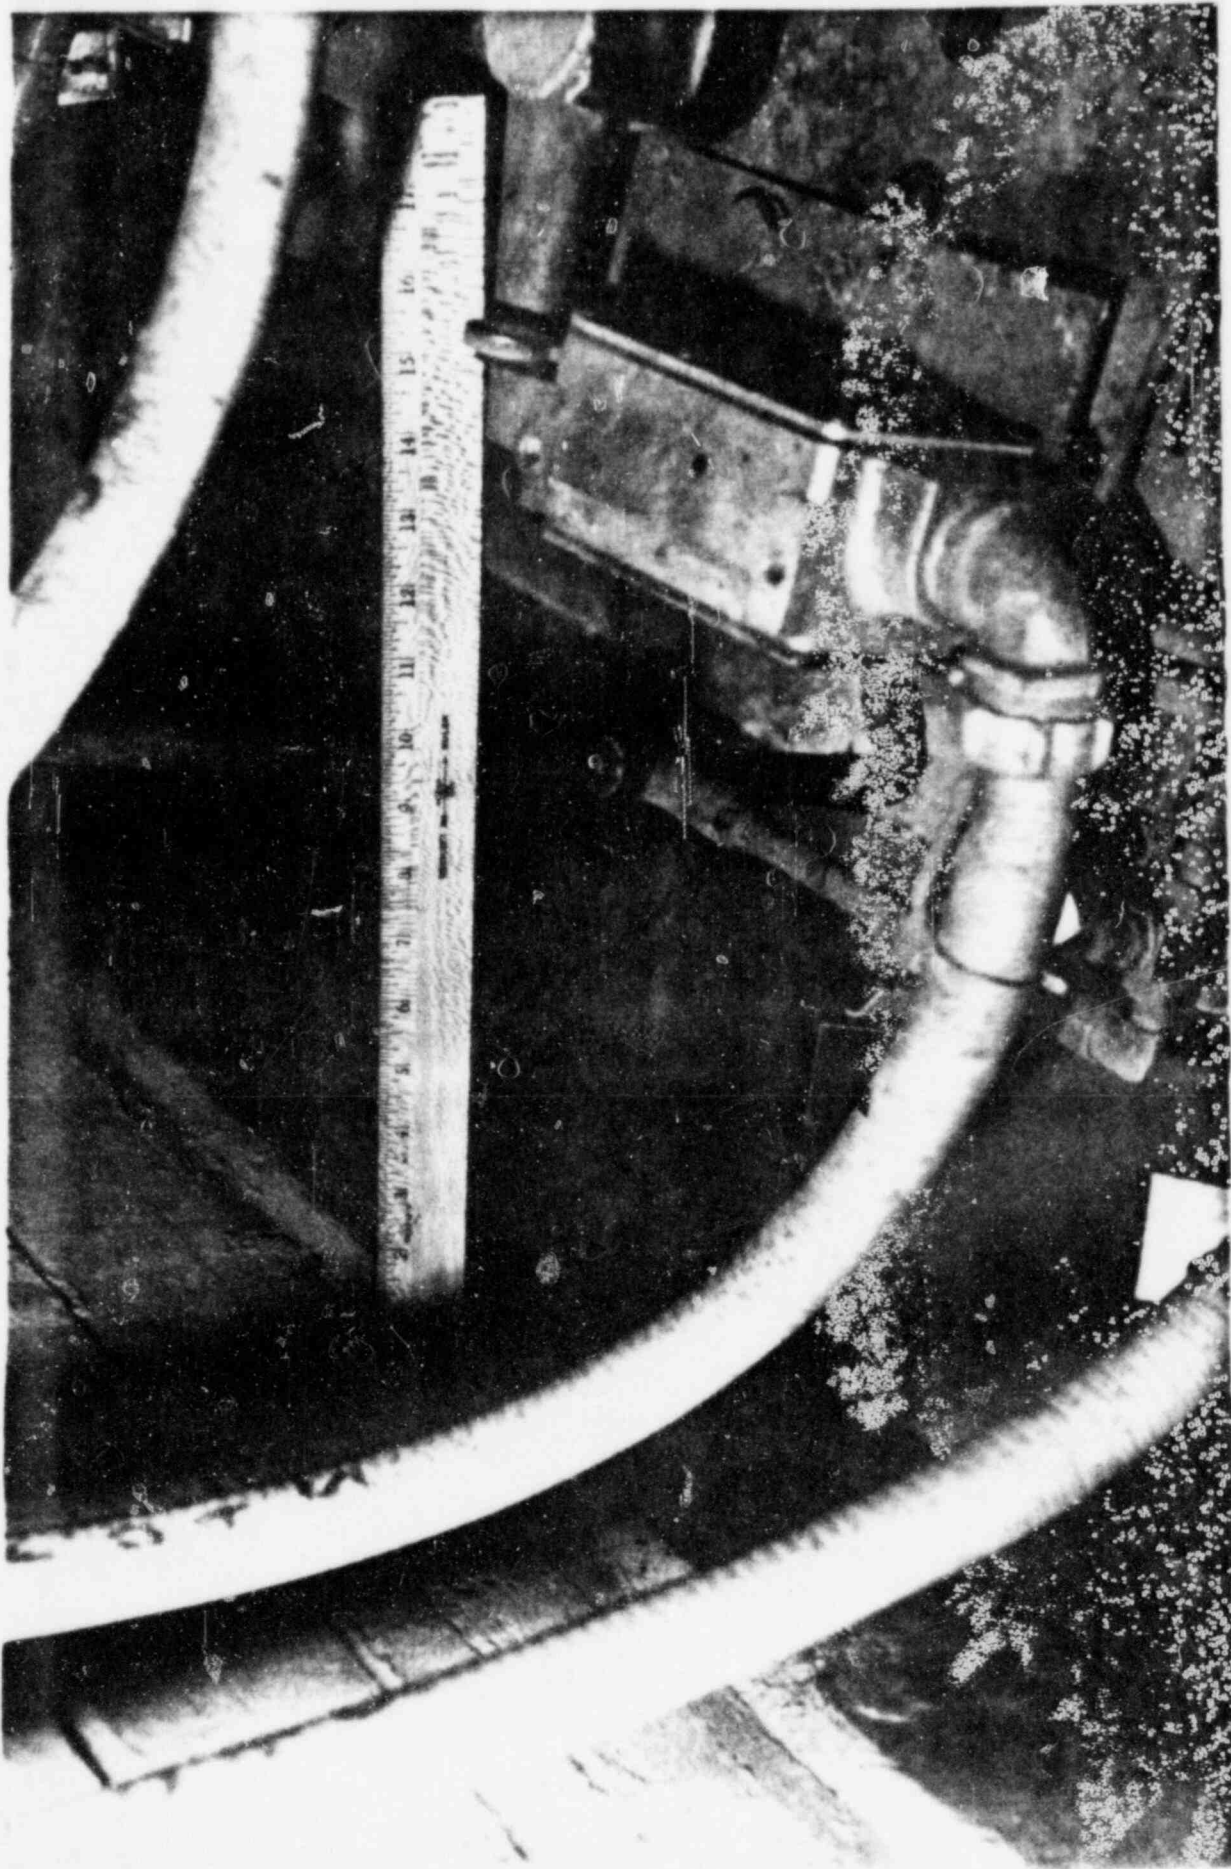
At approximately 2330 hours on 2/17/85, an unsuccessful attempt was made to open the 1B Floor Drain Concentrator Feed Tank Side Suction Valve 1WF201B. Investigation determined that the air supply valve to the valve operator was closed. Experimentation determined that valve 1WF201B will close approximately 5 seconds after isolation of its air supply.

This valve is normally always open and is positioned such that it would be virtually impossible to inadvertently bump the valve closed.

LSCS EVENT #3 1WF201B AIR ISOLATION VALVE

LSCS EVENT #3 IWF 201B AIR ISOLATION VALVE

AIR ISOLATION VALVE

LSCS EVENT #3 1WF201B AIE ISOLATION VALVE

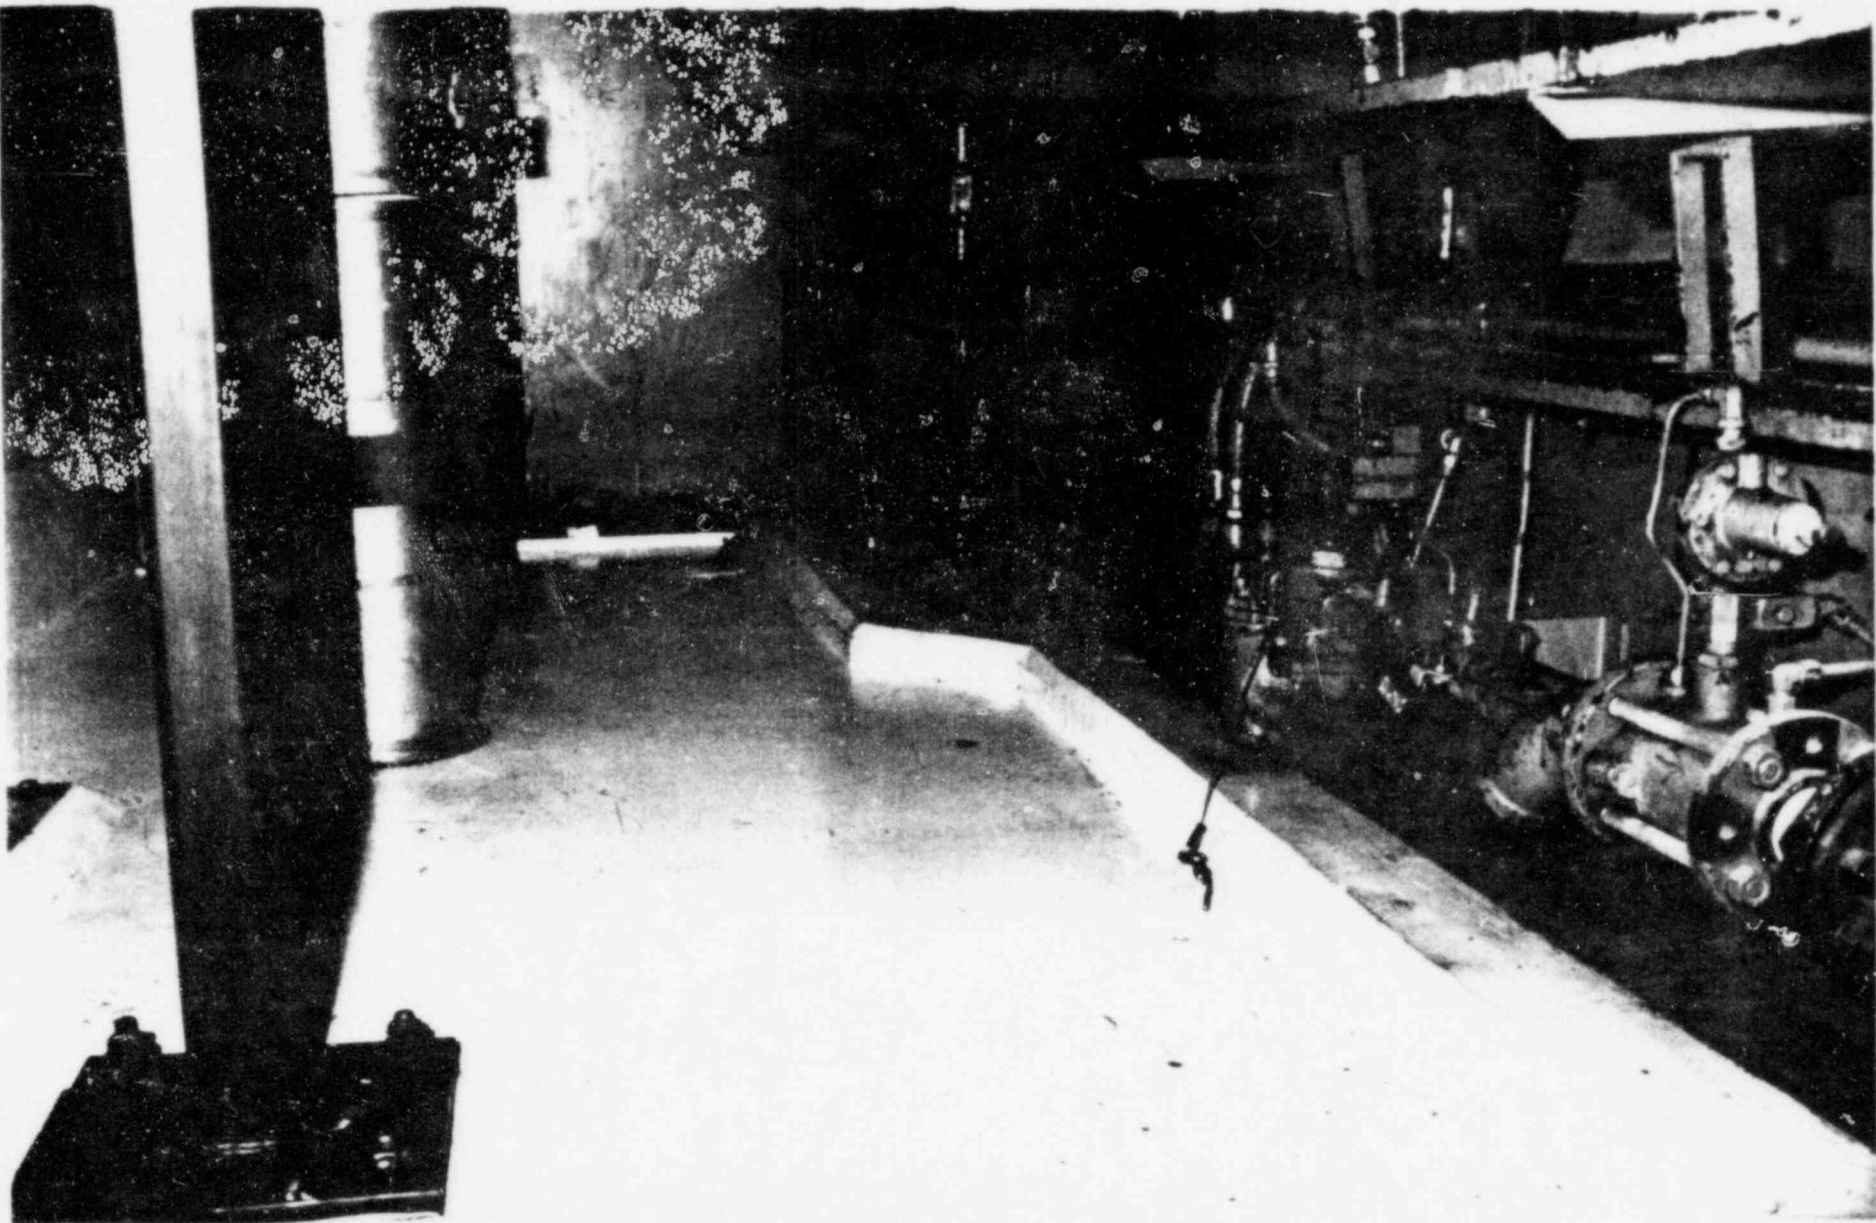
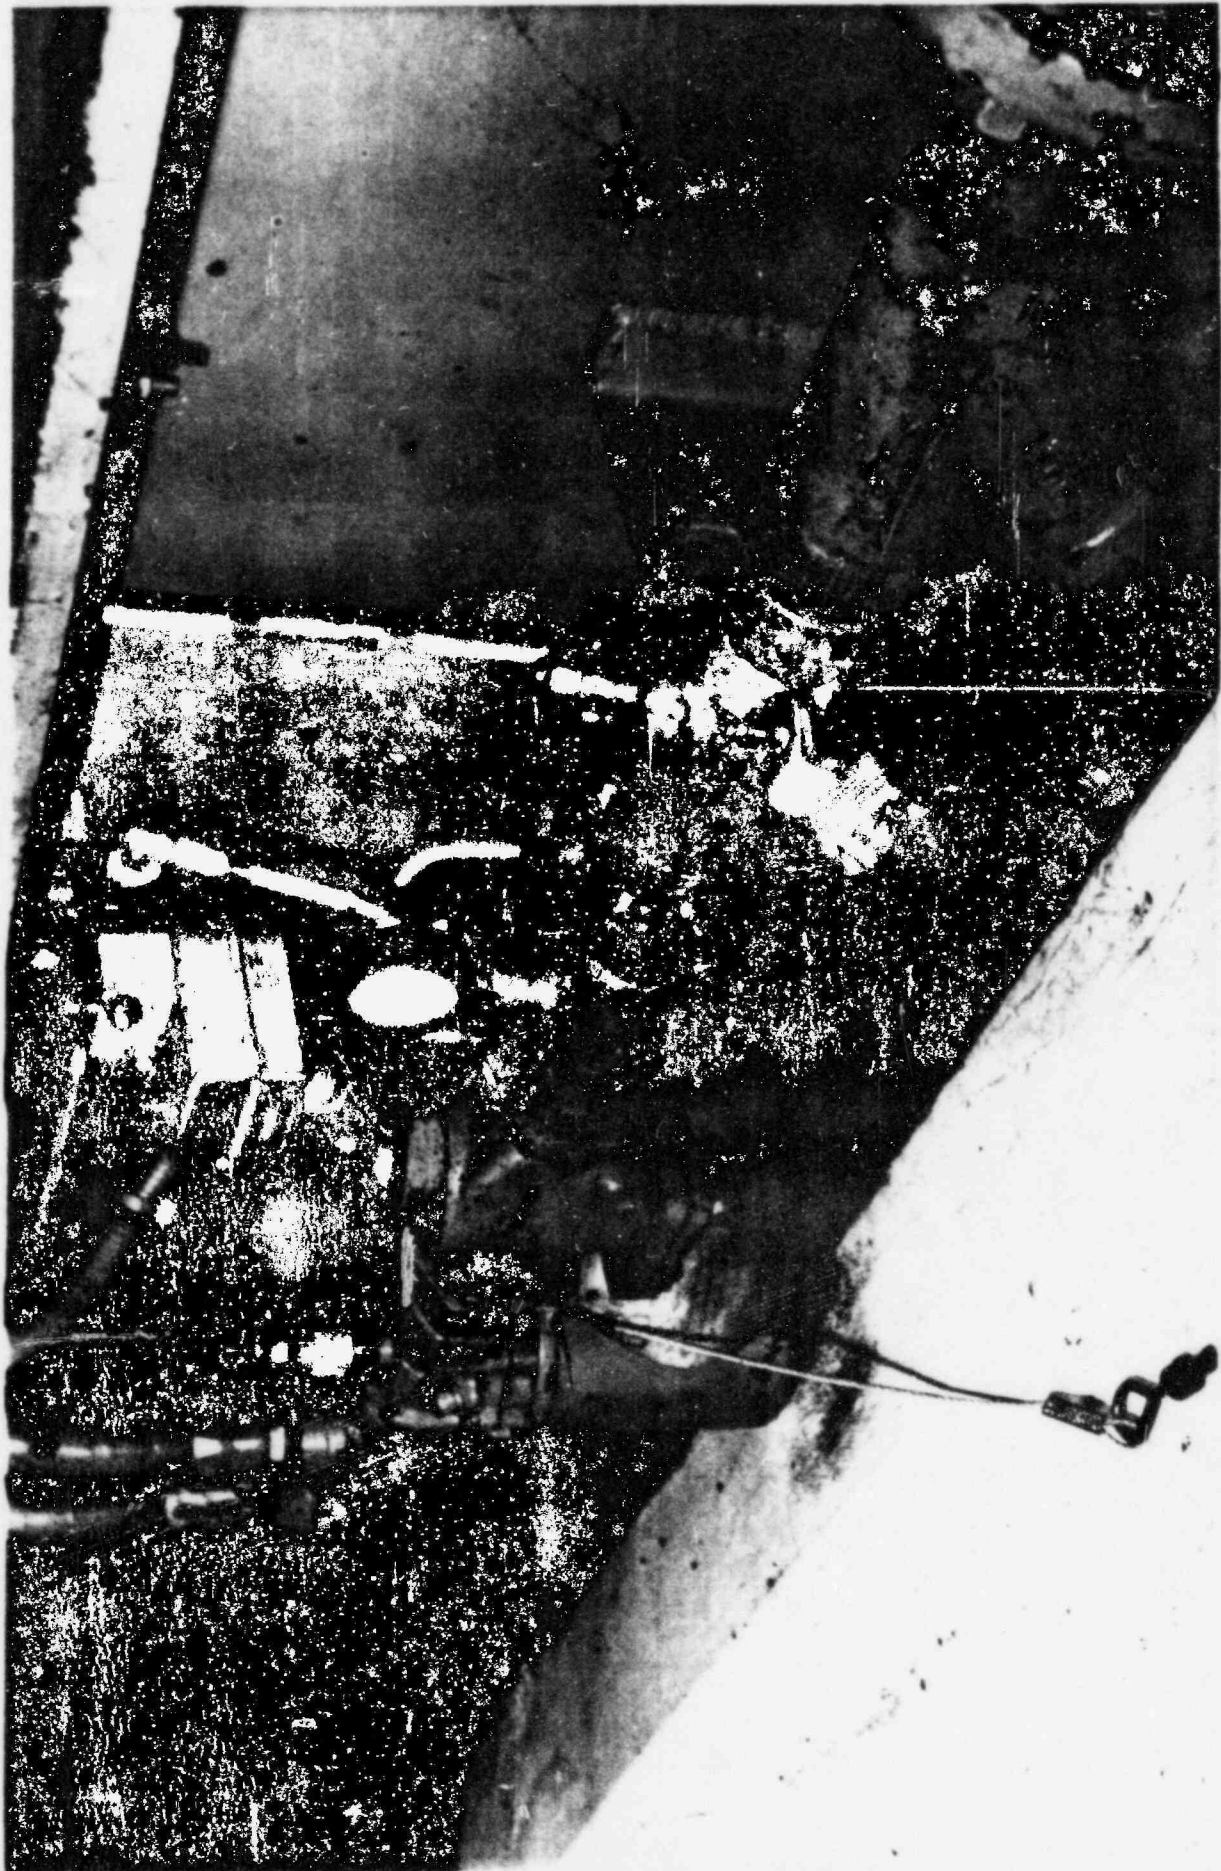
At 0840 hours on 2/18/85, a Security Guard on fire watch patrols discovered that the air supply valve to the 1A Diesel Generator Air Start Motors was unlocked and in the closed position. The Security Guard immediately notified the Shift Engineer who had the valve locked in the open position.

An investigation was initiated to determine how the valve became mispositioned. The last documented operation of the valve was on 1/18/85 when outages 1-41-85 and 1-42-85 were cleared following completion of planned maintenance. The valve was double verified in the correct position at that time. Both of the individuals who performed the verification have been interviewed but no useful information was obtained. They both state that there is no way the valve could have been mispositioned upon return to service.

The valve was apparently correctly positioned following the outage since one of the Shift Foremen has stated that he observed the valve in the correct position on 2/16/85. The diesel generator was started and ran on 2/14/85 in preparation for taking the 2A Diesel Generator out of service for routine maintenance. However, this is inconclusive because the diesel generator will start and run on one bank of air start motors.

The investigation also revealed that some of the locked valve keys have been lost from the Shift Engineer's controlled key cabinet, which makes it difficult to determine who may have improperly manipulated the valve. Plans are to upgrade all valve locks as soon as new locks can be obtained and to upgrade control of the keys.

LSCS EVENT #4 IA D/G AIR START VALVE

LSCS EVENT #4 1A D/G AIR START VALVE

Mechanical lineups for all five (5) diesel generator air systems were immediately performed with no other problems noted. Other corrective/precautionary measures are listed in the body of this report.
