Subject: LaSalle County Station Units 1 and 2
Confirmatory Action Letter
NRC Docket Nos. 50-373 and 50-374

March 5, 1985

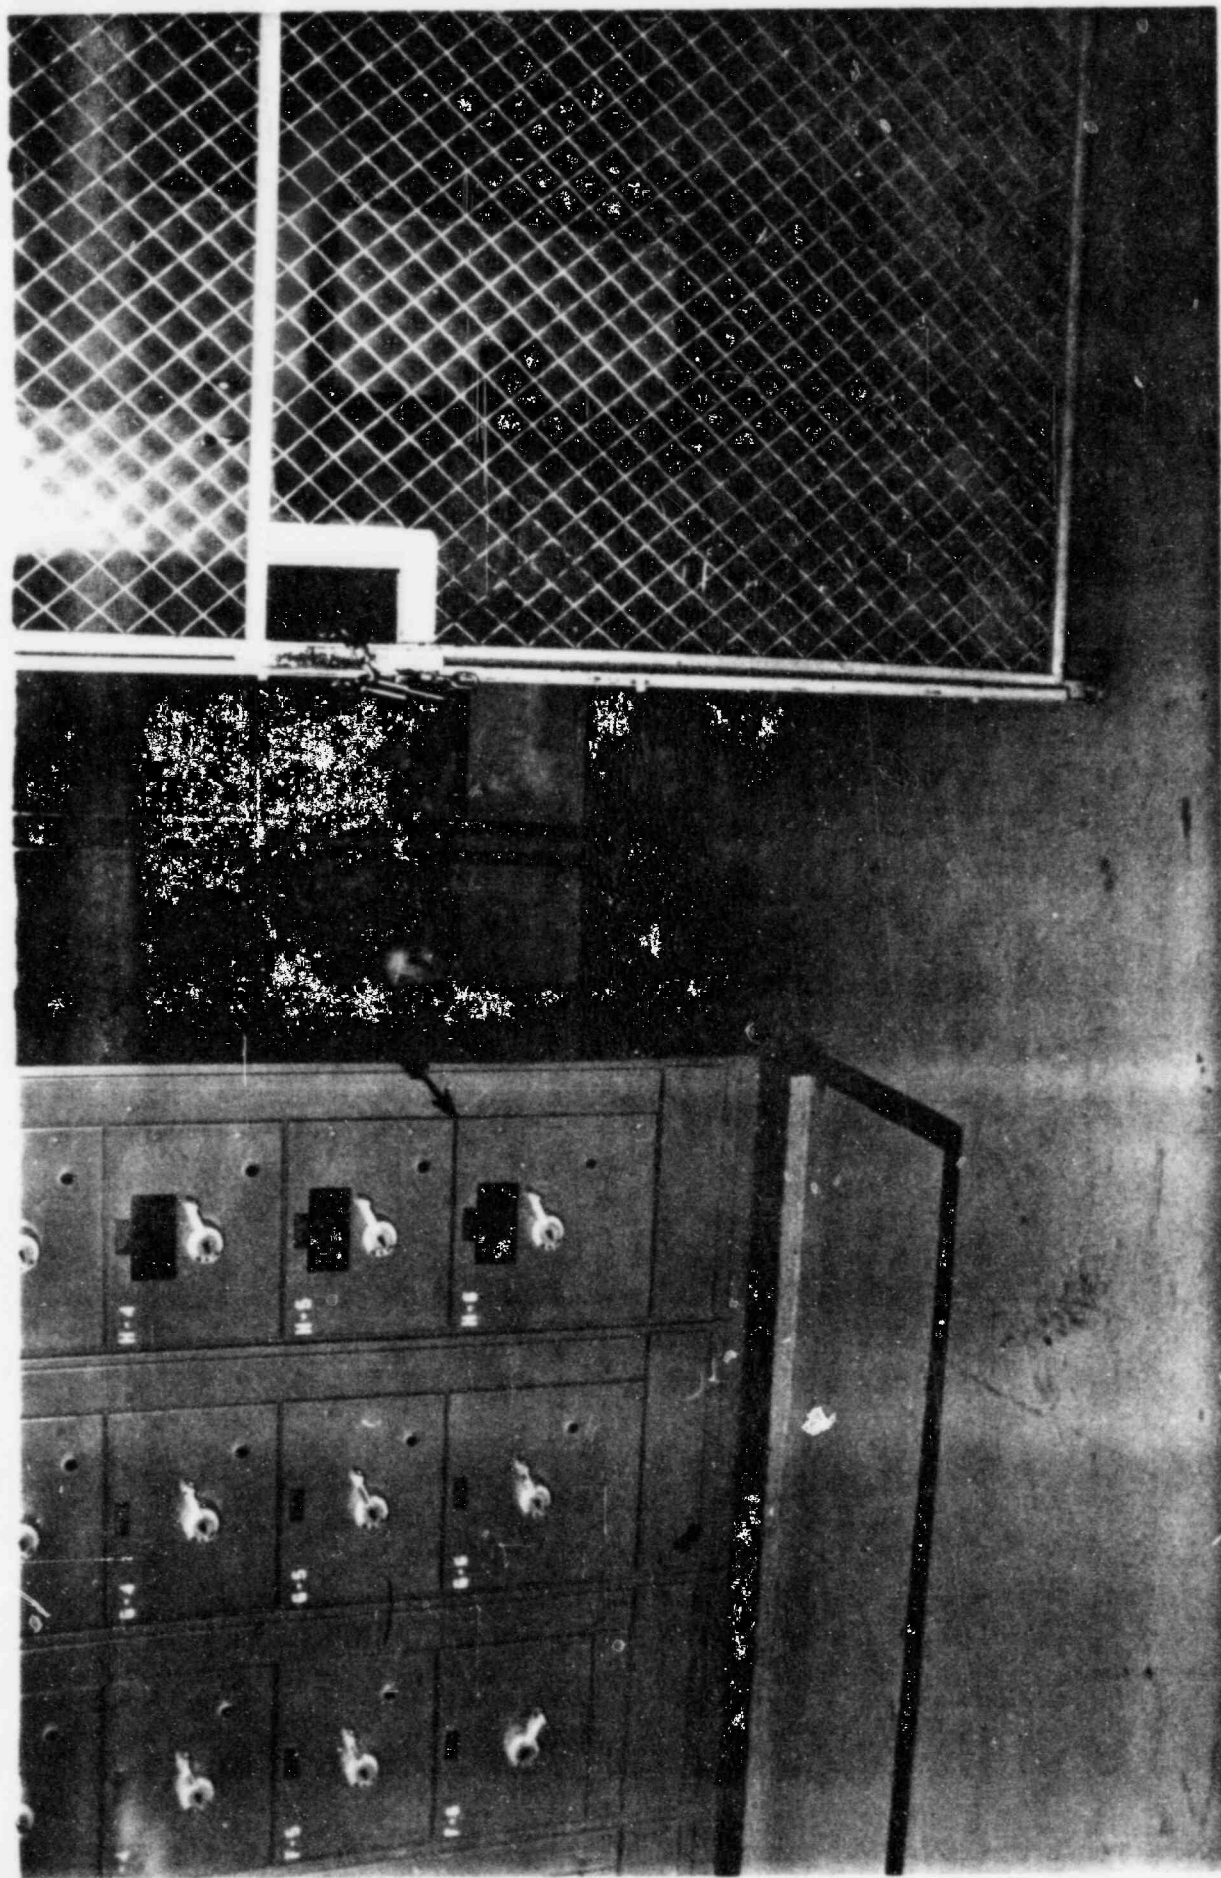
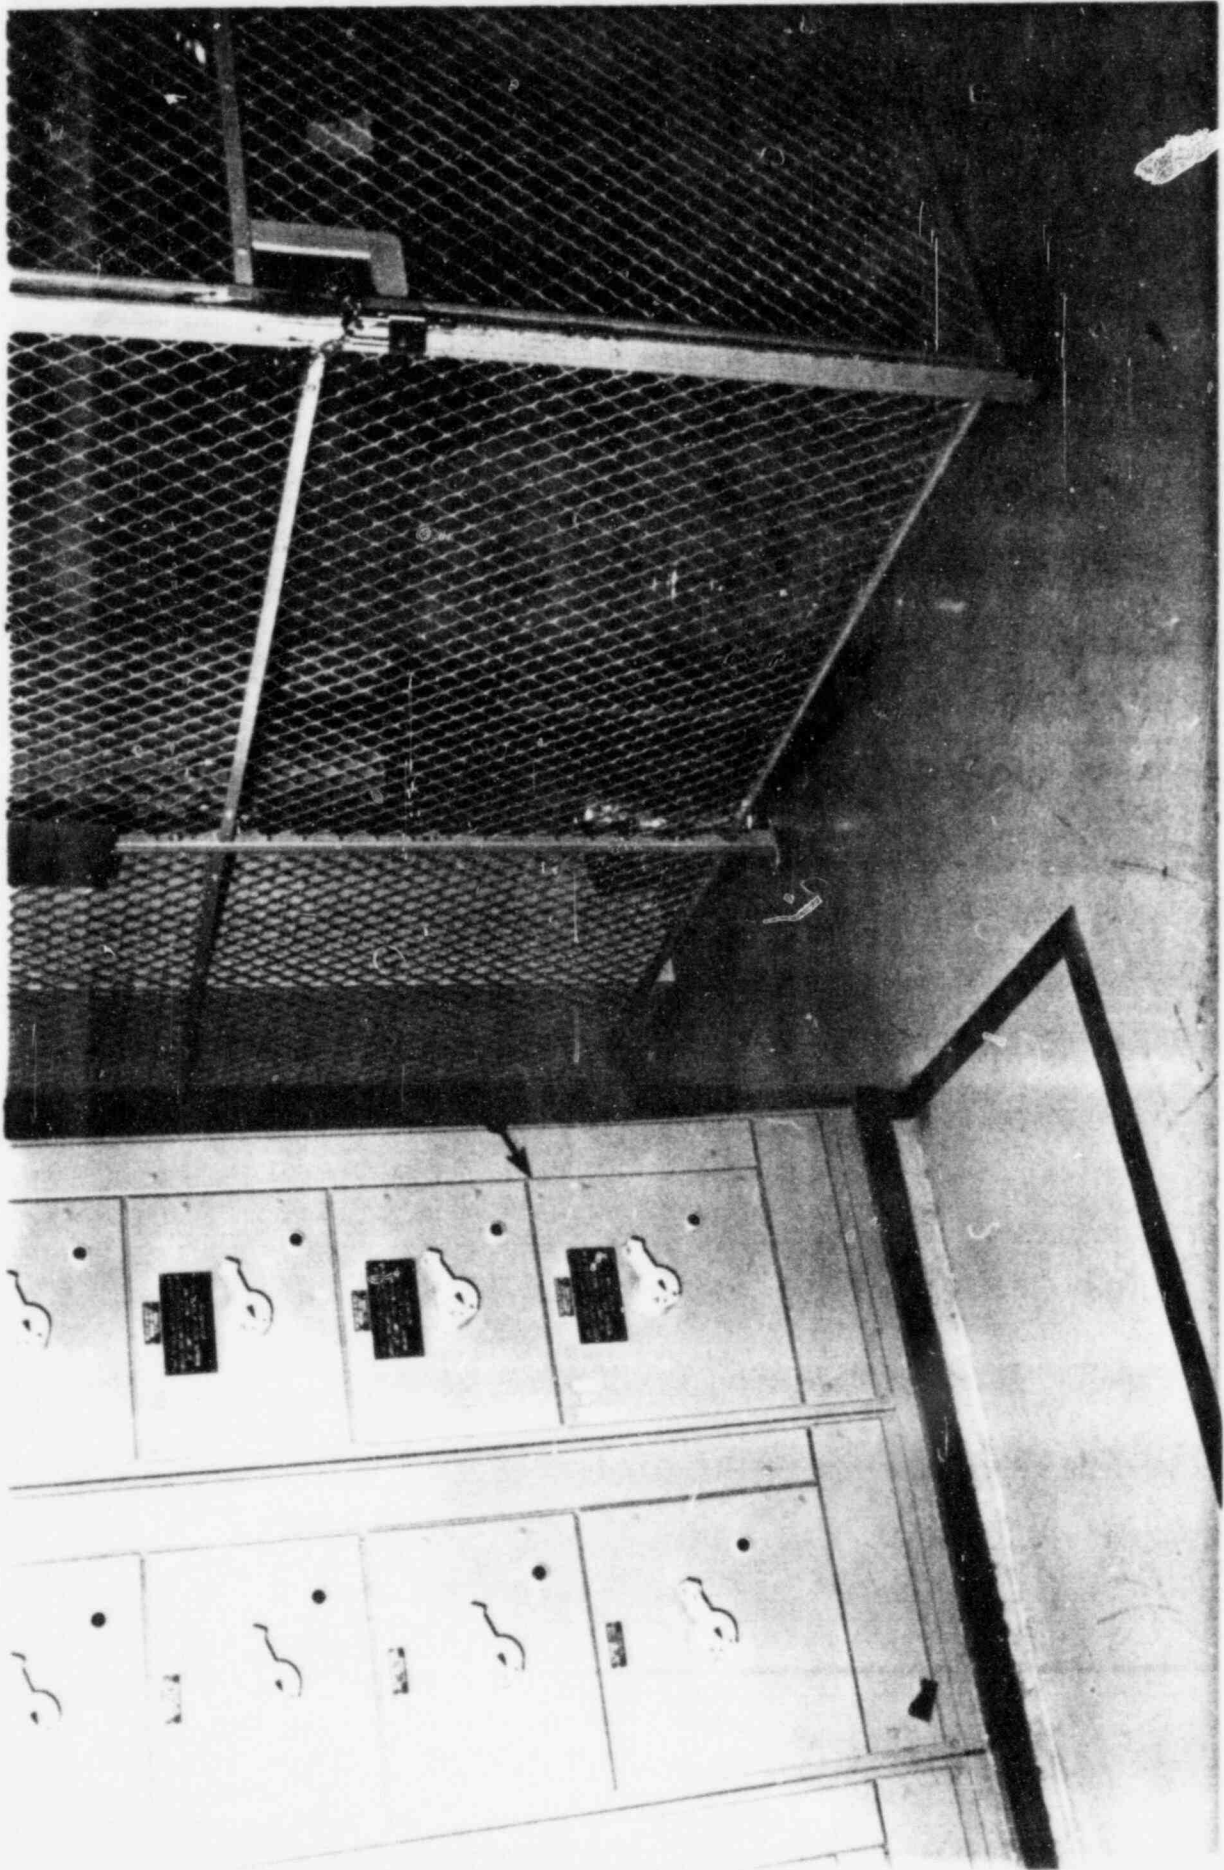
Investigation determined that the breaker for Primary Containment Chilled Water Inboard Isolation Valve 2VP114B had been turned to the "OFF" position. The breaker was immediately returned to the "ON" position within minutes of receipt of the alarm. This breaker is located on MCC236Y-1 (2AP823), Compartment H-6. This compartment is located in the lower right corner of the MCC near the floor. No personnel were observed in the surrounding area when the operator arrived to check out the breaker.

A test of the power supply breaker for valve 2VP114B was conducted on March 1, 1985, to ensure that there was not a malfunction that would allow the breaker to go to the "OFF" position instead of the "Trip" position following an electrical malfunction. The breaker operated as designed.

Due to the physical location of the breaker, it is possible that personnel in the area could have inadvertently bumped the breaker into the wrong position. Although several stationmen were in the area in about the right time frame, interviews of the stationmen involved identified no one with information as to how the breaker came to be in the "OFF" position.

LSCS EVENT #5 CIRCUIT BREAKER FOR 2VP114B

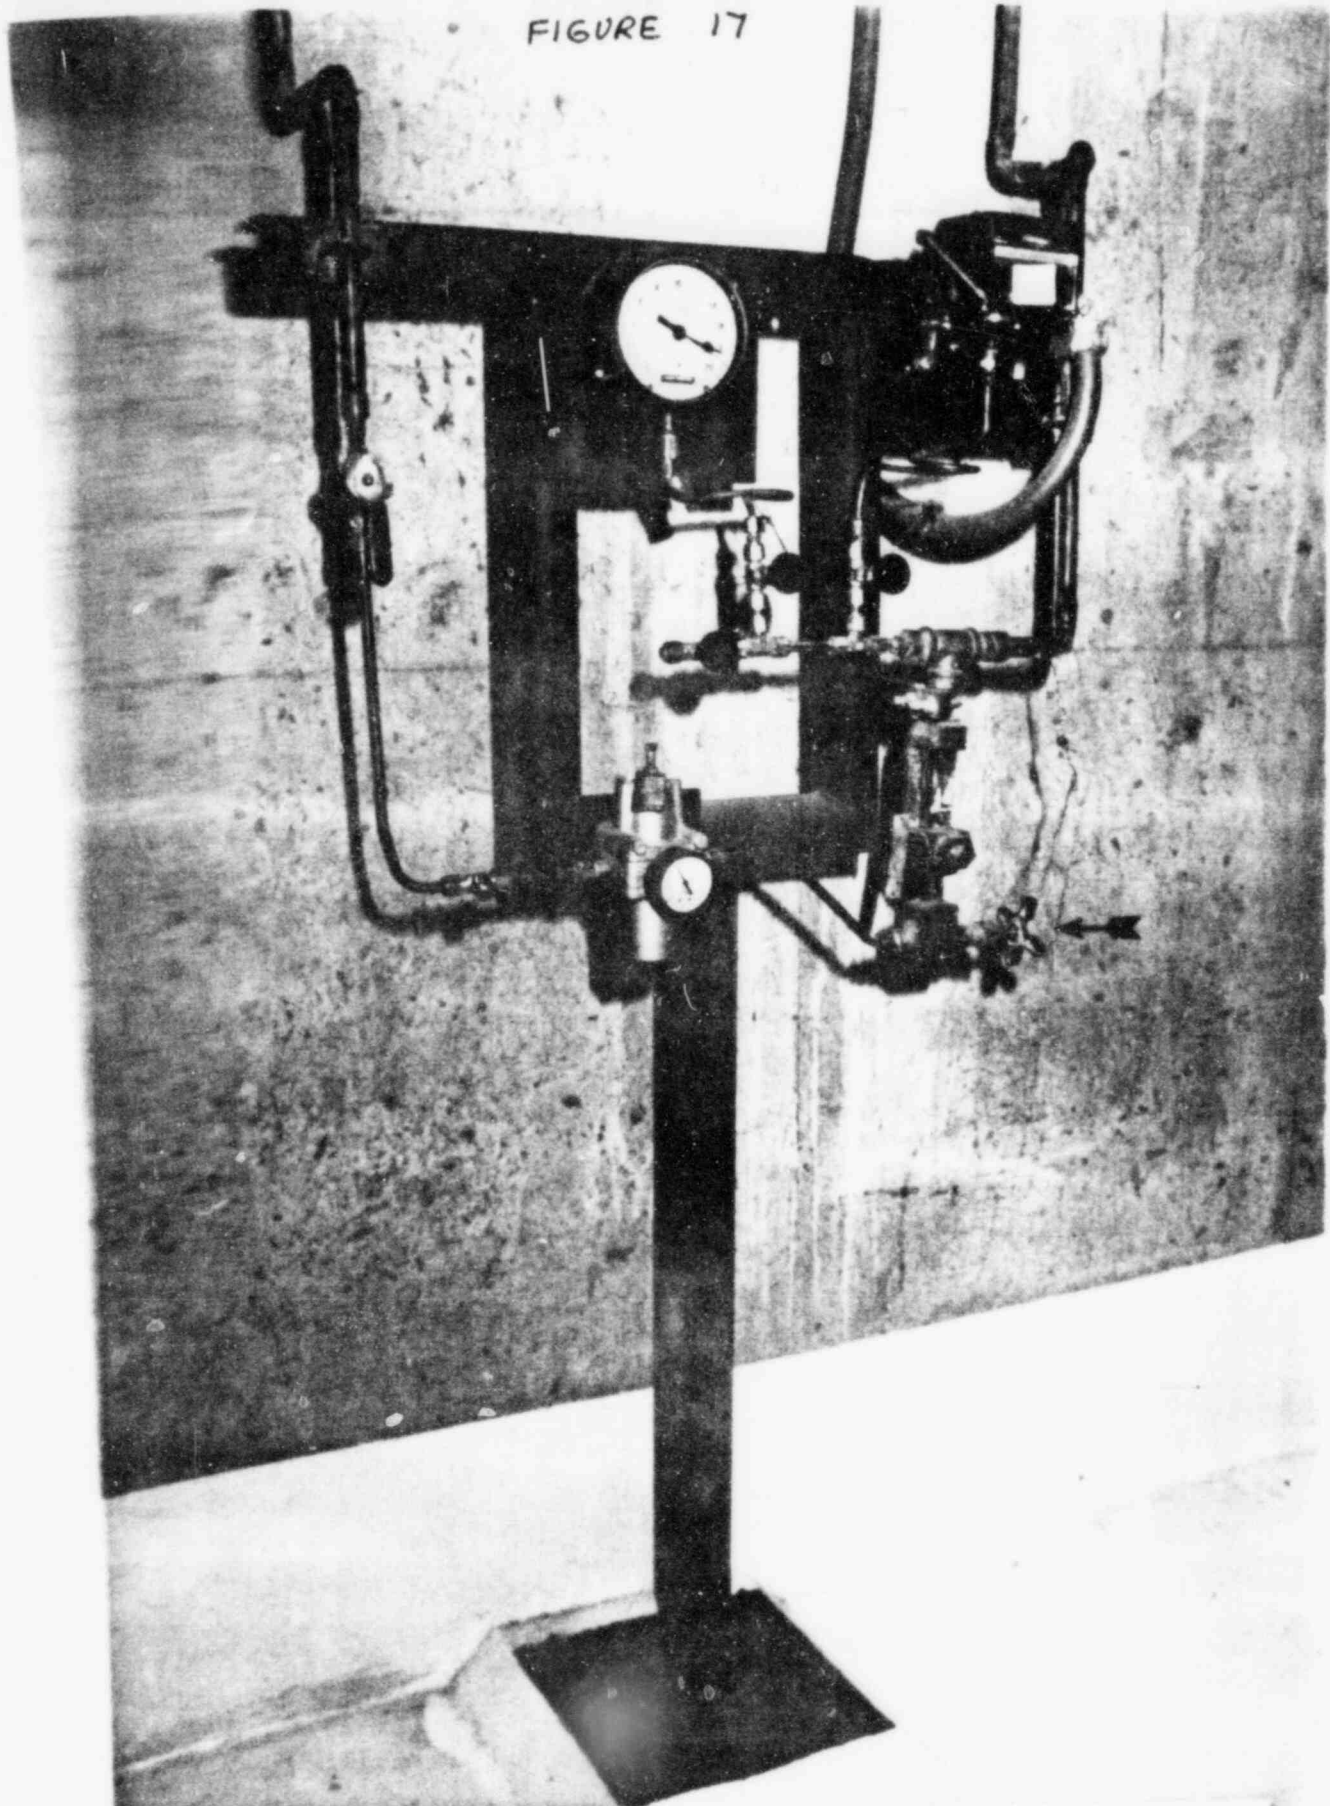
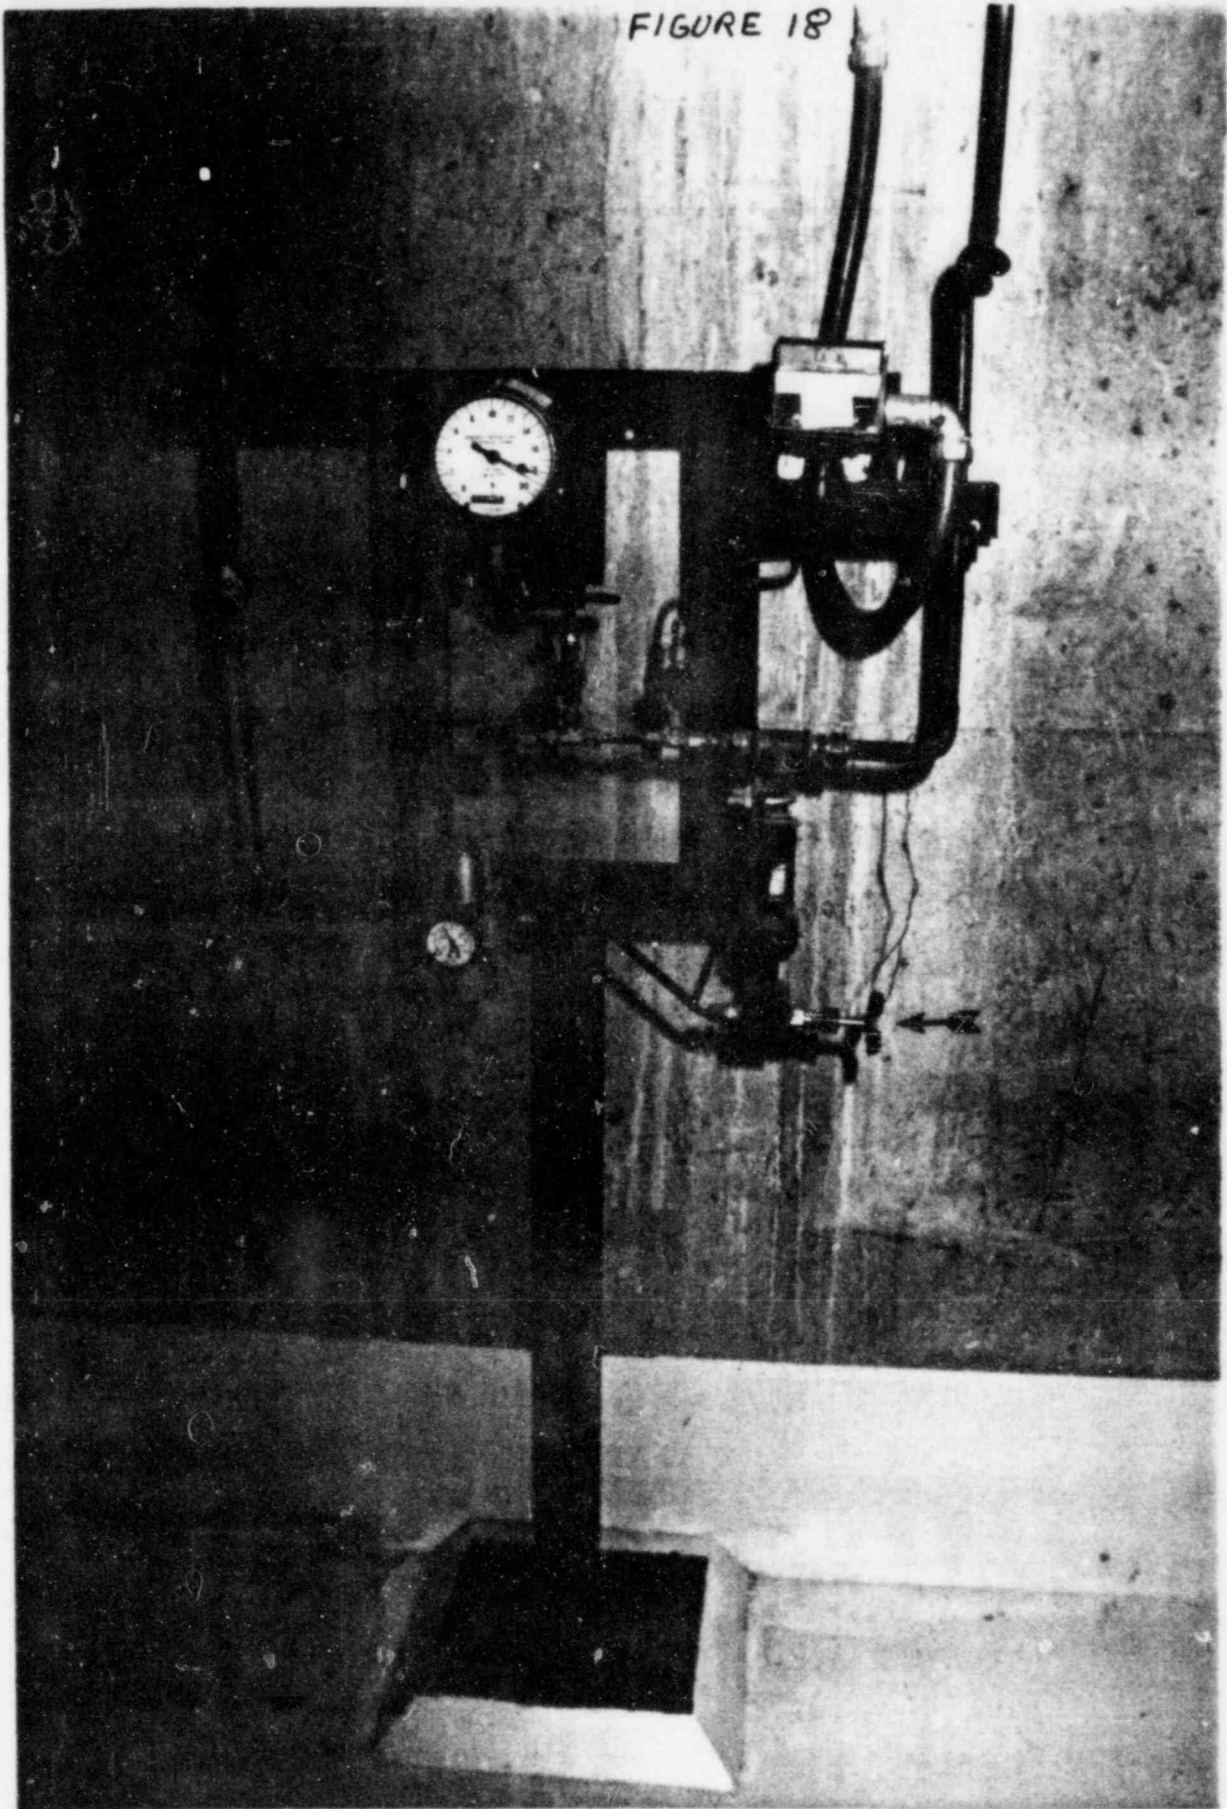
At 1634 hours on 2/19/85, the control room received a 1B Diesel Generator Fuel Oil Storage Tank Lo-Lo Level Alarm. An operator was dispatched to respond to the alarm, but due to other duties, did not arrive in the area until approximately 55 minutes later. When the operator arrived in the area, he found the level indicator bubbler valve closed and three stationmen in the area assigned to housekeeping duties.

The valve and instruments involved are supported from the wall of the room about three feet off the floor. One of the stationmen admitted to dusting (utilizing a foxtail brush) the brackets supporting the instruments in question and the other had swept the floor immediately below the valve. Neither individual recalled having bumped or otherwise disturbed the valve.

The investigations concluded that one of the individuals most probably inadvertently bumped the valve in question causing it to close. The valve is normally cracked open and could easily have been bumped closed without the individual responsible being aware that anything unusual had happened.

Another possible cause is that a foreign material became lodged in the valve, blocking flow and became dislodged when the operator adjusted the valve. The valve involved is a needle valve and due to close tolerances could easily be clogged by foreign particles. Experienced operating personnel state that this type of valve requires periodic adjustments to maintain proper level indication.

LSCS EVENT #7 1B D/G FUEL OIL LEVEL BUBBLER
