In the Matter of)
)
METROPOLITAN EDISON COMPANY, ET AL.) Docket No. 50-289-OLA
) (Steam Generator Repair)
(Three Mile Island Nuclear Station,)
Unit No. 1))

TMI-1 OTSG REPAIRS

DEPARTMENT/SECTION Engineering & Design
Materials Engrg/Failure Anal.

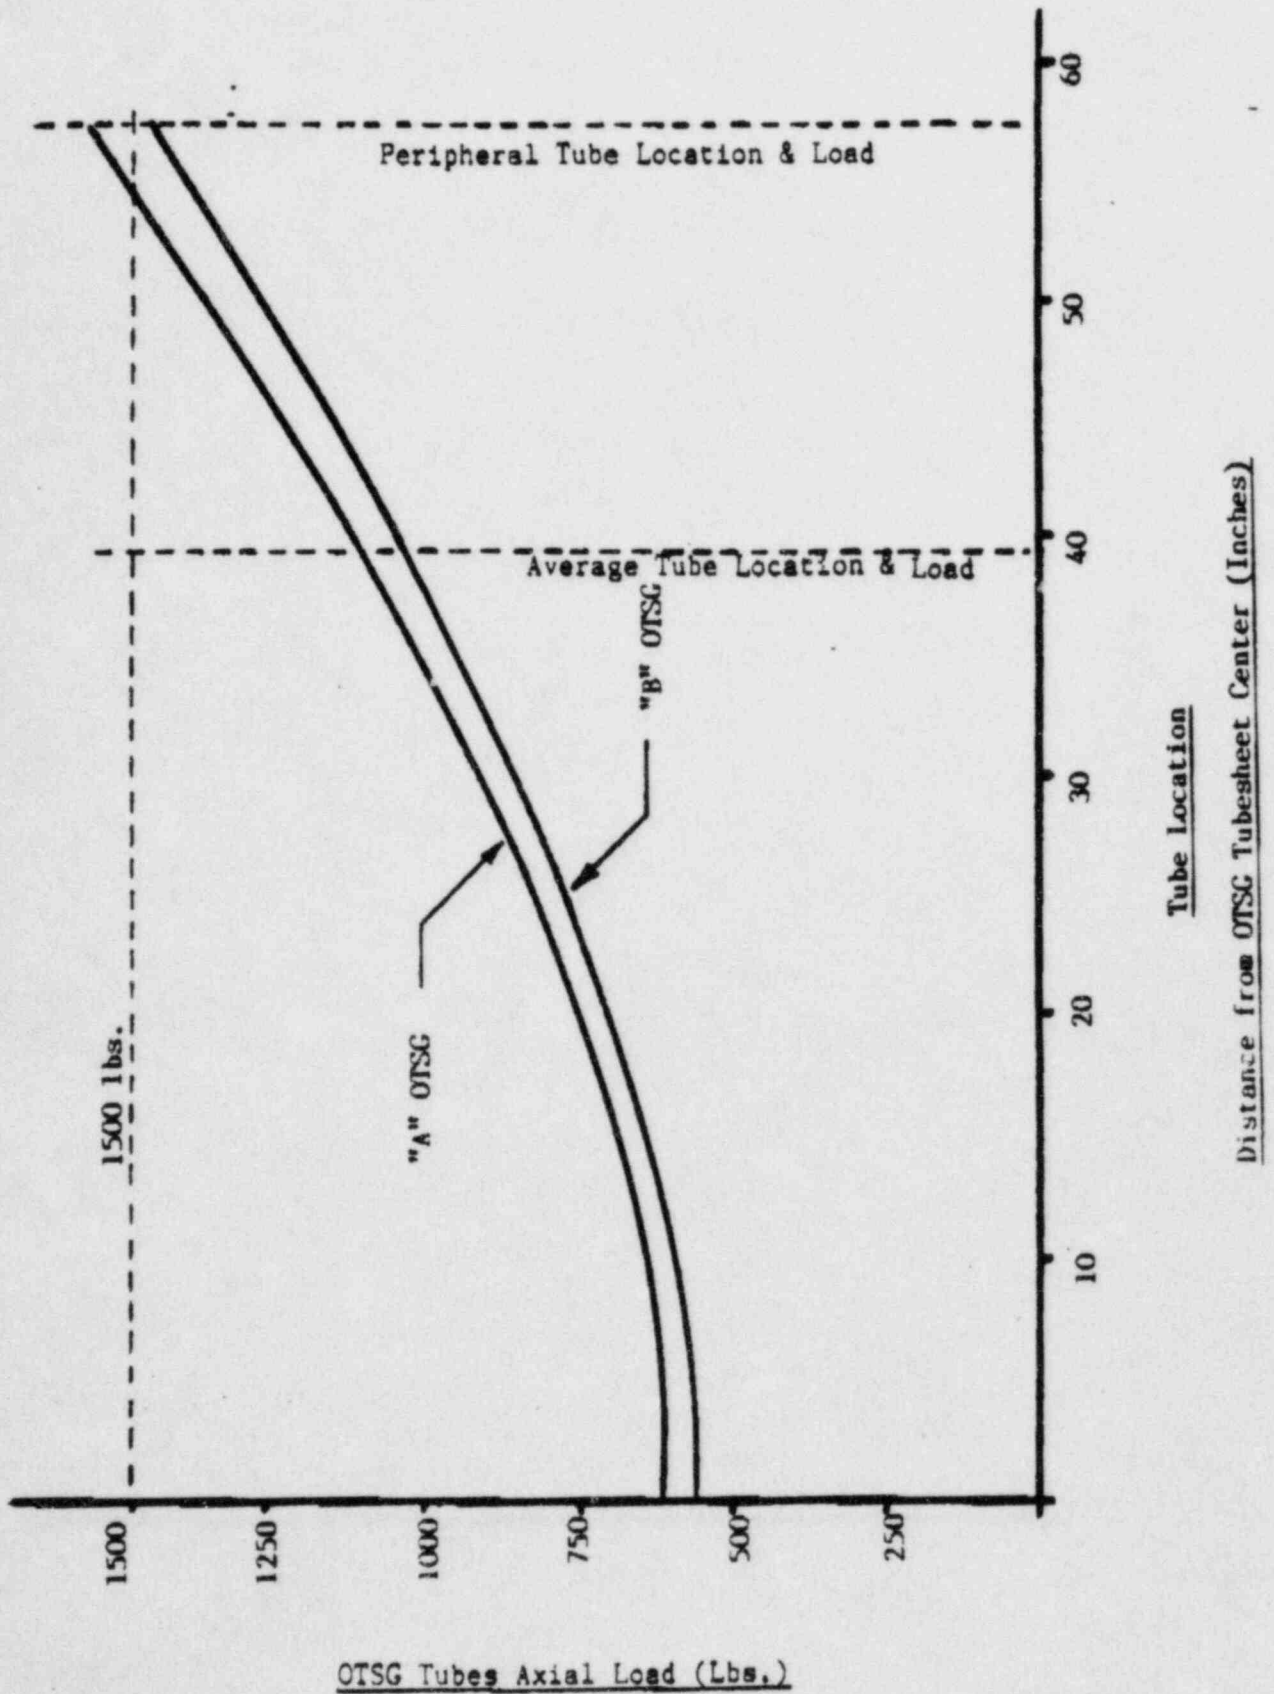
Figure 1 - TMI-1 OTSG Testing 3rd Cooldown (10-2-83)

Two additional pieces of data from Ref. 16 lend support to the mechanical scenario. First, peripheral tubes consistently see higher loads than core tubes. Therefore, in the periphery, the highest stresses would also act on this IGA. Second, the A-OTSG cooled down more quickly than the B unit. The peak load during the most rapid cooldown (Ref. 16) was 200 lb, or higher (12%), in the A-OTSG than in B-OTSG. Figure 1 is a representation of how the A-OTSG would have had significantly more tubes carrying loads high enough to cause IGA to become more detectable.

Tube Load Distribution as a Function of Tube Location
at the Peak Applied Load for "A" and "B" OTSGs

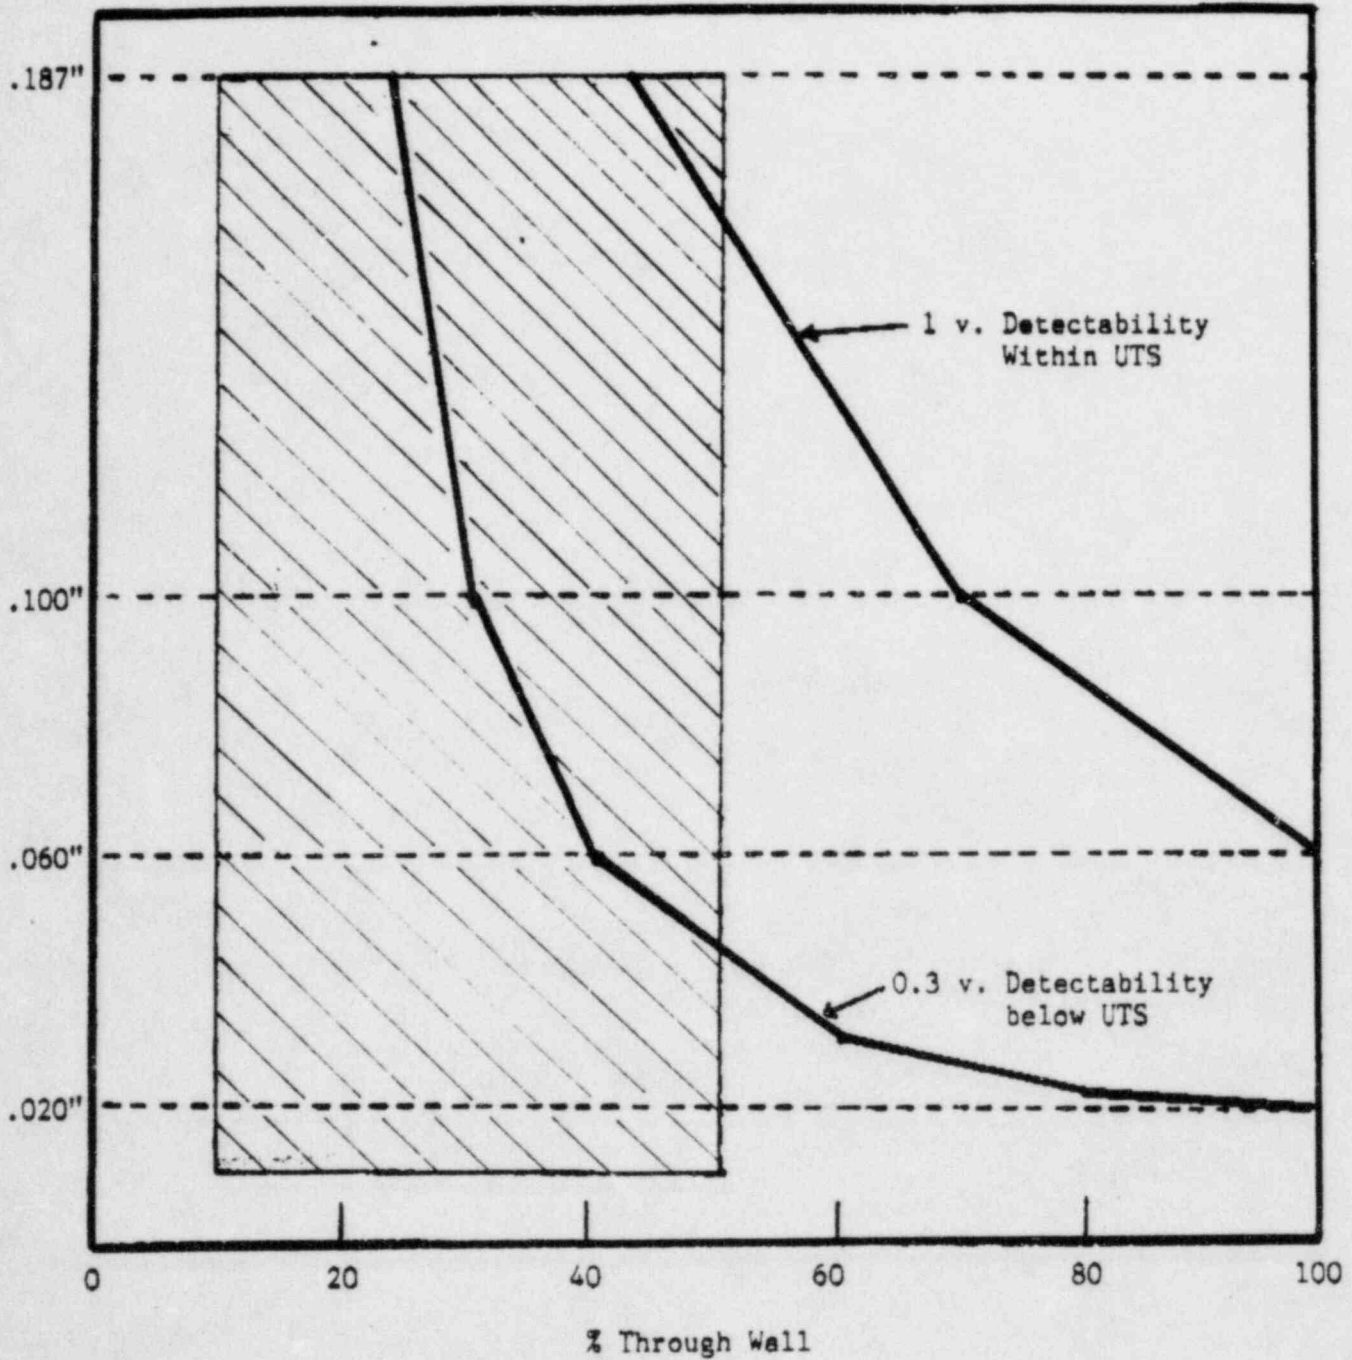
Figure 2 - 1984 Eddy Current Date

Statistical analysis of the eddy current data reveals that 90% of the observed indications fall between 10% and 50% through wall penetration, and between .020" and .190" long.

Compared to Detectability Limits

90% of 1984 Indications
Lie Within This Area

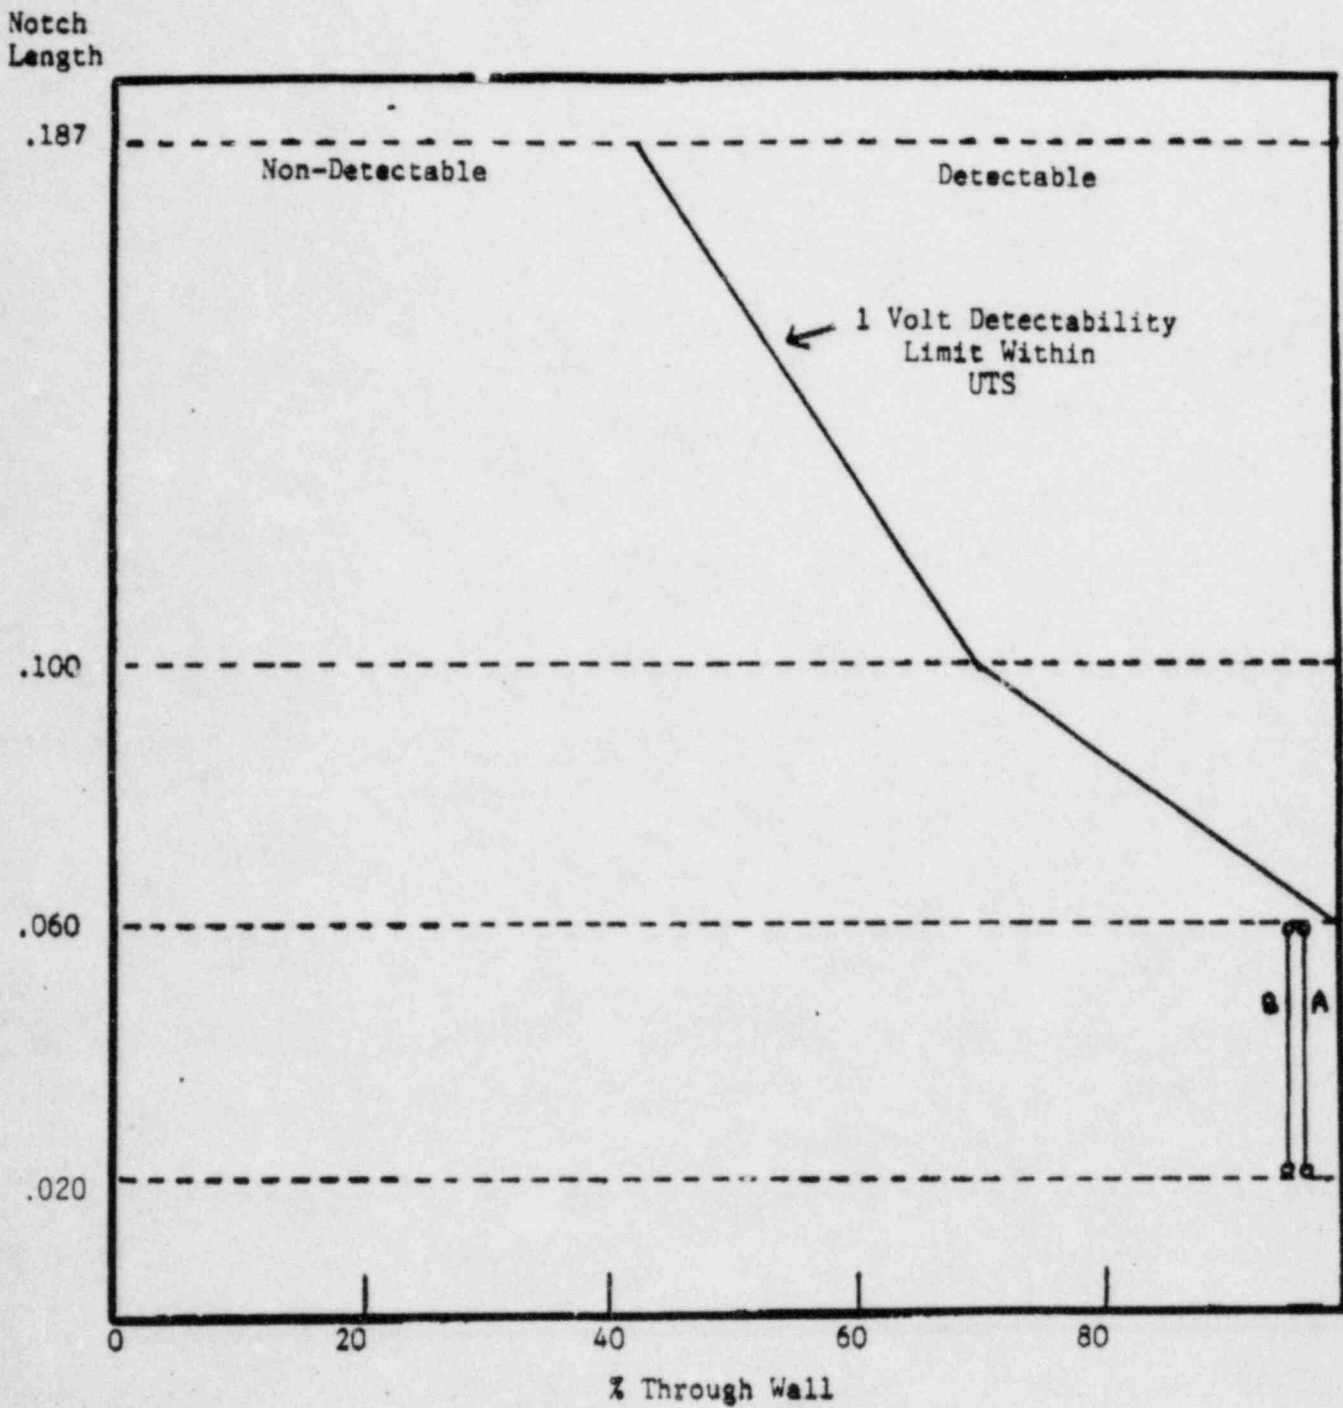
Figure 3a - Within - Tubesheet
Fiberscope Indications
Compared to Detectability Limit

Visual observations made during the fiberscope examination of selected OTSG tubes support the cause of the present eddy current indications being mechanical damage to existing IGA. At locations where eddy current indications existed, we frequently saw rounded, darkened areas of a size consistent with IGA detected in the original failure analysis.
