Duke Power Company
McGuire Nuclear Generation Department
12700 Hagers Ferry Road (MO01A)
Huntersville, NC 28078-8985

July 29, 1992

Subject: McGuire Nuclear Station, Unit 1
Docket Nos. 50-369
Gamma Plug Seal Weld Failure
Main Feedwater (CF)

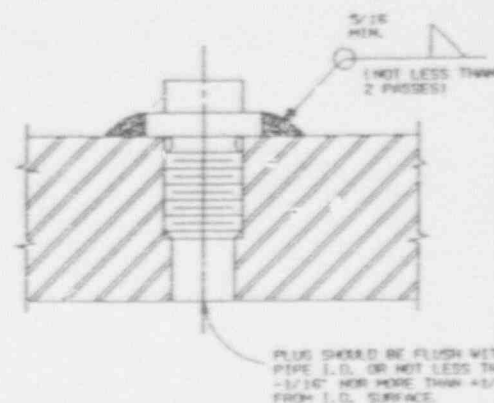
FIGURE 5
CLOSURE ASSEMBLY OF PLUG TO
ACCESS HOLES

On June 16, 1992, during the final reactor building inspections prior to unit 1 startup, leakage from the inspection port for the pipe to elbow welds (CF1F712) was discovered. This inspection port (or gamma plug) is located on the feedwater supply to the 1B Steam Generator down stream of check valve 1CF29. The unit was in mode 3 (hot standby) with the CF system pressure and temperature approximately 1169 PSIG and 557° F respectively. The leakage was characterized as minor due to the size of the steam plume (less than a 1 foot) and the slight amount of water spraying from the leakage location.

A 1-1/8 inch, seven thread per inch, non tapered solid plug is inserted into the inspection port (see attached drawing, MDS-EG-4). The plug is then seal welded to provide a leak tight joint. Since the strength of the threaded joint is not a function of the seal weld, the seal weld is categorized as a non-structural weld. The seal weld provides a sealing surface and keeps the non-tapered threaded plug from backing out.

On June 17, 1992, members of my staff discussed the CF gamma plug seal weld failures with members of the NRC staff. We discussed our intentions to stop the leak by peening the seal weld area that had the crack. In addition, the monitoring of potential leakage from this plug until the next refueling outage was also discussed. Any leakage from this location will be collected by the Containment Building Floor and Equipment Sump, which is monitored from the control room by an annunciator alarm. When unusually frequent annunciator alarm rates occur, a chemical sample of the sump contents will be obtained to determine if the leakage is from the feedwater system (indicated by a unusually high levels of hydrazine). Further, this plug will be visually inspected for leakage during any unscheduled unit shutdown or reactor trip.

Final repair of this plug will be performed at the next refueling outage. At that time the plug will be removed and the piping and plug will be inspected for damage. The repair per this inspection will be performed in accordance with the ASME code.
