ATTENTION: Document Control Desk
SUBJECT: Calvert Cliffs Nuclear Power Plant
Unit Nos. 1 & 2; Docket Nos. 50-317 & 50-318
Electrical Distribution System Functional Inspection, Combined Inspection
Report Nos. 50-317/92-80 and 50-318/92-80

REPLY TO A NOTICE OF VIOLATION
INSPECTION REPORT NOS. 50-317/92-80 AND 50-318/92-80

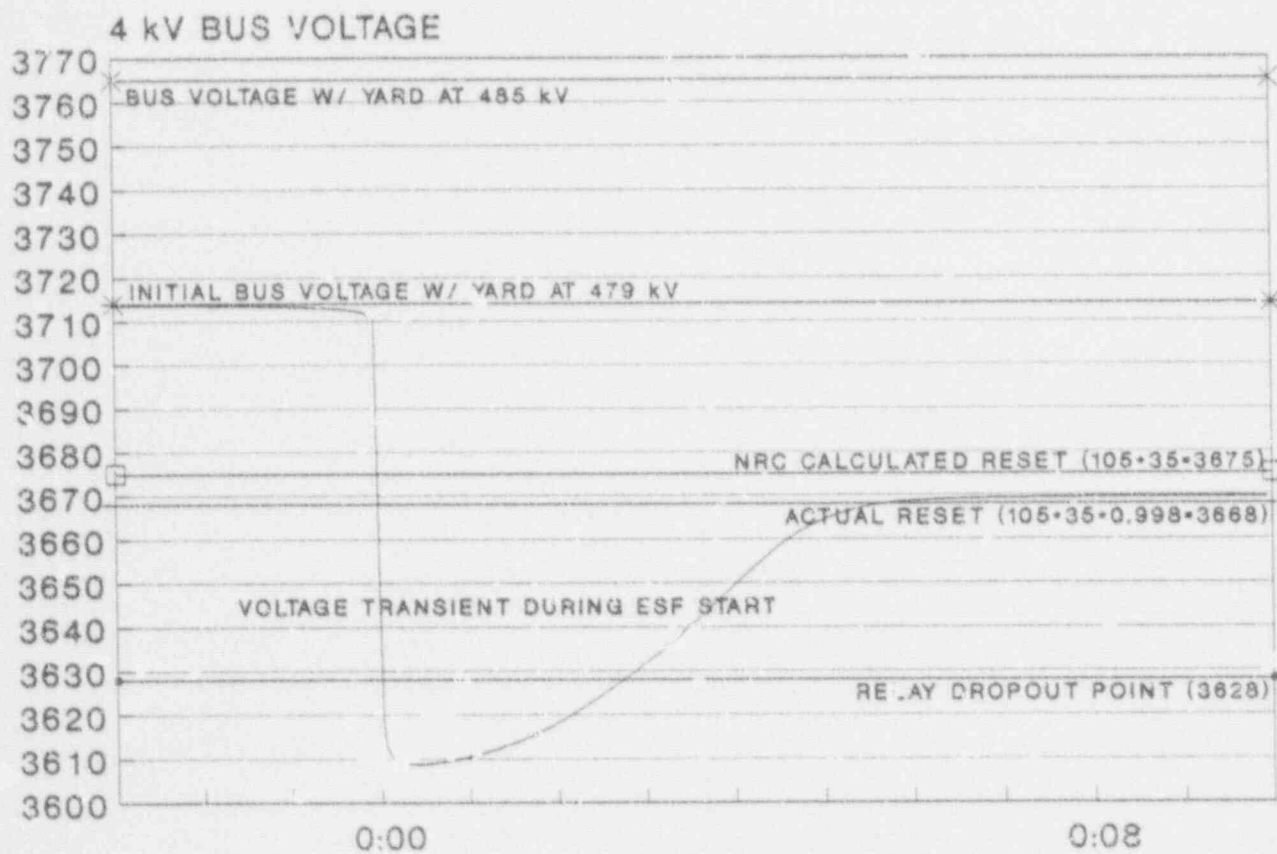
graph [1]

By including PT error, it becomes clear that 105.0 volts corresponds to 3668 volts on the 4 kV bus. It is an acceptable setting for the relay reset.

Second, Calculation E-90-31 did not determine 3668 volts to be the reset point or "the worst case 4160 bus running voltage" as stated in the report. Rather, the calculated reset setting of 105.0 volts discussed above was equated to a 4 kV bus voltage of 3668 volts. That number was then used as an input to calculate the minimum acceptable switchyard voltage necessary to clear the maximum reset setting following an Engineered Safety Features actuation (limiting case transient) under worst case conditions. This switchyard voltage was found to be 479 kV and would result in a final steady state 4 kV bus voltage of 3668.5 volts. (See attached graph [1])

DEGRADED BUS RELAY PROTECTION AT CALVERT CLIFFS
