U.S. NUCLEAR REGULATORY COMMISSION

Report No: 50-341/96004

Facility: Enrico Fermi, Unit 2

Enrico Fermi, Unit 2
NRC Inspection Report 50-341/96-04

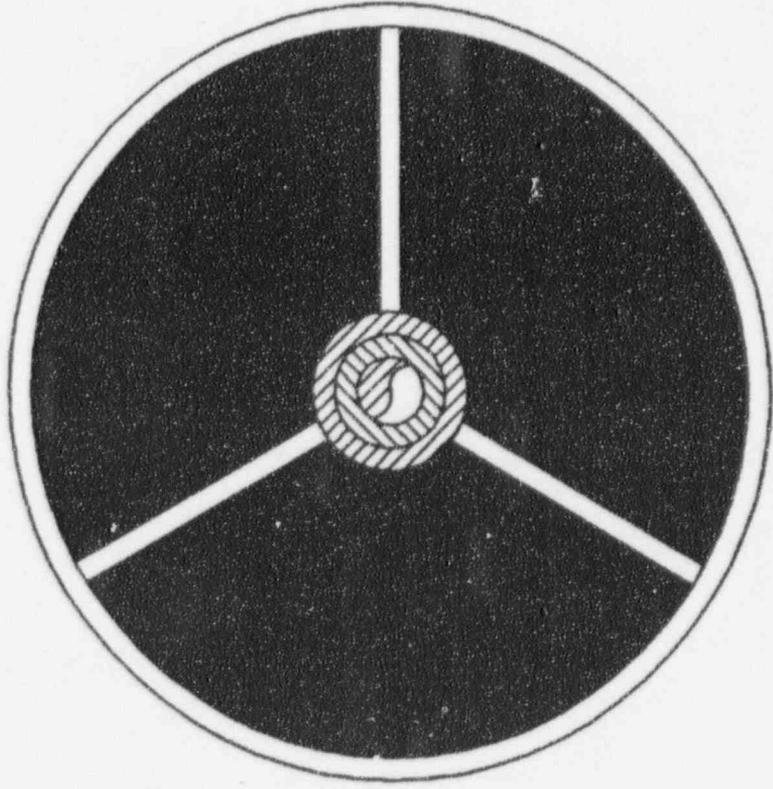
*Typical View Of Spider Bearing
Looking Axially Down Pump Column*

- ◆ Effects Of Sub-Freezing Temperatures In Air Space Above Reservoir And Below Pump Room Floors
 - ◆ DGSW Check Valve Back Leakage
 - + Pump Column Designed To Drain Upon Stopping Pump
-
-
