U. S. NUCLEAR REGULATORY COMMISSION
REGION I

Report Nos. 50-352/92-26
50-353/92-26

Facility Name: Limerick Nuclear Generating Station, Units 1 and 2

Inspection Conducted: September 18, 22 and 29, 1992

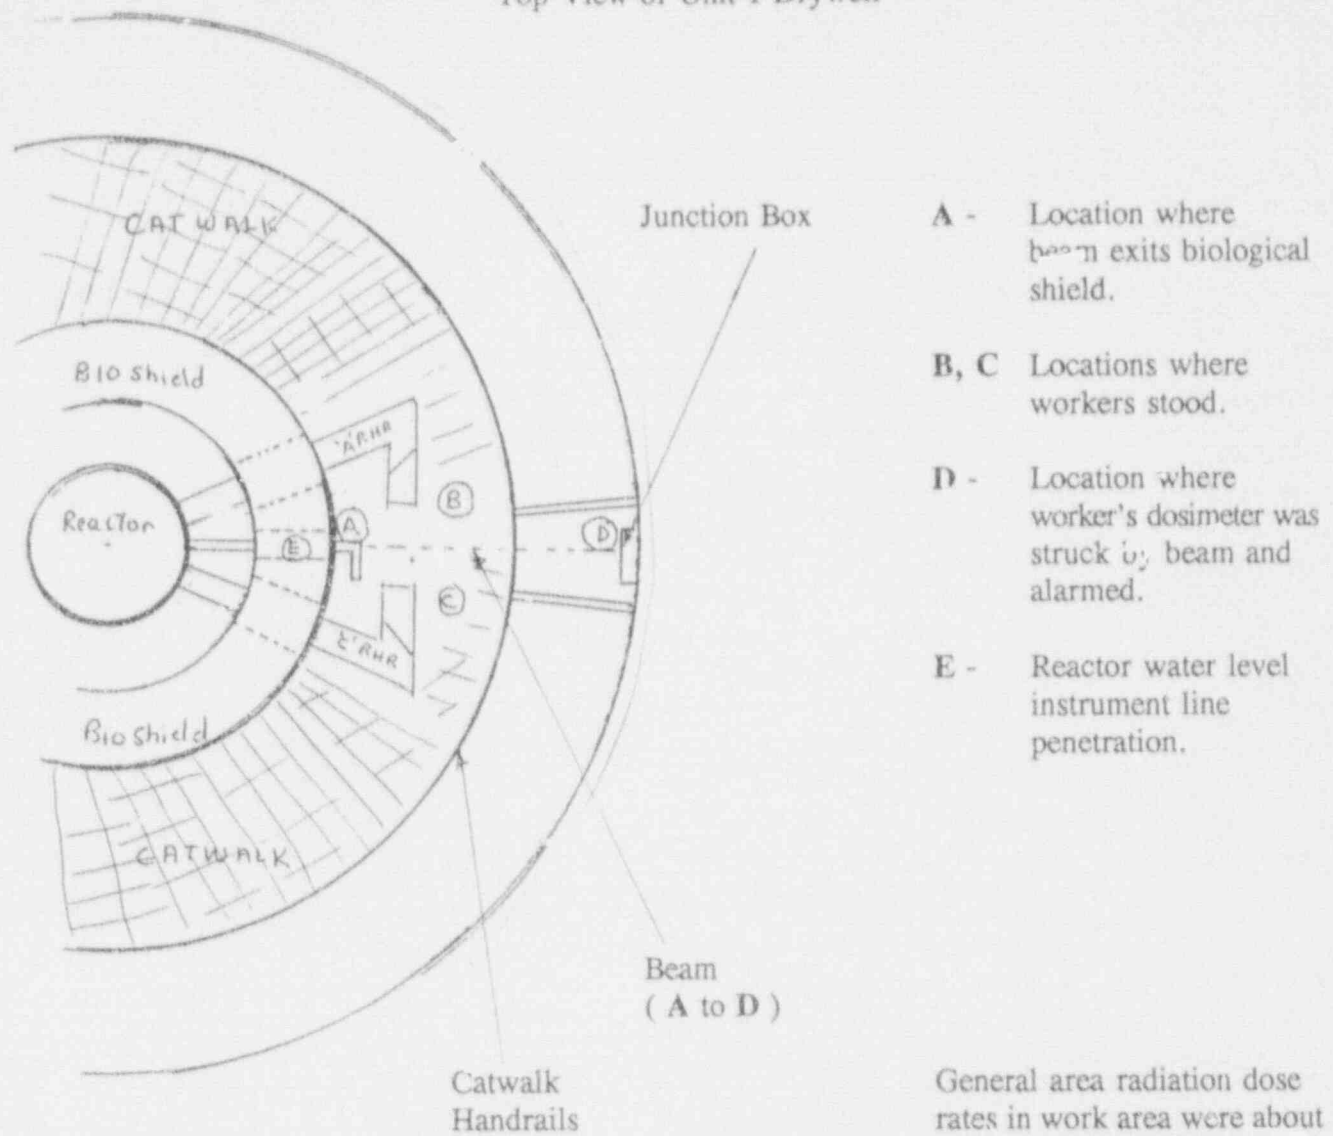
Figure 1
Top View of Unit-1 Drywell

During start-up of Unit 1 on July 7, 1992, following the fourth refueling outage, at about 6:47 a.m., a main steam line sample flow isolation valve (HV-041-1F084) failed to operate properly from the control room. Operations group personnel felt that troubleshooting was needed to ascertain the apparent problem with the valve. An action request was generated to troubleshoot the valve. The request was generated because it was at first believed that the valve needed to be repaired since it was an in-board primary containment isolation valve. The valve is located on the 303' elevation of the drywell (@ azimuth 280 degrees). The electrical junction box for the valve is located on the 296' elevation at about the same azimuth directly across the drywell from the reactor water level instrument line penetration (X16-D) in the biological shield. (See Figure 1.)

The narrow beam was readily accessible to personnel and exhibited radiation levels of between about 3 R/hr gamma and 25 R/hr gamma as compared to general area radiation levels of about 1 R/hr gamma and 500 millirem/hr neutron. This is an apparent violation of 10 CFR 20.201 (b), which requires that licensees make surveys as may be necessary and reasonable for the licensee to comply with the requirements in 10 CFR 20. 10 CFR 20.201 (a) defines a survey as an evaluation of radiation hazards (50-352/92-26-02).

Beam radiation dose rates:

- Radiation dose rates at A were about 150 R/hr gamma and greater than 5 rem/hr neutron.
- Radiation dose rates at locations between A, B, and C were a maximum of about 25 R/hr.
- Distance from locations A to D was about 15 feet.
- Drawing not to scale.
