September 22, 1992

This report covers the evaluation of a 4" x 4" x 1/2" wall section of ASTM A-500 Grade B steel tubing heat number T42510 from coil number 924544. This sample was found to have a cracked weld by your customer, TVA/Bechtel at the Browns Ferry Nuclear Plant in Alabama. This tubing was supplied to Consolidated Power Supply on P.O. #S65-17742.

Subject: Corrective Action Request on A500 Grade B Tubing

Subject: TRIP REPORT, EXAMINATION OF TUBE STEEL

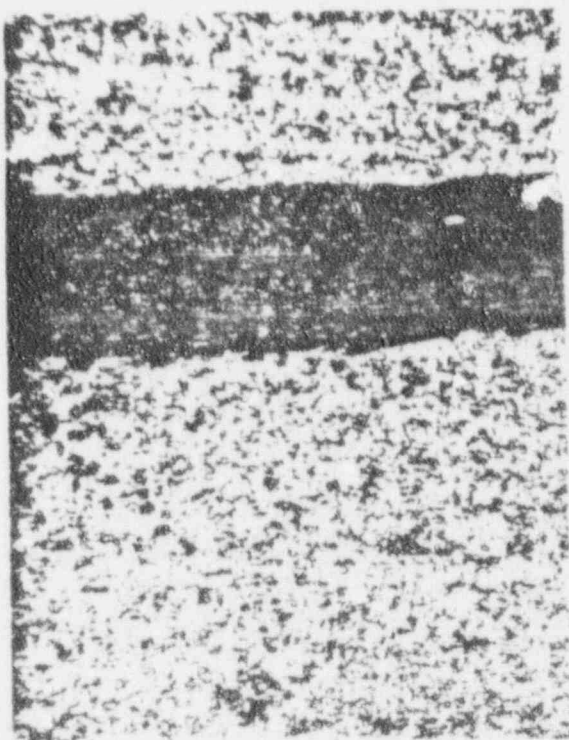
NEAR
O.D.

The sample represents a portion of a defective tube which in turn represents a portion of the overall 0.65% customer rejection rate due to poor weld for this size and thickness of tubing. The lack of fusion was due to incorrect mill set-up and is not heat or material related.

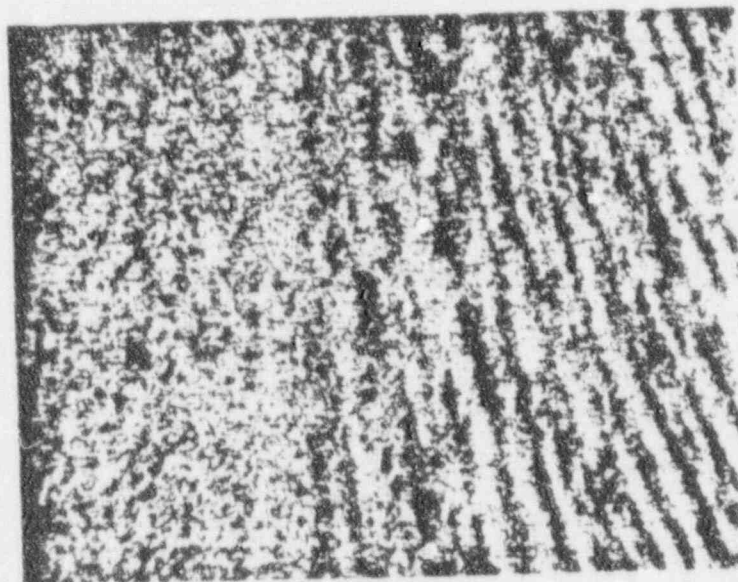
2

(WELDED
SECTION)

The corrective action requested by your letter will take the form of re-instructing the mill operator, mill foreman and other mill personnel on the importance of weld quality. If the operator is making an adjustment which could affect weld quality, he is to immediately advise the Quality Control inspector so that weld quality can be examined. This meeting will take place within the next 30 days.
