REFERENCE: Docket No. 50-186
University of Missouri-Columbia Research Reactor
Renewed Facility Operating License No. R-103

SUBJECT: Written communication as required by University of Missouri Research Reactor
Technical Specification 6.6.c(3) regarding a deviation from Technical Specifications
3.2.a and 3.2.f.8

Licensee Event Report No. 20-01 – April 8, 2020
University of Missouri Research Reactor

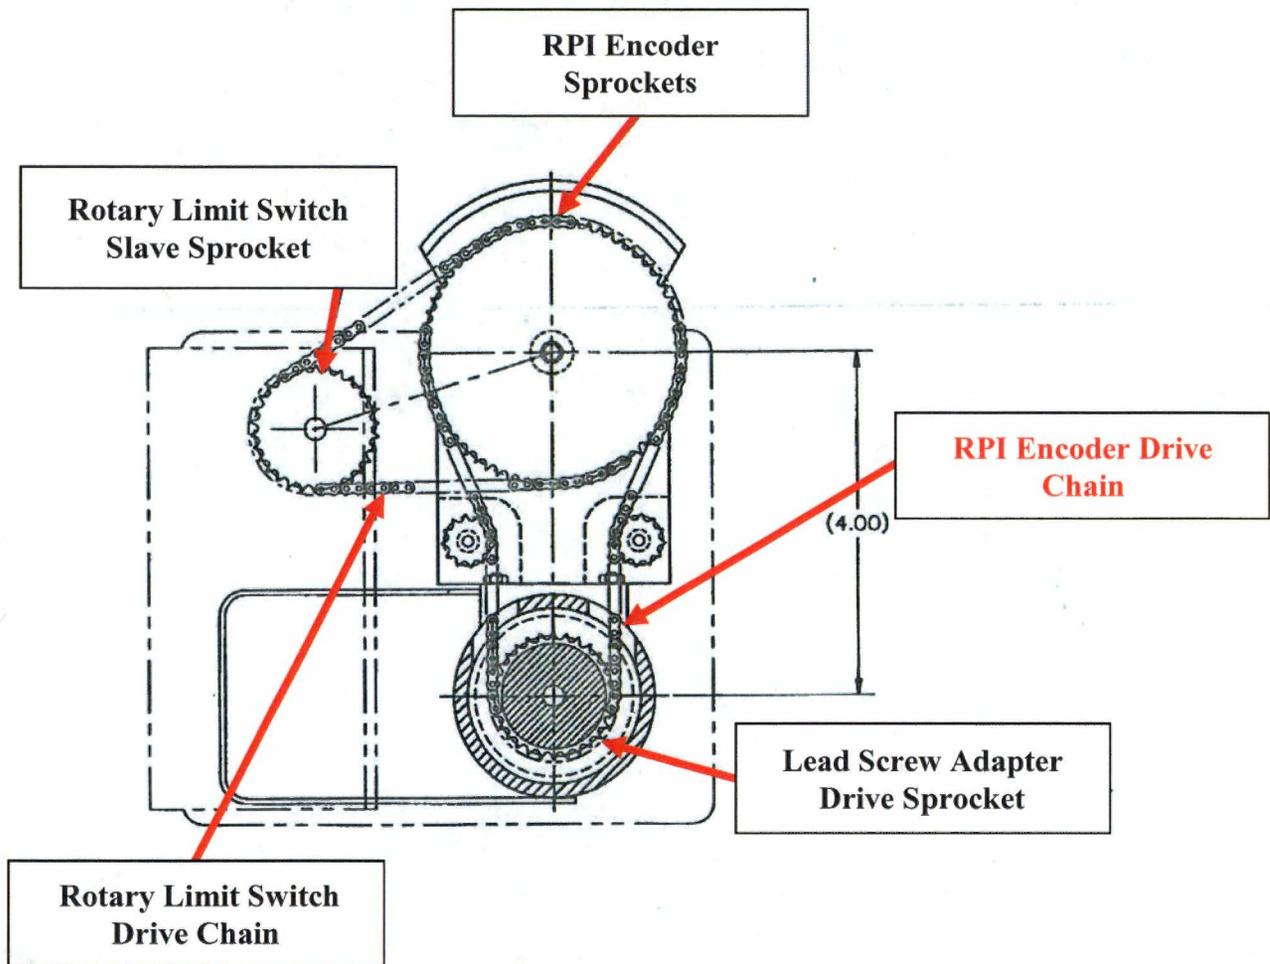
Regulating Blade Drive Assembly Diagram

Initial investigation revealed that the regulating blade drive mechanism RPI encoder drive chain had disengaged. The regulating blade drive mechanism was removed and taken to the Instrumentation Support Shop for further inspection and troubleshooting. Examination revealed a broken pin inside the regulating blade drive mechanism gearbox, which holds the drive gear to the gearbox output shaft. Therefore, the regulating blade drive mechanism motor could run, but no corresponding movement of the regulating blade occurred because the gear was spinning freely on the gearbox output shaft.

After replacing the regulating blade drive mechanism gearbox and placing the RPI encoder drive chain back on its associated sprockets, the RPI encoder drive chain alignment and tension seemed to be normal and satisfactory. After further inspection, it was noted that the rotary limit switch drive chain alignment needed adjustment. The upper RPI encoder sprocket, which drives the rotary limit switch slave sprocket, was lowered to align the chain correctly.

The reactor was shut down by manual scram when it was determined that the regulating blade was inoperable. The regulating blade drive mechanism was removed for inspection and troubleshooting. After replacing the regulating blade drive mechanism gearbox and placing the RPI encoder drive chain back on its associated sprockets, the RPI encoder drive chain alignment and tension seemed to be normal and satisfactory. After further inspection, it was noted the rotary limit switch drive chain alignment needed adjustment. The upper RPI encoder sprocket, which drives the rotary limit switch slave sprocket, was lowered to align the chain correctly.
