SUBJECT: SUMMARY OF THE OPERATING REACTORS EVENTS
MEETING ON APRIL 4, 1985

OPERATING REACTOR EVENTS BRIEFING

APRIL 4, 1985

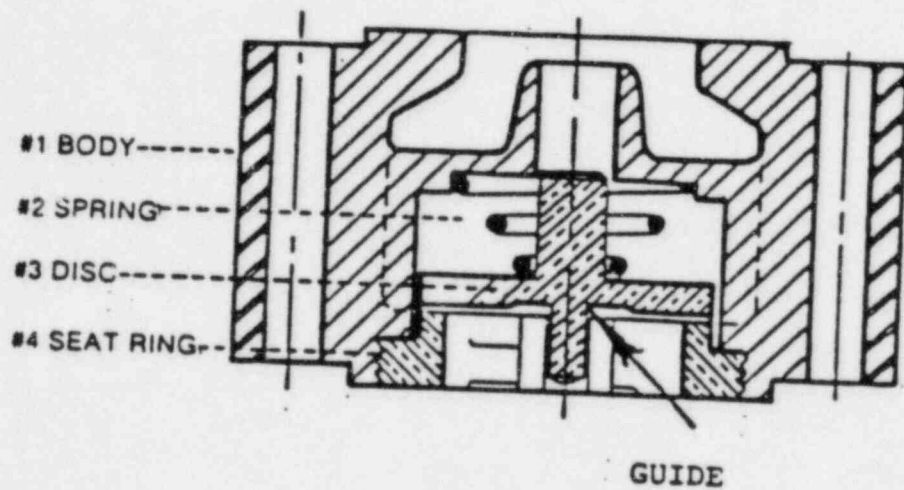
STARTING AIR CHECK VALVE

- DURING SURVEILLANCE TESTS OF A TDI DIESEL GENERATOR, FLAMES WERE OBSERVED AT A FLEXIBLE COUPLING IN THE AIR START ASSEMBLY.
- DIESEL GENERATOR WAS SHUTDOWN AND THE AIR START VALVE ON NO. 6 CYLINDER WAS REMOVED.

- PIECE OF METAL (7/8" X 3/8" DIA) FOUND ON TOP OF PISTON.
- EXAMINATION OF CHECK VALVES (4 IN STARTING AIR SYSTEM) SHOWED PIECE OF METAL WAS A PIECE BROKEN OFF THE BOTTOM GUIDE OF A CHECK VALVE. ONE OTHER VALVE HAD CRACKED GUIDE AND OTHER TWO HAD NO VISUAL CRACKS.

- MALFUNCTION CAUSE WAS PIECE OF METAL THAT WAS CARRIED BY AIR FROM CHECK VALVE TO AIR START VALVE AND LODGED BETWEEN DISC AND SEAT, ALLOWING BURNING GASES FROM CYLINDER INTO AIR START ASSEMBLY.

- TDI EXAMINED CHECK VALVES AND FOUND FAILURE OF GUIDE WAS DUE TO CYCLIC FATIGUE.
- LICENSEE HAS REPLACED ALL CHECK VALVES FOR BOTH TDI-DIESEL GENERATORS.

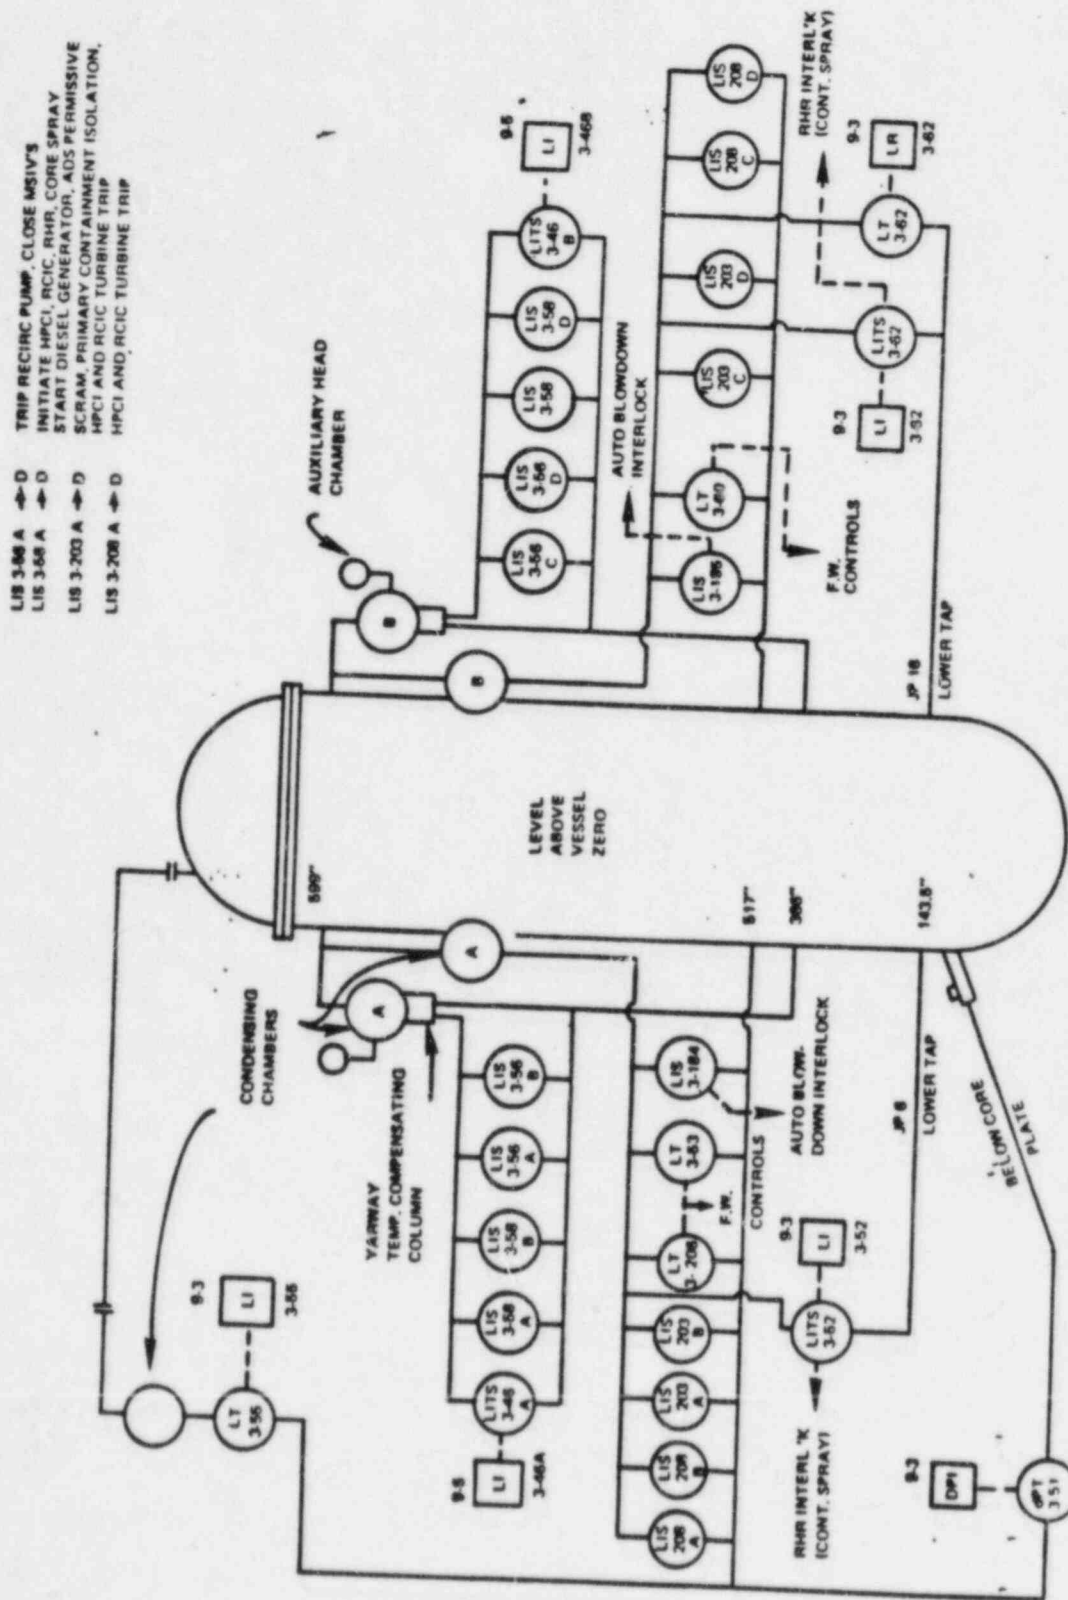
FIGURE 2.2-2 Reactor Vessel Level Instrumentation

- START UP IN PROGRESS FOLLOWING SHORT OUTAGE. REACTOR CRITICAL AT ABOUT 40 PSI ,286F
- DISCREPANCY IN LEVEL INSTRUMENTS NOTICED BY OPERATOR.
- HALF-SCRAM
- OPERATOR ADDS WATER, PESETS HALF-SCRAM
- LEVEL INSTRUMENTS STILL SHOW DISCREPANCY
- OPERATOR RESUMES PULLING RODS
- LEVEL DISCREPANCY DISAPPEARS
- INSTRUMENT SURVEILLANCE TESTS CONDUCTED
- EVENT REPORTED 43 HOURS LATER
- REGION II ADMINISTRATOR CALLS TVA, REQUEST JUSTIFICATION FOR CONTINUED OPERATION TVA SHUTS DOWN THE UNIT.

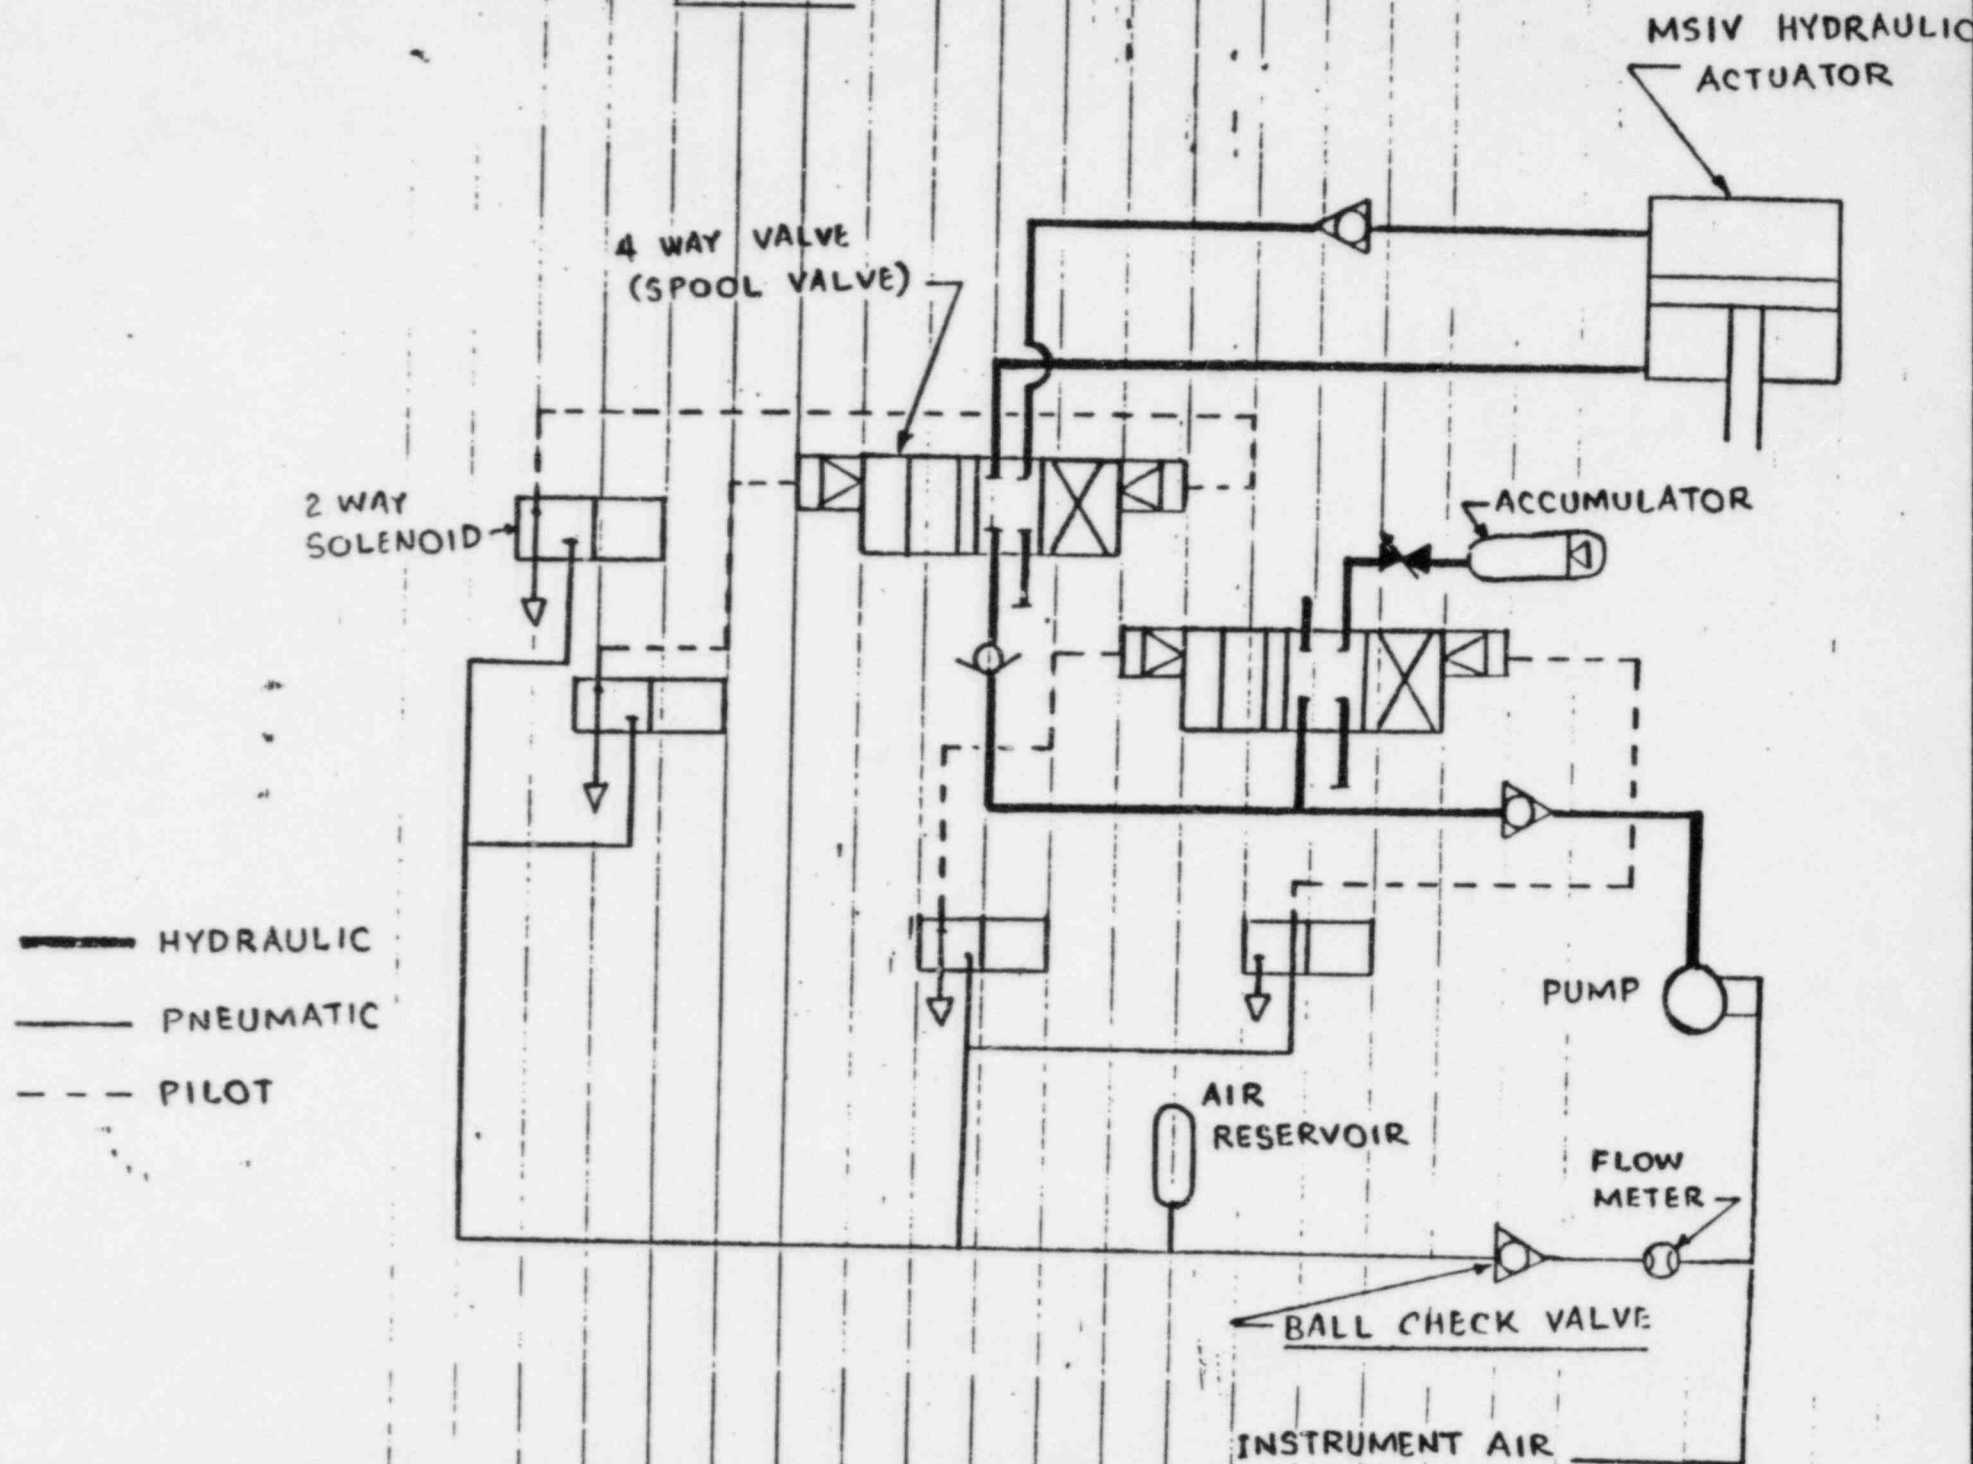
BYRON

- TRIED TO CONTROL PZR PRESSURE USING SG ATMOSPHERIC DUMP VALVES
- SAFETY INJECTION AND MSIV ISOLATION ACTUATED ON LOW STEAM LINE PRESSURE
- TWO MSIVs FAILED TO CLOSE DUE TO LEAKY BALL CHECK VALVE IN AIR SOLENOID CONTROL VALVE AFTER SLOW AIR SYSTEM PRESSURE DECAY

- SAFETY INJECTION CAUSED INCREASED PRESSURIZER PRESSURE AND PORV LIFTED
- PLANT STABILIZED
- CONFIRMATORY ACTION LETTER ISSUED BY REGION III
- LICENSEE INSTALLED EIGHT NEW BALL CHECK VALVES THAT PASSED SLOW PRESSURE DECAY TEST

- PART 21 REPORT ON PARKER-HANNAFIN BALL CHECK VALVES ISSUED BY LICENSEE
- FREQUENCY OF MSIV SURVEILLANCE TESTING INCREASED TO MONTHLY, FROM EVERY 18 MONTHS, UNTIL PERMANENT FIX IS IMPLEMENTED

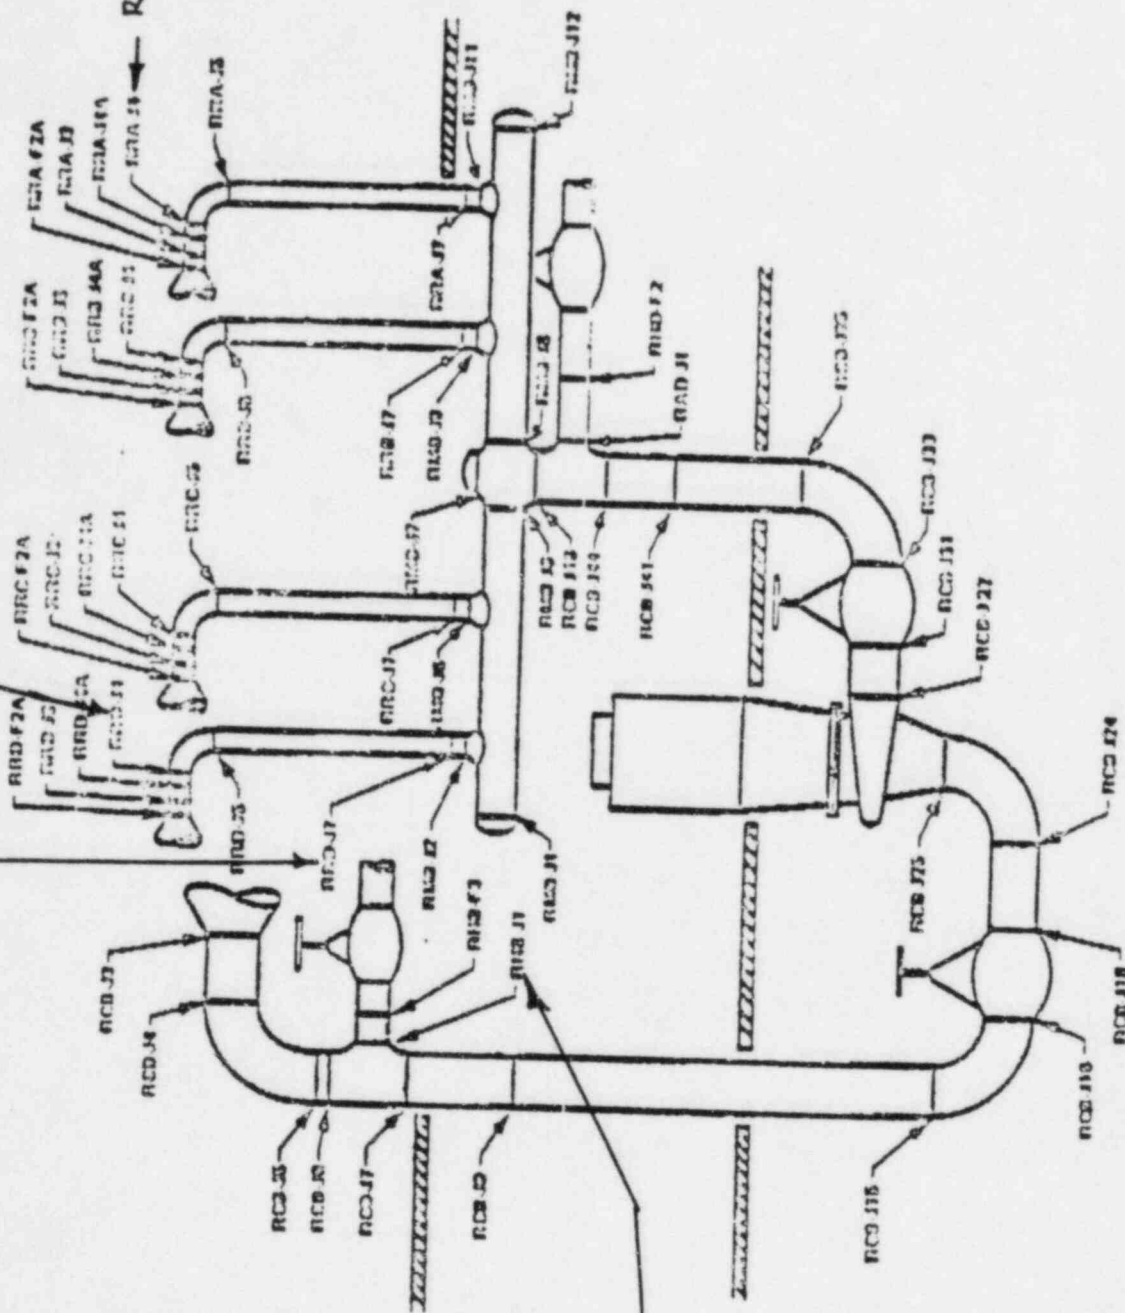
REACTOR RECIRCULATION SYSTEM
LOOP B - DUANE ARNOLD ENERGY CENTER

- PLANT IS IN REFUELING OUTAGE UNDERGOING INSPECTION OF STAINLESS STEEL PIPING REQUIRED BY GENERIC LETTER 84-11.
- ON MARCH 13, 1985, A $\frac{1}{2}$ INCH THROUGHWALL AXIAL CRACK WAS DISCOVERED IN THE RECIRCULATION LOOP "B" 10 INCH RISER, AFTER "IHSI" PROCEDURE. ON APRIL 2, 1985, A POST IHSI THROUGHWALL CRACK WAS DISCOVERED ON RHR-J7 WELD IN LOOP B PRIOR "UT" ON THE SAME WELDS DID NOT SHOW ANY CRACK INDICATIONS.

- "UT" CRACK INDICATIONS HAVE BEEN FOUND AT TWO OTHER LOCATIONS OF THE RISER PIPE WELDS IN THE RECIRCULATION LOOP B AND TWO LOCATIONS IN LOOP A.
- THE CRACK LOCATIONS ARE SHOWN IN THE ATTACHED DIAGRAMS.

75% - RRD-J7

RR A - J4 - THRU - WALL

THRU-WALL - RHR - 57

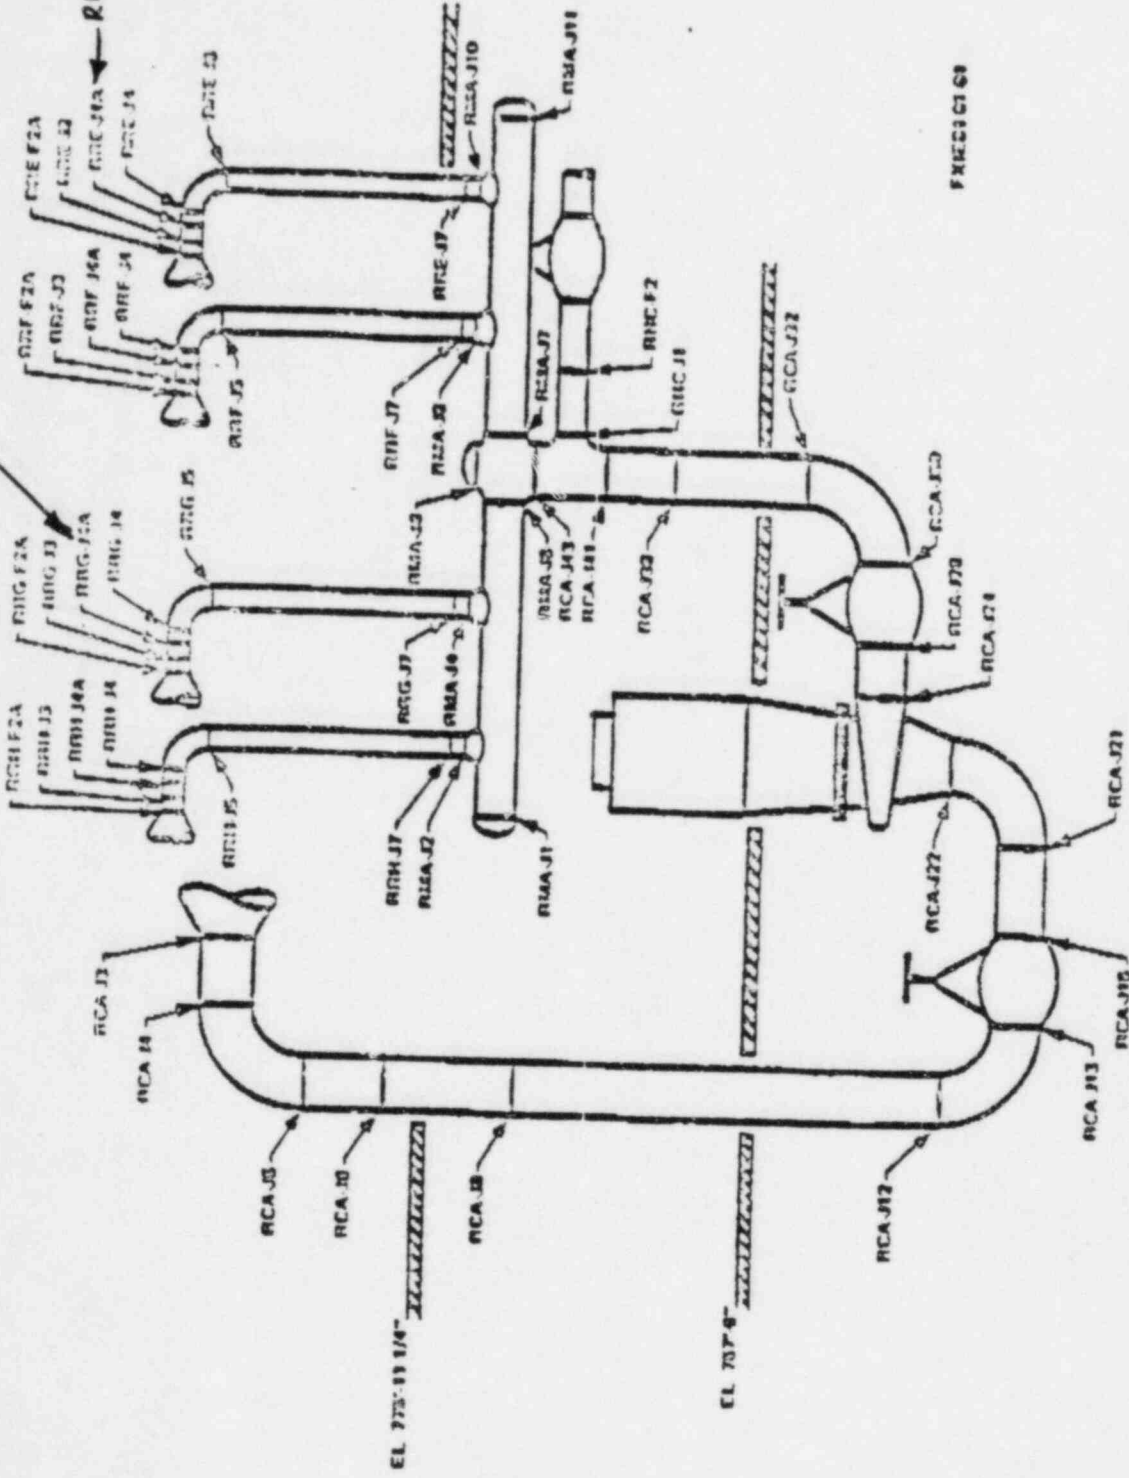
REACTOR REGULATION SYSTEM
LOOP A - GUNNIE ARMOLD ENERGY CENTER

RRE-J4A-70%
