AUGMENTED INSPECTION TEAM REPORT

U.S. NUCLEAR REGULATORY COMMISSION

CALLAWAY LOSS OF ANNUNCIATORS EVENT

INSPECTION REPORT NO. 50-483/92018(DRP)

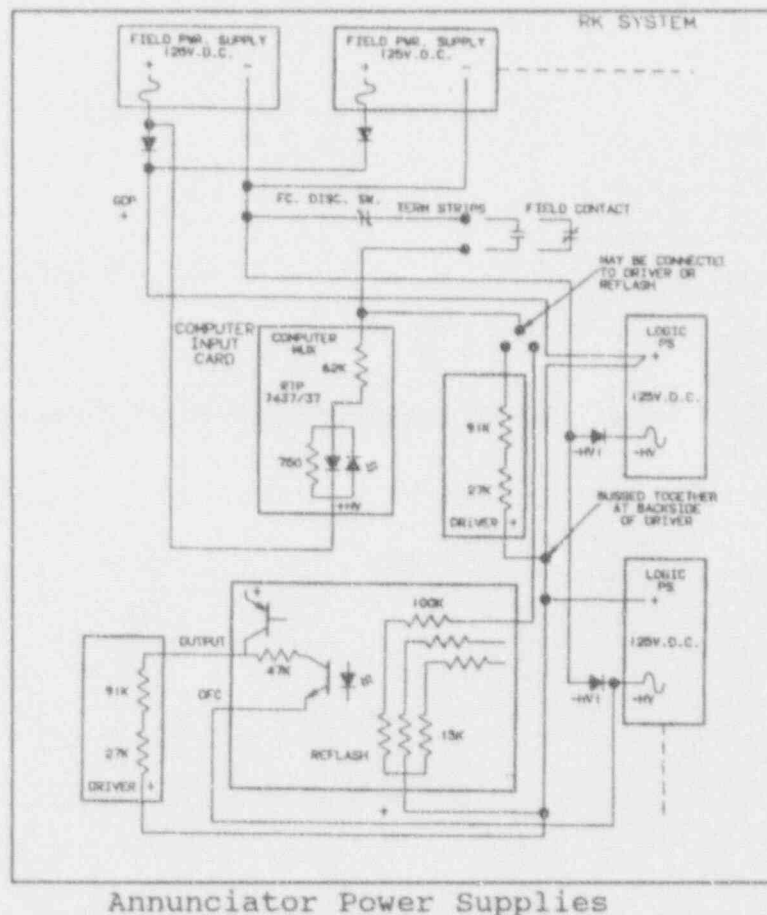
The annunciator system was designed by the Riley Corporation. The system is designed to monitor 1400 alarm points using field contacts which either open or close, to alert operators in the control room by illuminating an annunciator window and sounding an audible alarm. Individual alarm points that are grouped on a system basis also feed the plant computer for display on the cathode-ray tube and the alarm printer.
