SUBJECT: MEETING SUMMARY OF OCTOBER 27, 1992, ON THE SHROUD ACCESS COVER AT  
HATCH UNIT 2 AND POST-MEETING ACTIONS (SAC No. M84756)

PLANT HATCH UNIT TWO  
SHROUD SUPPORT PLATE ACCESS HOLE COVER CRACKING

# ***Access Hole Cover Examinations at Plant Hatch - Unit 2***

HATCH 2  
ACCESS HOLE COVER  
EVALUATION

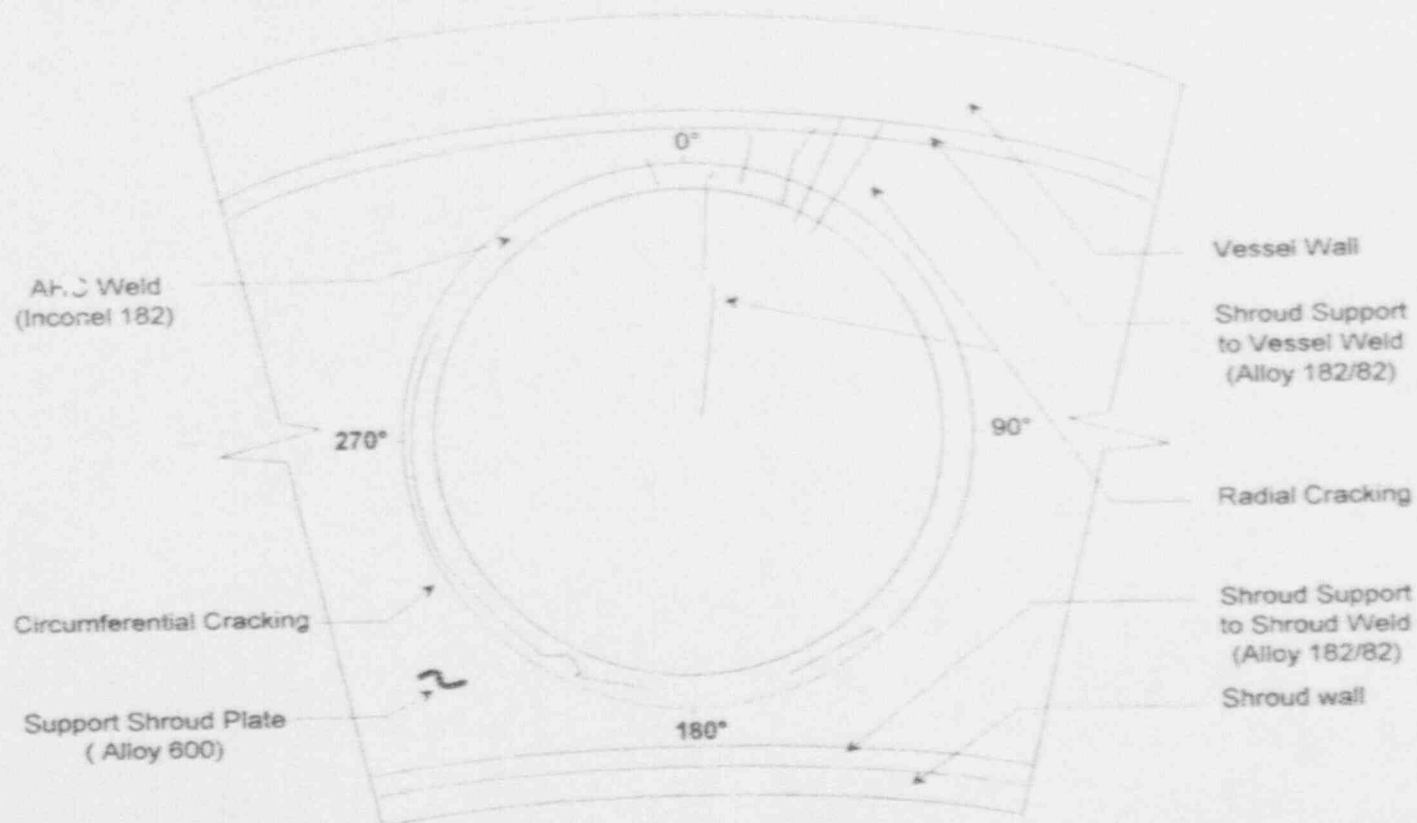
- Recent Visual examination reveals Radial Cracking
- Crack growth extending toward vessel wall
- SIL 462 updated and issued June 8, 1992

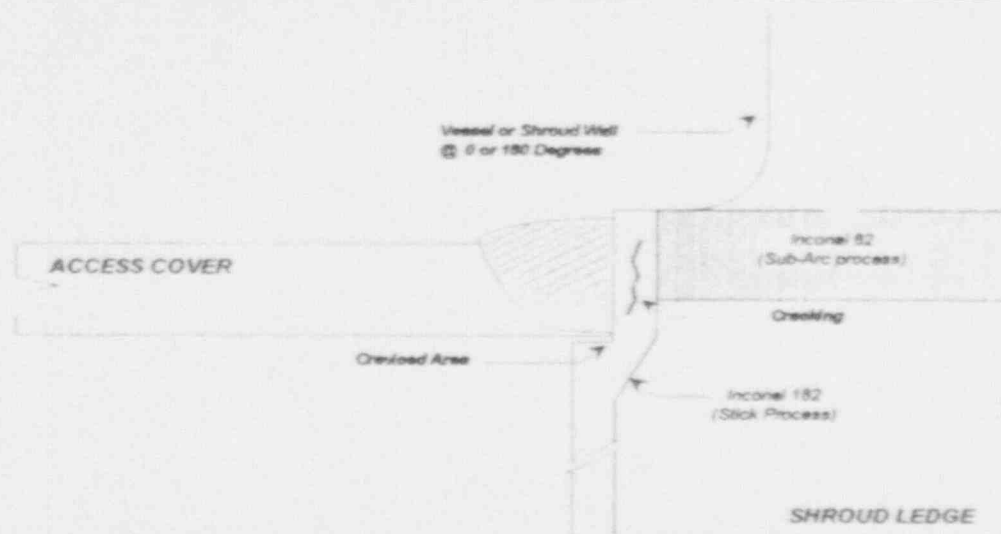
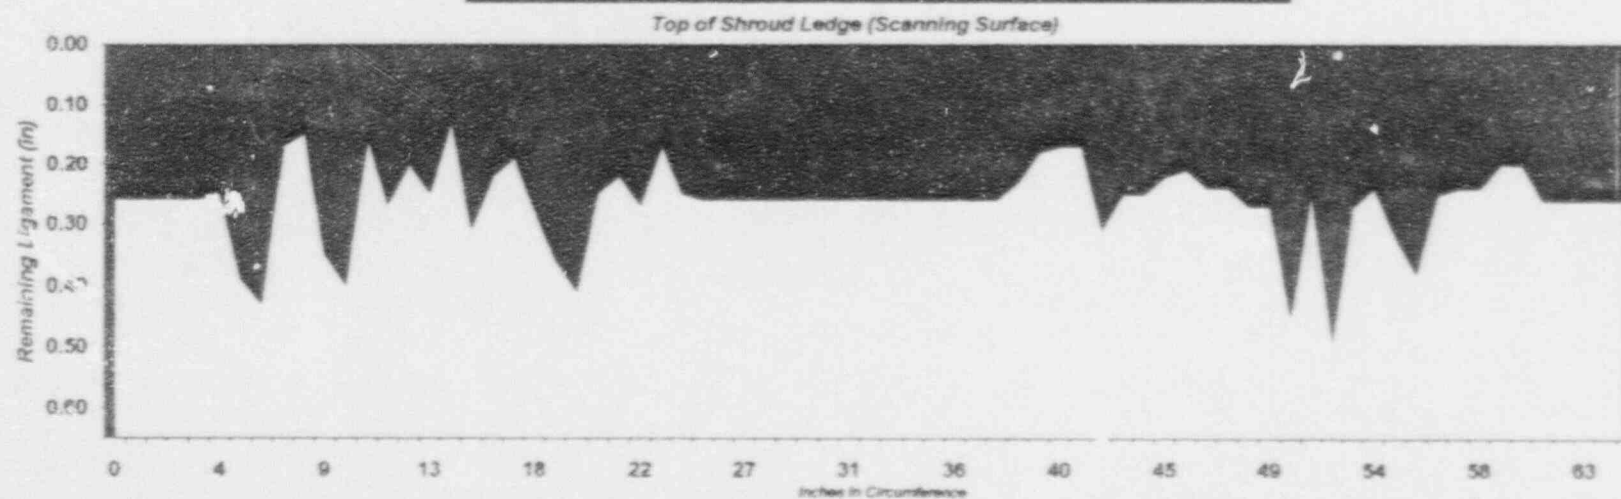
## Hatch - Unit 2 180 Access Hole Cover Exam Results

- 0° cover shows no reportable indications
- 180° cover has 2 circumferential planar indications
  - Indication 1 is from 25° to 135°
  - Indication 2 is from 215° to 335°
    - No axial exam on ledge side from 335° to 25° & from 135° to 215° due to RPV and Shroud wall
  - Indication location verified by ultrasonic landmarks and design dimensions
  - Indication has characteristics similar to IGSCC
    - Facetted appearance
    - Strong echo-dynamic pattern
- No radial cracking detected

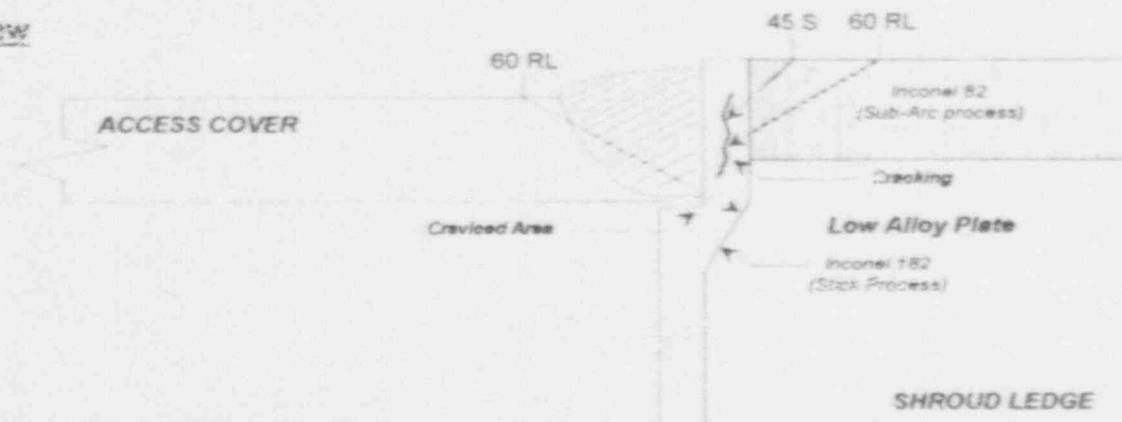
## Hatch - Unit 2 180 Access Hole Cover - Plant Comparison

- Clad Low Alloy
  - 9 inches thick
- 182 Butter Weld Prep
- Recessed Cover with ledge at prep
- Repairs documented during repair

### UT and Visual results are not consistent with other "Thin Cover" data

- Cracking can not be confirmed from Cover side
- Crevice area not detected
  - Interface recorded with beam propagating thru crevice area
- Patterns of thru-wall are not consistent
- No areas of pop-thru detected by Visual examination
- First thin cover p. with only one cover cracked

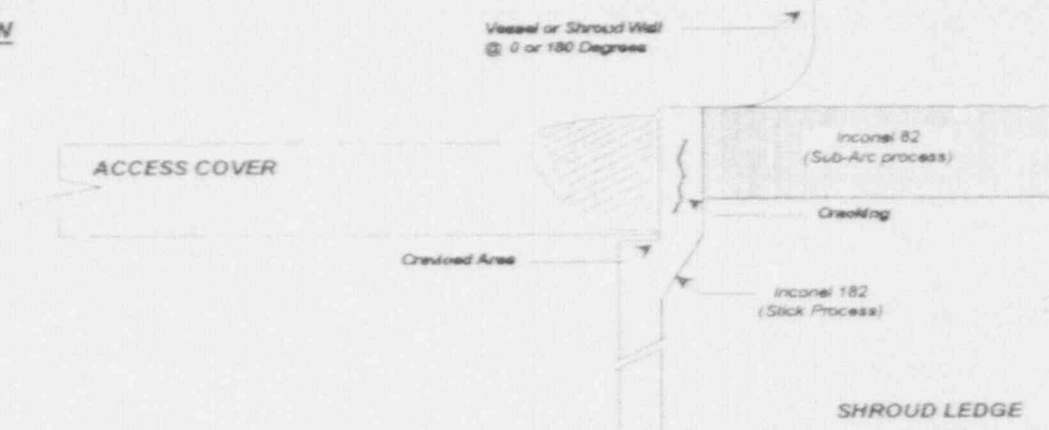
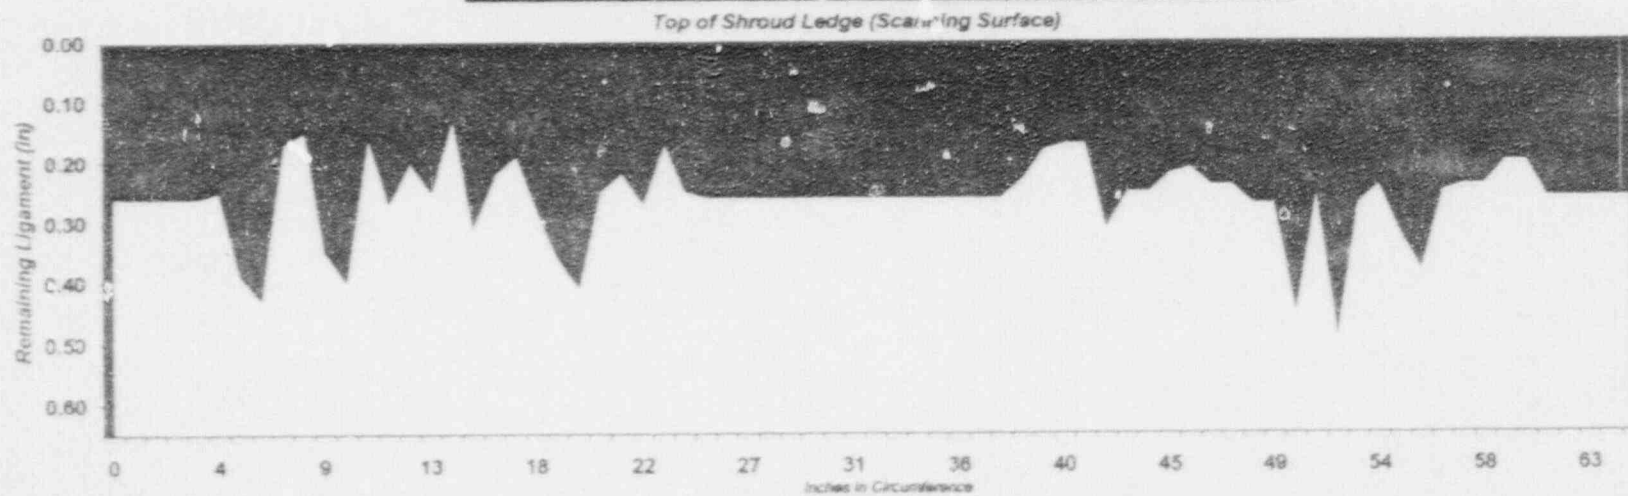
## Hatch - Unit 2 180 Access Hole Cover Exam Results

- 0 CRACK INDICATION IN THE ACCESS HOLE COVER NOT A PRESSURE BOUNDARY CONCERN, BUT CAN BE EVALUATED WITH SIMILAR STRUCTURAL MARGIN CRITERIA.
- 0 CIRCUMFERENTIAL CRACKING IN THE WELD NOT CONSIDERED A SAFETY ISSUE. REVIEWED WITH THE NRC IN THE PAST.
- 1 AHC SEPARATION CAN BE READILY DETECTED BY SIL 462 SYSTEM RECOMMENDATIONS.
- 0 CRACK INDICATIONS ARE CIRCUMFERENTIAL, ENTIRELY IN THE LEDGE. NO RADIAL CRACKING OBSERVED. AVERAGE LIGAMENT THICKNESS APPROXIMATELY 0.26 INCH WITH THE CRACK OFFSET AT LEAST 1/8 INCH FROM THE WELD INTERFACE.

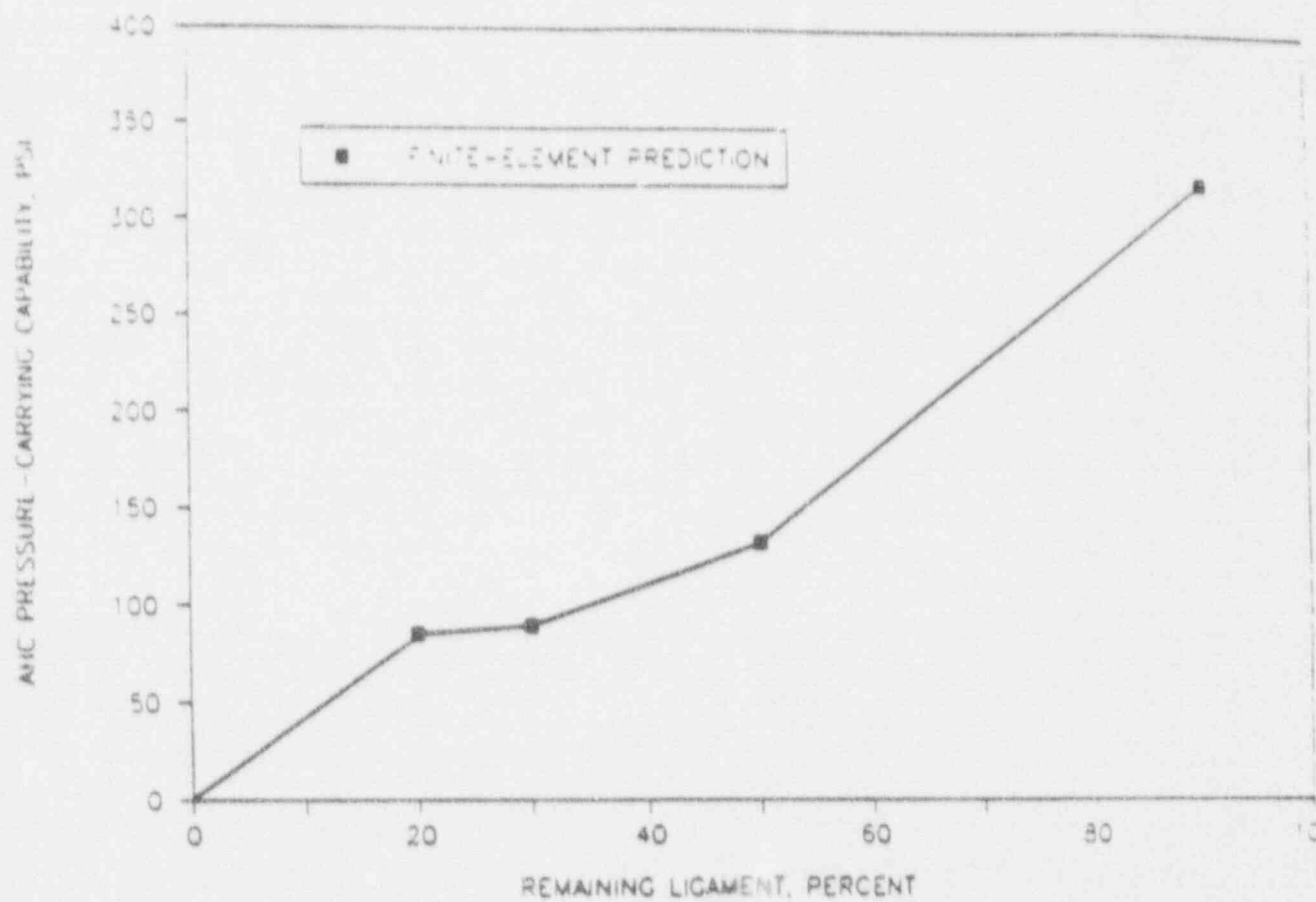
Figure 5-1 Pressure Capability as a Function of Remaining Ligament

- 0 EVEN AFTER ACCOUNTING CRACK GROWTH AND INCLUDING THE STRUCTURAL MARGIN OF 3.0, THE REQUIRED LIGAMENT IS 0.14 INCH. THE AVAILABLE AVERAGE LIGAMENT OF 0.26 INCH IS WELL IN EXCESS OF THE REQUIRED VALUE.

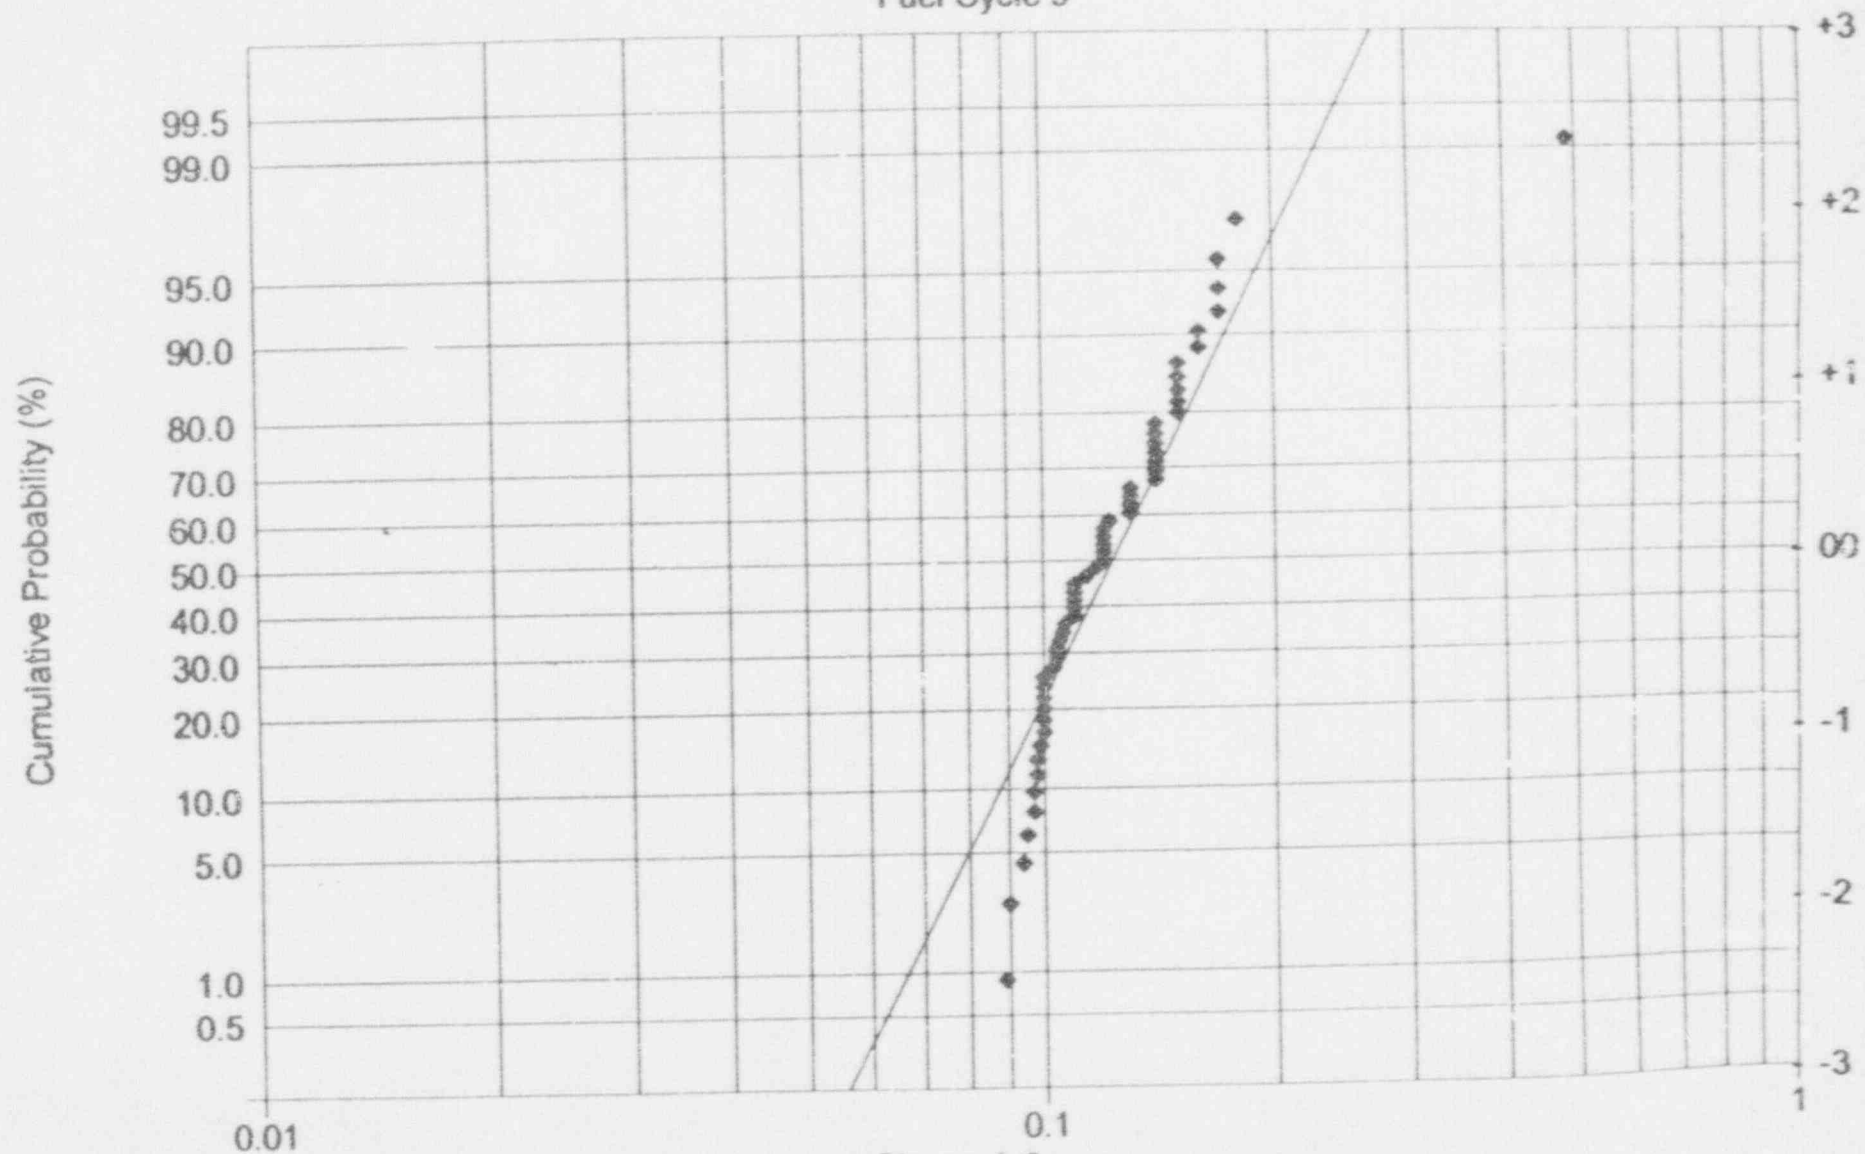
Figure 4-8

- 0 IGSCC CRACK GROWTH RATE IS A STRONG FUNCTION OF WATER CHEMISTRY - CONDUCTIVITY AND ECP.
- 0 HATCH 2 WATER CHEMISTRY HAS BEEN EXCELLENT DURING THE LAST FUEL CYCLE
  - + WEEKLY AVERAGE WATER CONDUCTIVITY HAS BEEN LESS THAN 0.2 MICROSIEMEN/CM FOR OVER 95 PERCENT OF THE TIME
  - + PLANT HAS BEEN OPERATING UNDER HYDROGEN WATER CHEMISTRY WITH 0.6 PPM FEEDWATER HYDROGEN INJECTION
- 0 BASED ON LOWER PLENUM ECP MEASUREMENTS DONE AT FITZPATRICK (SIMILAR TO HATCH 2), ECP BELOW THE AHC AT 0.6 PPM FEEDWATER HYDROGEN INJECTION LEVEL IS -100 mV.
- 0 CRACK GROWTH RATE AT -100 mV ECP IS PREDICTED TO BE 16 TIMES LOWER THAN THAT UNDER NORMAL WATER CHEMISTRY (+100 mV) GIVING A RATE OF 1.2 MICROINCH / HOUR. THIS GIVES AN INCREMENT OF 15 MILS IN THE NEXT 12000 HOURS.
