SUBJECT: REVIEW OF PRELIMINARY ACCIDENT SEQUENCE PRECURSOR ANALYSIS OF THE
ICING EVENT AT WOLF CREEK

Plant: Wolf Creek

Loss of Circulating Water Due to Icing on Traveling Screens Causes Reactor Trip

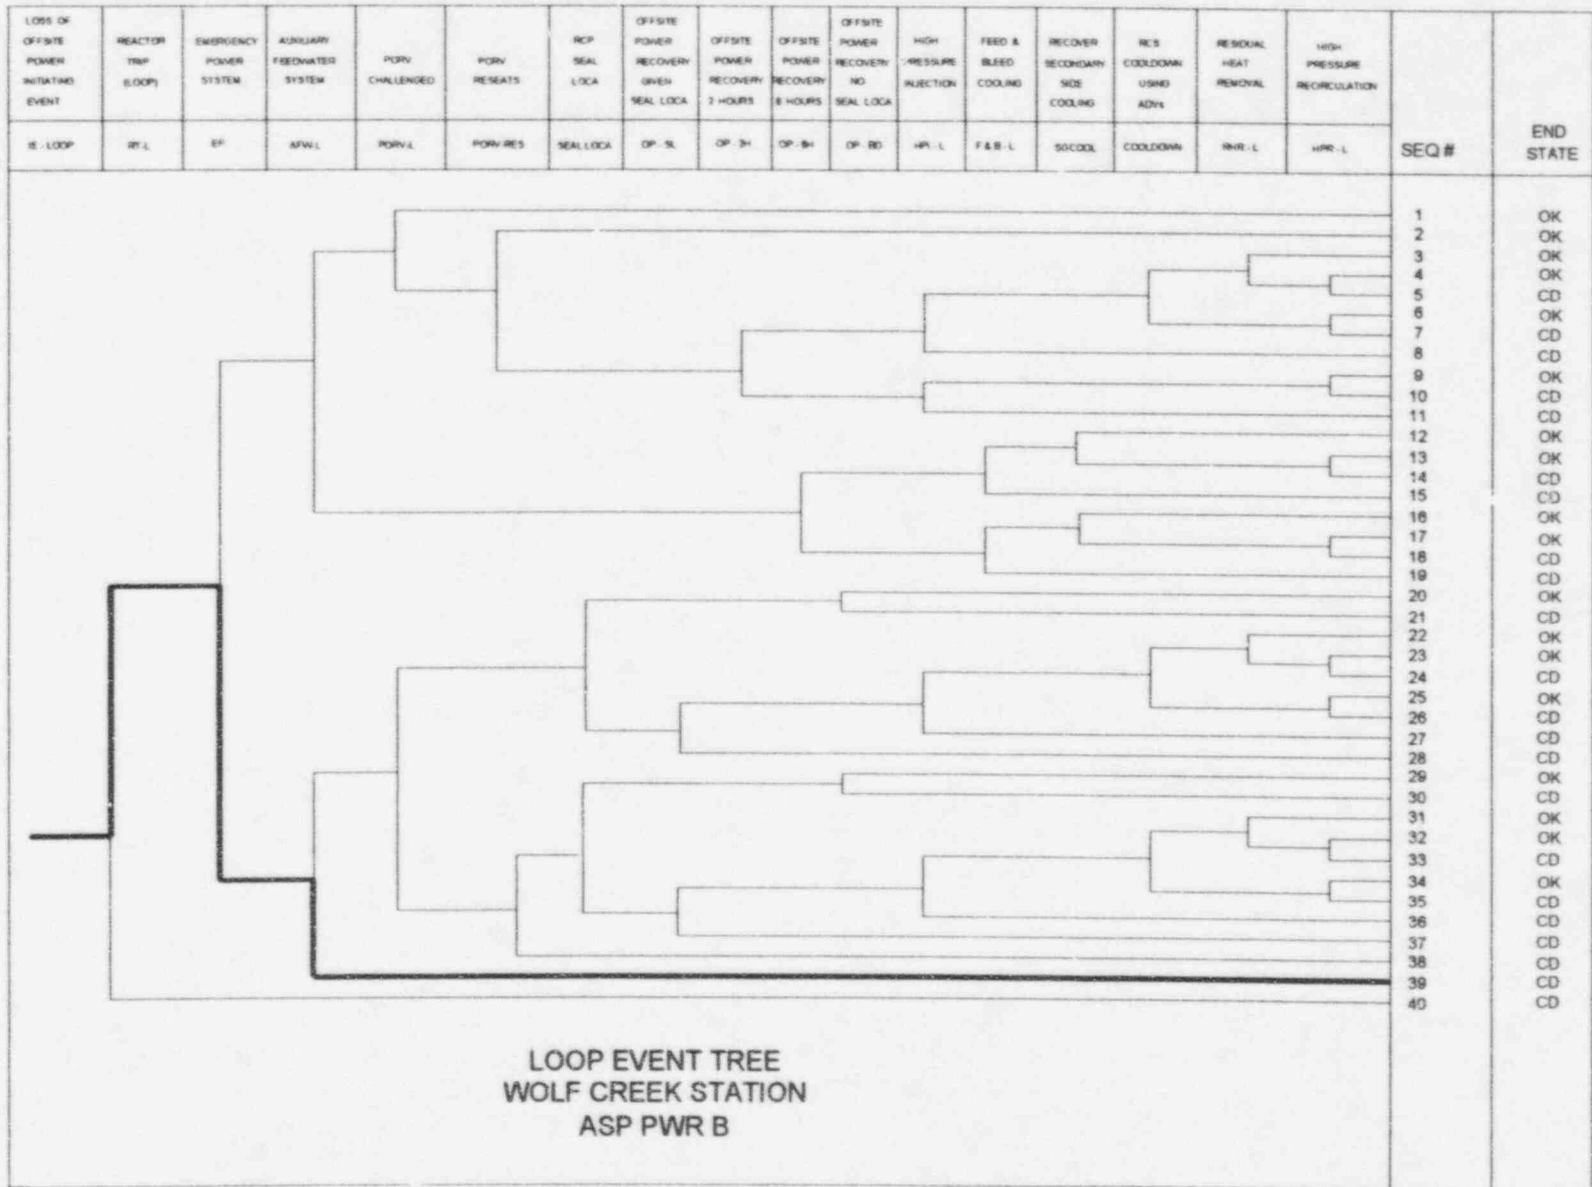
Fig. 1 Dominant core damage sequence given a LOOP for LER No. 482/96-001.

The estimated conditional core damage probability (CCDP) associated with this event is 4.8×10^{-5} . The dominant core damage sequence, highlighted as sequence number 39 on the event tree in Fig. 1, contributes approximately 25% to the CCDP estimate. This event involves:

- given a loss of offsite power, the reactor successfully trips,
- both trains of emergency power fail, and
- AFW fails to provide sufficient flow.

This sequence is driven by the loss of the TDAFWP and a nominal failure of the B EDG. In an actual LOOP, the operators would likely have continued to operate the TDAFWP with the gland leak until it failed, while working in parallel to restore emergency power. The combined LOOP sequences contribute 53% of the total

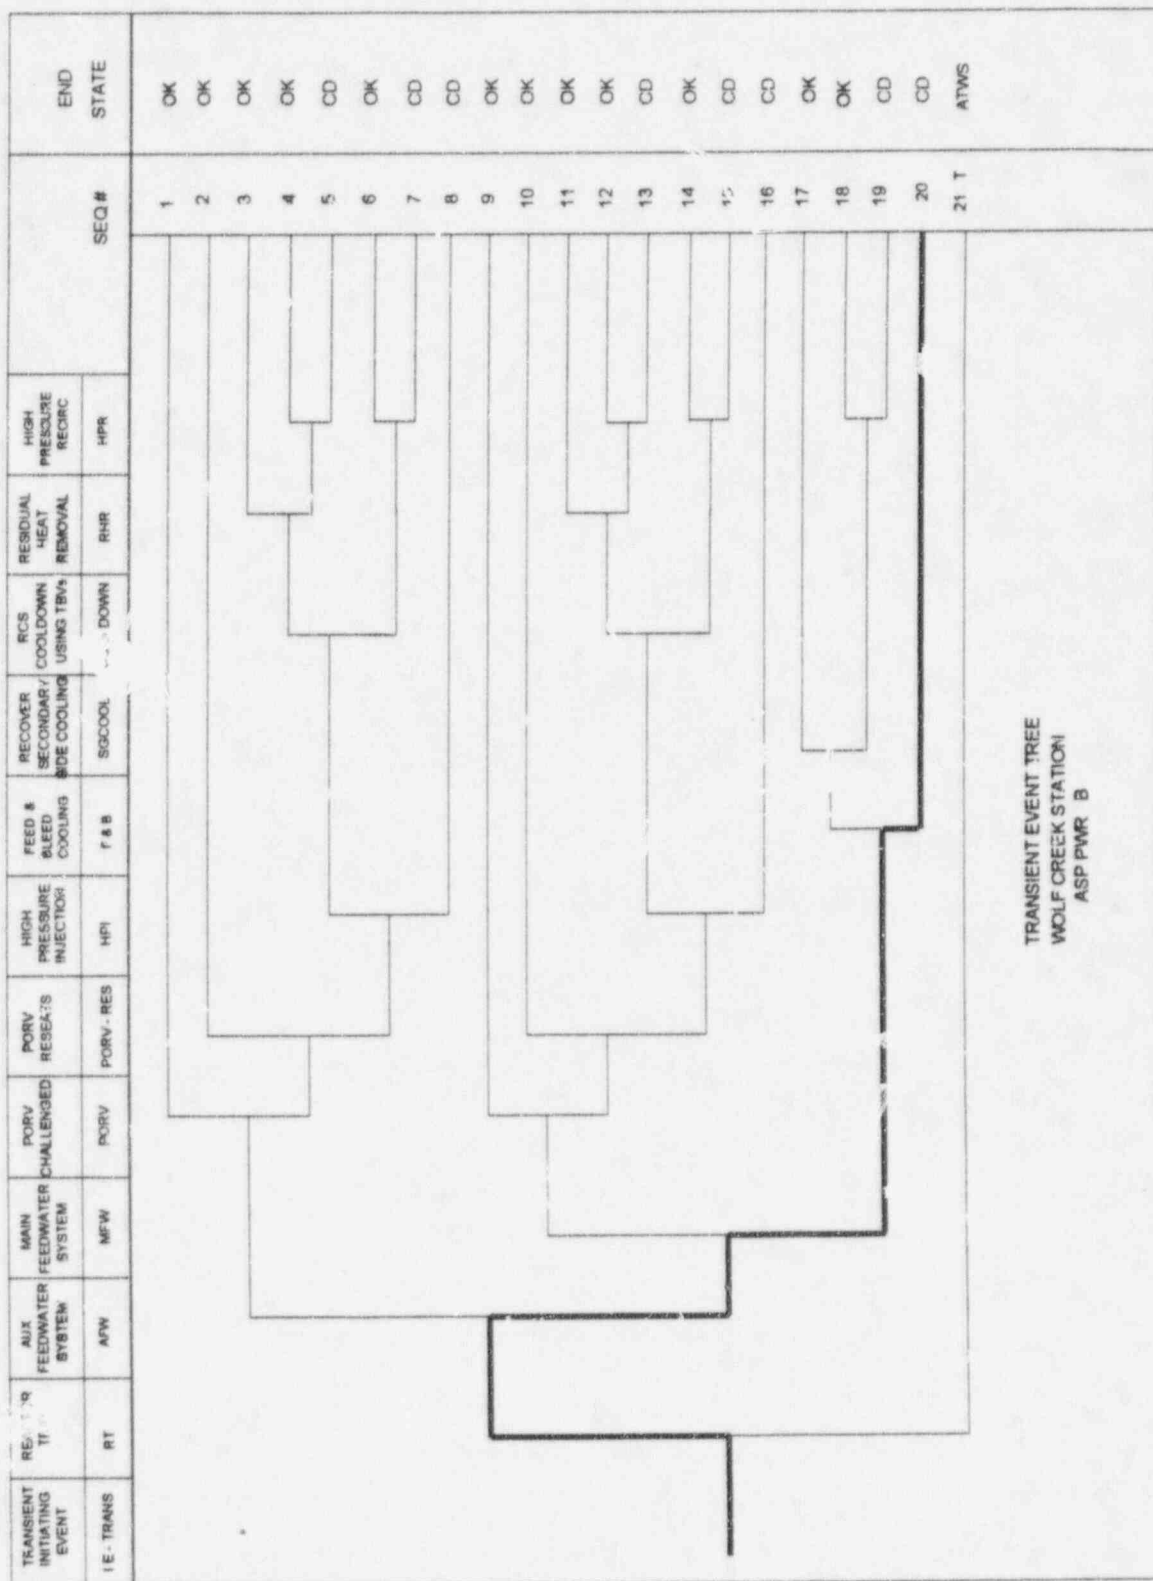
Fig. 2 Dominant core damage sequence given a transient for LER No. 482/96-001.

- a successful reactor trip,
- failure of AFW,
- failure of MFW, and
- failure of feed and bleed.

This transient sequence is driven by the common cause failure of the ESWS pumps.

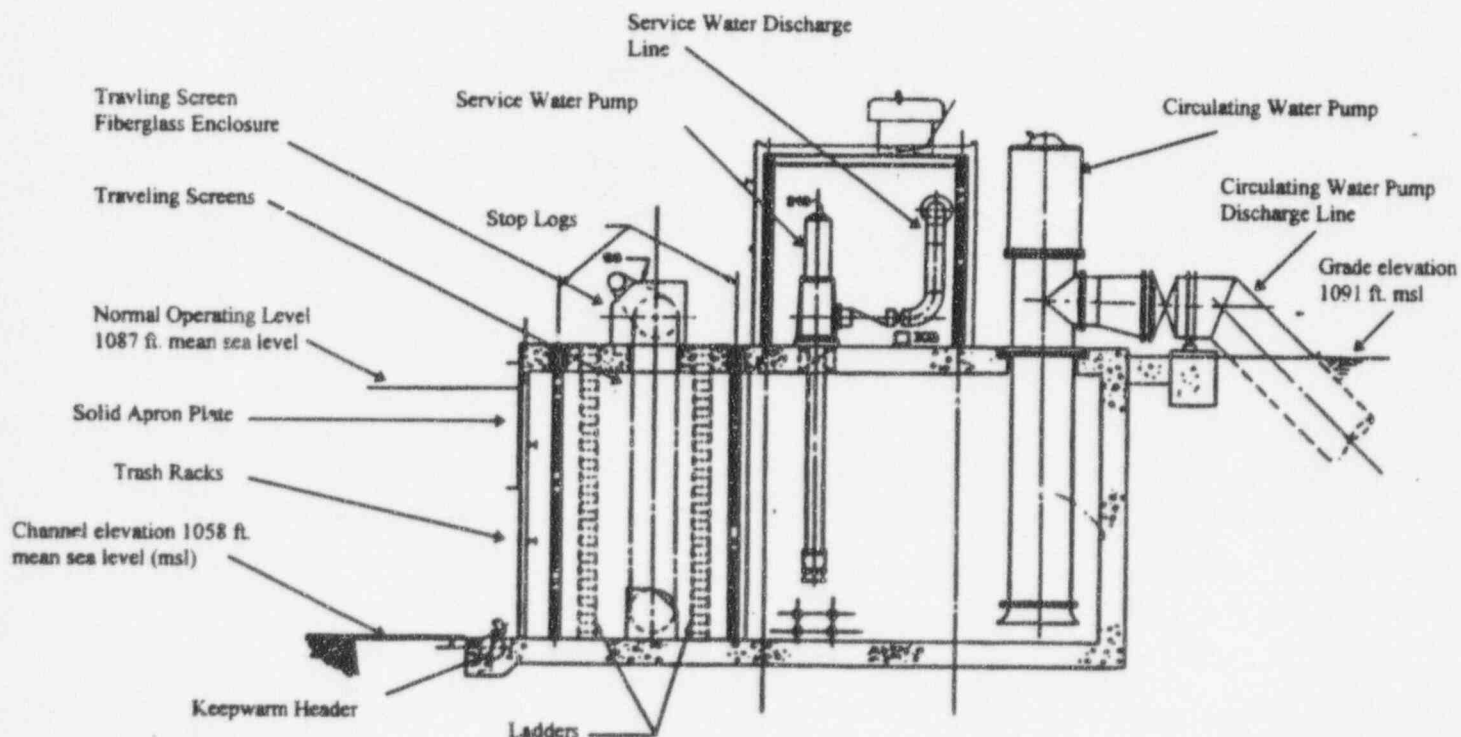
FIGURE 1

The root cause of the event was that the design of the Circulating Water Intake Structure and associated traveling screens did not account for the harsh environmental conditions imposed on them during the events of January 30, 1996. A potential contributing factor to the event was the spraying of near freezing water onto the screens exposed to atmospheric conditions. This spray water caused an initial ice build-up on the screens, which grew when exposed to the water from the lake.

The CW traveling screens are a series of stainless steel wire mesh basket assemblies with 3/8" openings. The screens are chain driven by a two speed motor (1800/450 RPM). In the slow speed operation (whether manual or automatic), 1 complete basket cycle takes 36 minutes. In fast speed operation (whether manual or automatic) 1 complete cycle takes 9 minutes.

While in manual slow speed operation, as procedurally required, the screens are exposed to the atmospheric conditions for approximately 7 minutes during the 36 minute cycle. While exposed to the atmosphere, the screens are backwashed by sprays supplied by SW at approximately 80 psi. This spray, when exposed to the atmospheric conditions present on January 30, 1996, caused an initial ice build-up on the steel mesh. As the traveling screens continued through their cycle, they were exposed to the water coming into the CW Bay. This incoming water was believed to be warmed sufficiently to prevent ice buildup on the trash racks in front of the screens, yet near enough to freezing that the initial ice build-up caused a rapid growth of ice to block the screens completely.

Procedures SYS SW-121, "Circ Water Screen Wash System," and STN GP-001, "Plant Winterization," were revised on February 6, 1996, to delete the requirement to operate traveling screens continuously in the slow manual mode during cold weather or unusual icing conditions. These revisions allow the screens to be operated in an automatic mode in which the screens remain stationary without sprays until the system is started either by timer or on high differential level. The automatic mode will cycle the screens through two-thirds of one complete cycle before stopping, providing there is no high differential level still present across the screens. The screens will be automatically started again by either the timer or a high differential level. This mode of operation is recommended by Engineering when icing conditions are present. The winterization procedure previously had the screens started in slow, as a conservative action, during cold weather in anticipation of surface icing or of moss or other aquatic vegetation floating into the screens.
