PEACH BOTTOM ATOMIC POWER STATION

SUBJECT: Licensee Event Report
Peach Bottom Atomic Power Station - Unit 2

Reference:	Docket No. 50-277
Report Number:	2-92-015
Revision Number:	00
Event Date:	08/17/92
Report Date:	09/16/92
Facility:	Peach Bottom Atomic Power Station RD 1, Box 208, Delta, PA 17314

Reactor Scram Due to a Less Than Adequate Load Dispatcher Permit in the Substation

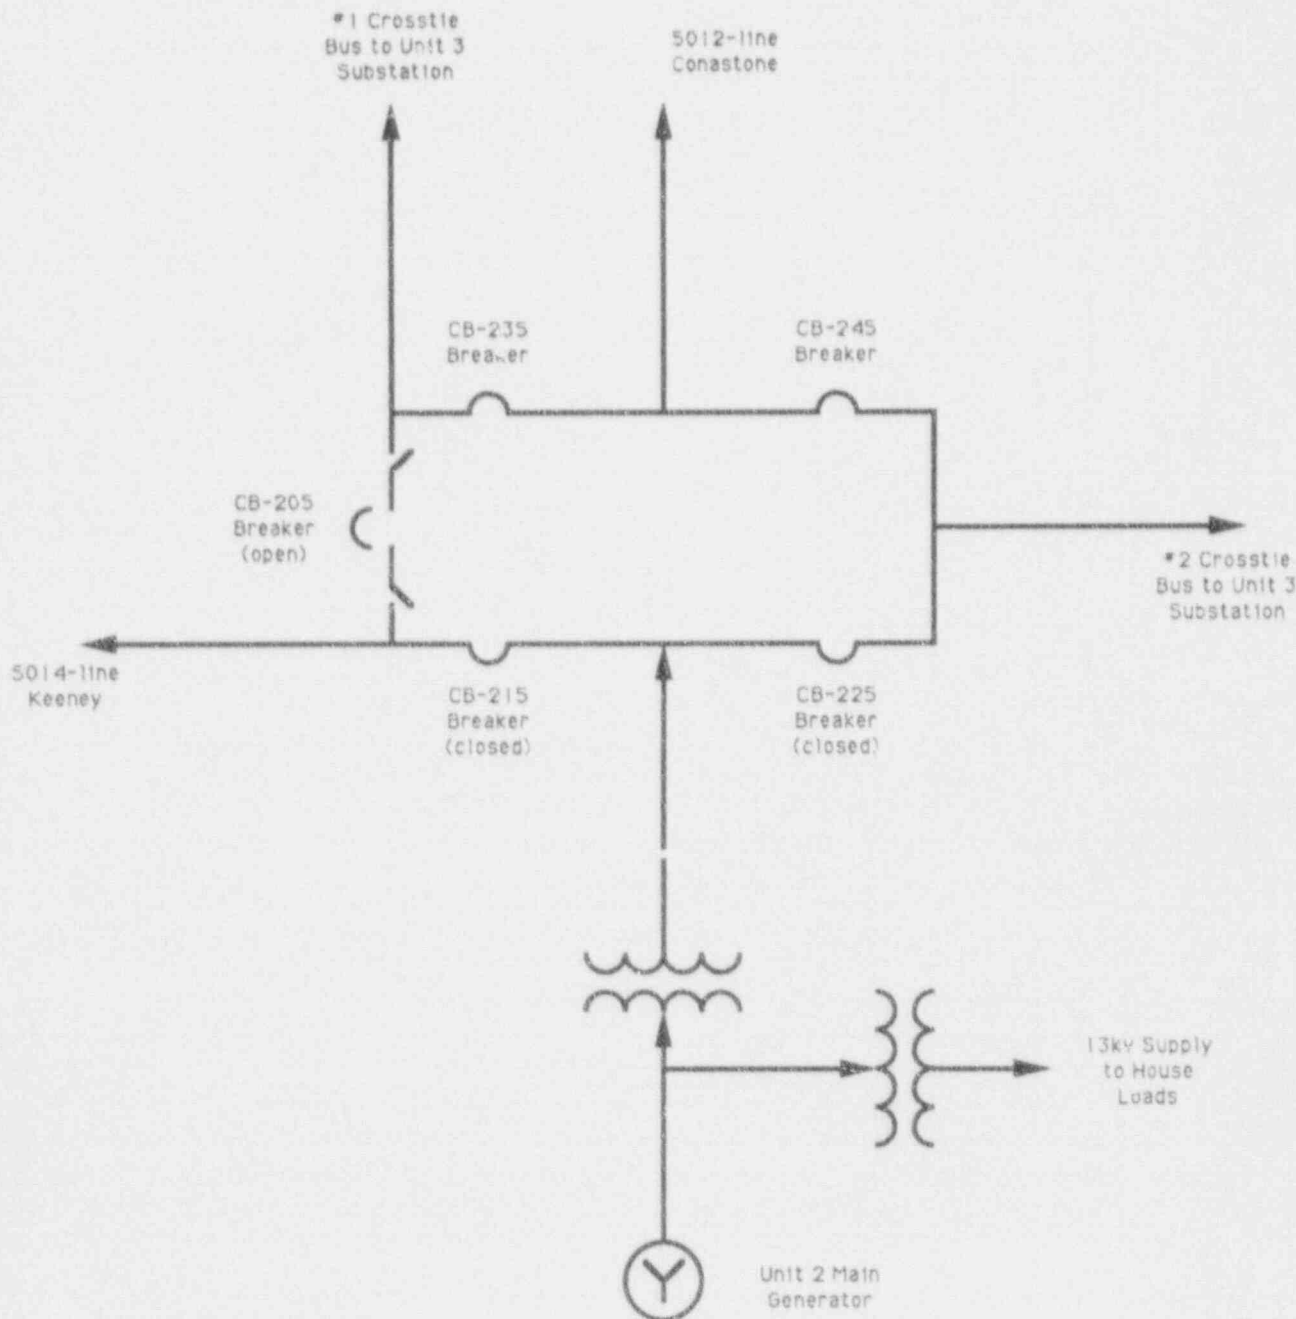
SIMPLIFIED UNIT 2 SUBSTATION ELECTRICAL DIAGRAM

On 8/17/92 at 0712 hours, during the application of a Substation Load Dispatcher (LD) permit on a Circuit Breaker (CB-205) (see attached diagram), a reactor scram occurred following a Main Generator Lock Out. CB-205 was being removed from service for maintenance activities. The maintenance activities included circuit breaker muffler replacements. The event occurred when the Substation operator opened the "5014 Line Relay Block Switch" located on the Main Generator Output Breaker (CB-215) rather than "5014 Line Back Up Relay Block Switch" on CB-205. The combination of the relay block switch open on CB-215 and the breaker open on CB-205 simulated a CB-215 breaker failure. With the CB-215 breaker failure signal and the breaker not open, a CB-215 failure signal was sent to the other Main Generator Output Breaker (CB-225) and to the Main Generator Lock Out circuitry which tripped CB-215. The actuation was recreated later that day to ensure understanding of the event.

Less than adequate generation and approval of a Substation LD permit on CB-205. The LD permit had an unnecessary step which caused the event. The "5014 Line Back Up Relay Block Switch" on CB-205, which should have been opened, was an unnecessary step to perform the specified maintenance activity. LD permits on the Transmission and Distribution system are controlled and administered by the LD. The LD is the individual in charge of Transmission and Distribution of electrical power produced and transmitted within the Philadelphia Electric Company system. No pre-approved blocking sequences, similar to those used at the plant, were available for CB-205. In addition, the LD permit did not include equipment locations.

A contributing factor to this event was less than adequate labels on Substation equipment. The relay block switches were poorly labeled with pencil markings. Had the "5014 Line Relay Block Switch" on CB-215 and the "5014 Line Back Up Relay Block Switch" on CB-205 been labeled in a uniform method similar to those used at the plant, the Substation operator may have realized that he was performing a step at the wrong circuit breaker.

As an interim corrective action, Substation LD permits are being reviewed by Station personnel for reliability prior to LD permit application. In the future, approved blocking sequences will be generated and labeling will be enhanced for Substation equipment which could impact plant reliability.
