NORTHEAST UTILITIES

Reference: Facility Operating License No. DPR-21
Docket No. 50-245
Licensee Event Report 91-020-01

This letter forwards update Licensee Event Report 91-020-01 required to be submitted pursuant to 10CFR50.73(a)(2)(v).

FACILITY NAME (1) Milestone Nuclear Power Station Unit 1	EVENT NUMBER (2) 0 5 0 0 0 2 4 5 9 1	LER NUMBER (6)			PAGE (3)	
		YEAR	SEQUENTIAL NUMBER	REVISION NUMBER		
			0 2 0	0 1	0 2	OF 0 8

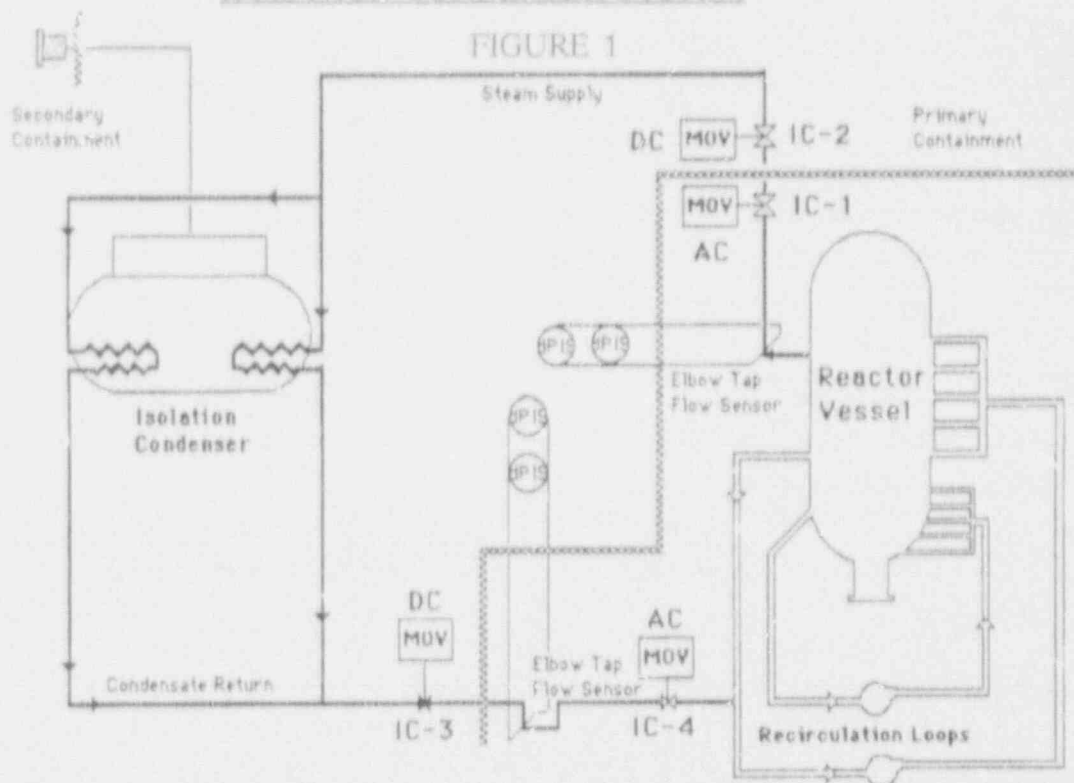
MILLSTONE UNIT ONE
ISOLATION CONDENSER SYSTEM

The Isolation Condenser is provided to remove decay heat following a reactor scram and reactor isolation from the main condenser. The Isolation Condenser is also credited for a small break Loss of Coolant Accident (LOCA). The Isolation Condenser has a heat removal capacity sufficient to handle the decay heat production at 300 seconds following a reactor scram. The Isolation Condenser system automatically initiates on high reactor pressure in excess of 1085 psig sustained for 15 seconds, or at low-low reactor water level of -48 inches. The Isolation Condenser automatically isolates on a sensed condition of either high steam flow or high condensate flow. The isolation system senses the high flow conditions from elbow taps located in the system piping as shown in Figure 1.

A single failure of the S2 DC power supply, along with an assumed LNP, could result in the inability to isolate an Isolation Condenser line break. The four Isolation Condenser isolation valves are powered from the S2 facility for both the AC and DC valves. Loss of the S2 DC bus prevents the closure of IC-2. Loss of the S2 DC bus also prevents the ability to close the Diesel Generator output breaker and flash the generator field which results in the inability to provide power for closure of the AC valves, IC-1 and IC-4 (see Figure 1).

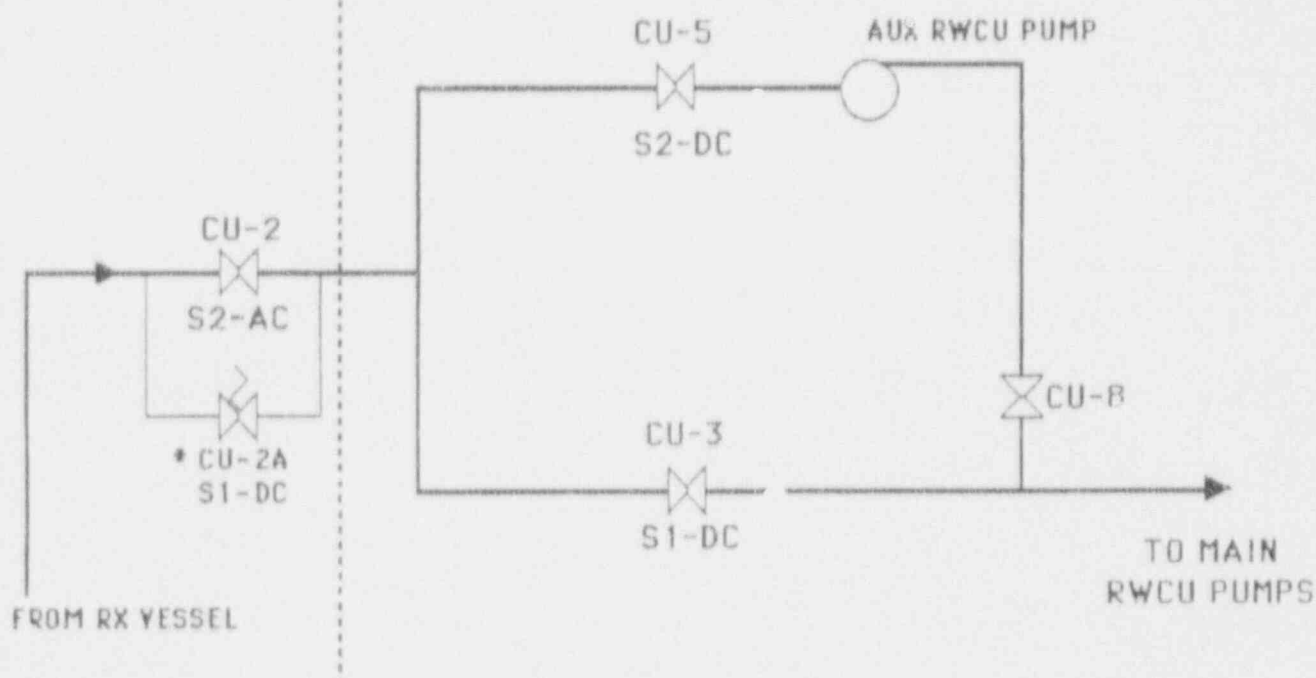
Figure 2

2. Reactor Water Cleanup (RWCU) system containment isolation valve CU-2A was identified as being powered from S1-DC division power with its power cable located in an S2 division cable tray. CU-2A is a normally closed solenoid operated bypass valve designed to equalize pressure around CU-2 when placing the RWCU system in service. Loss of power to CU-2A results in the valve failing closed to the position required for containment isolation. The power cable for CU-2A was relocated from the S1 division to the S2 division to correct the S1/S2 cable tray separation discrepancy.

*CU-2A power supply changed from S1-DC to S2-DC during 1991 refueling outage
