9B DTU Density Gauge — Shutter Failure

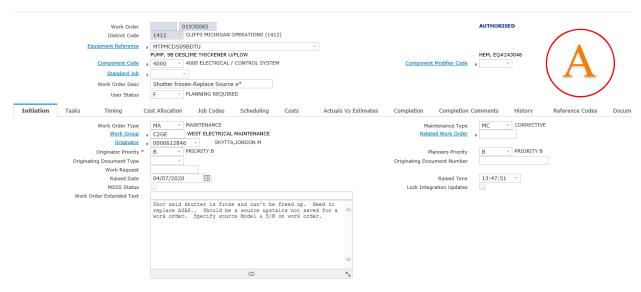
- 1. On 04-07-20 a trained technician was in the process of performing the by annual inventory/shutter checks, when he reported that Ohmart Model #ED-6, Serial #65902, 100 mCi, Cs-137 gauge located on 9B DTU (Deslime Thickener U/Flow) in the Deslime basement had a frozen shutter mechanism, rendering the shutter non-operable.

- 2. On 04-07-20 A Work Order was entered (1930085) that 9B DTU Density Gauge Shutter was stuck. See attachment "A"
- 3. 04/07/20 RSO went to look at gauge.

- 4. 04/07/20 RSO instructed technicians to take spare gauge out of storage and replace.
- 5. 04/07/20 RSO was told by operations that they needed to keep the unit running and they could not shut the line down at this point in time.

- 6. 04/07/20 RSO wrote a memo to file indicating a course of action. The gauge won't be replaced till the first time the line goes down for repair. (Estimate May 1, 2020). If the line goes down prior to that, we will take the opportunity to get it changed out.
