FACILITY: Three Mile Island, Unit No. 1 (TMI-1)

SUBJECT: SUMMARY OF MEETING WITH GPUN ON JUNE 28 and 29, 1982
CONCERNING GPUN'S STEAM GENERATOR RECOVERY PROGRAM

**TMI-1 OTSG Status
and
Repair Process Description**

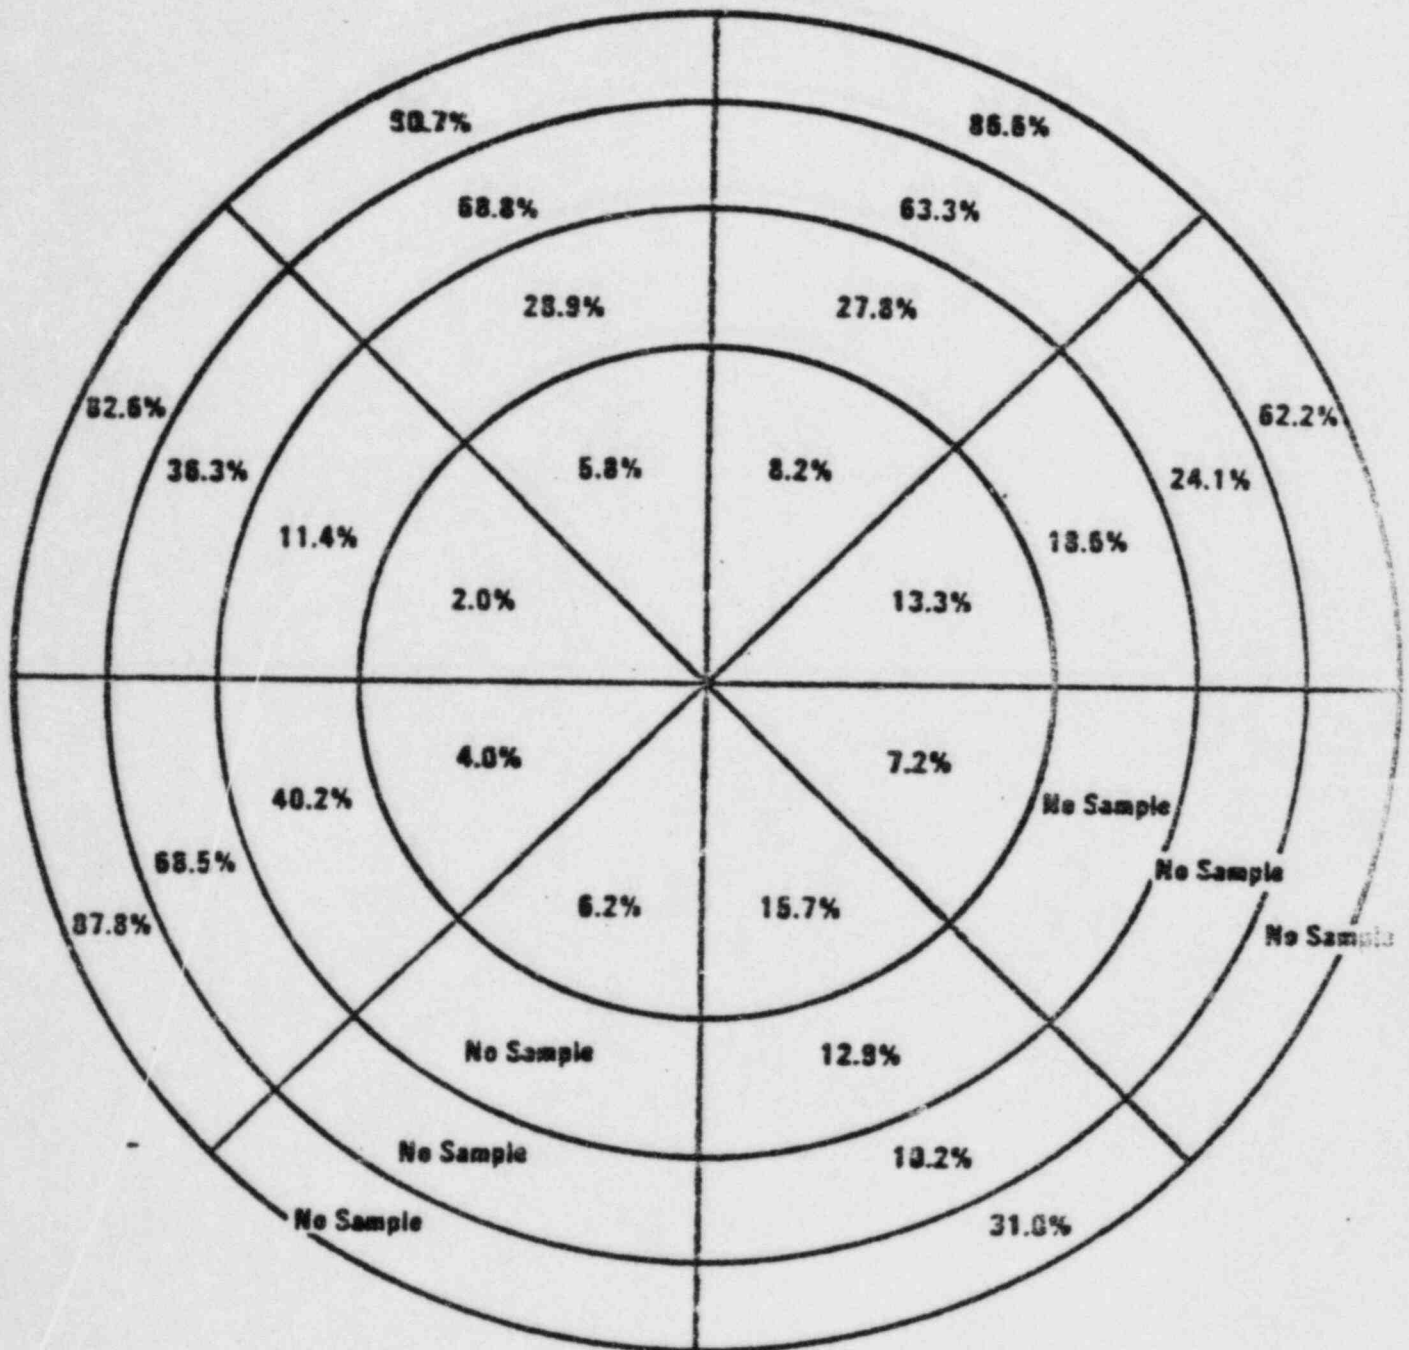
4 X 1 Eddy Current Results
Percent of Tubes with Defects

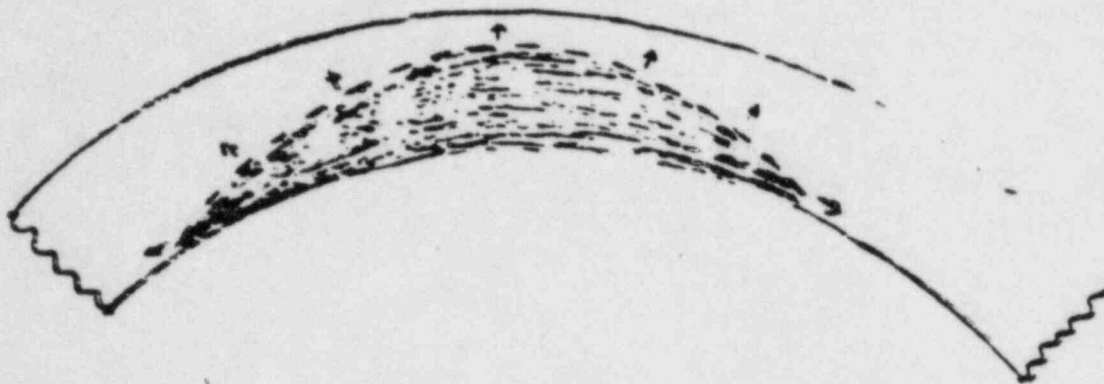
FIGURE VI - 1

a) Advancing crack not yet through wall.

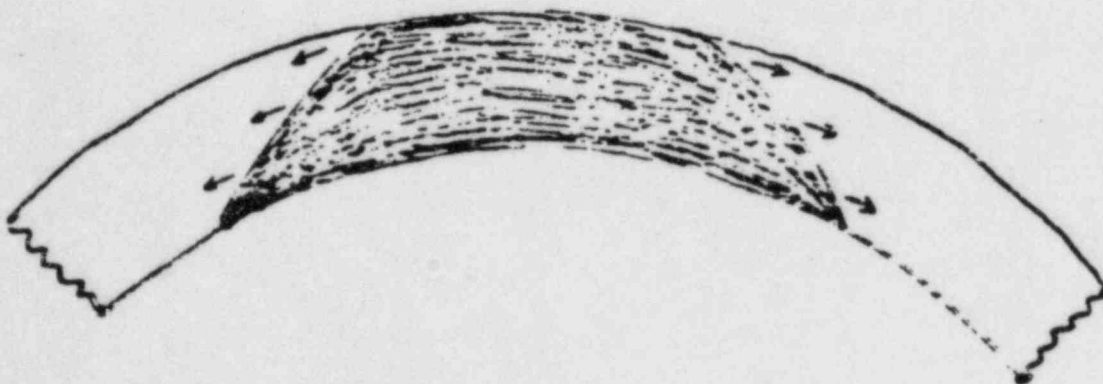
b) 100% through-wall crack continuing to grow.

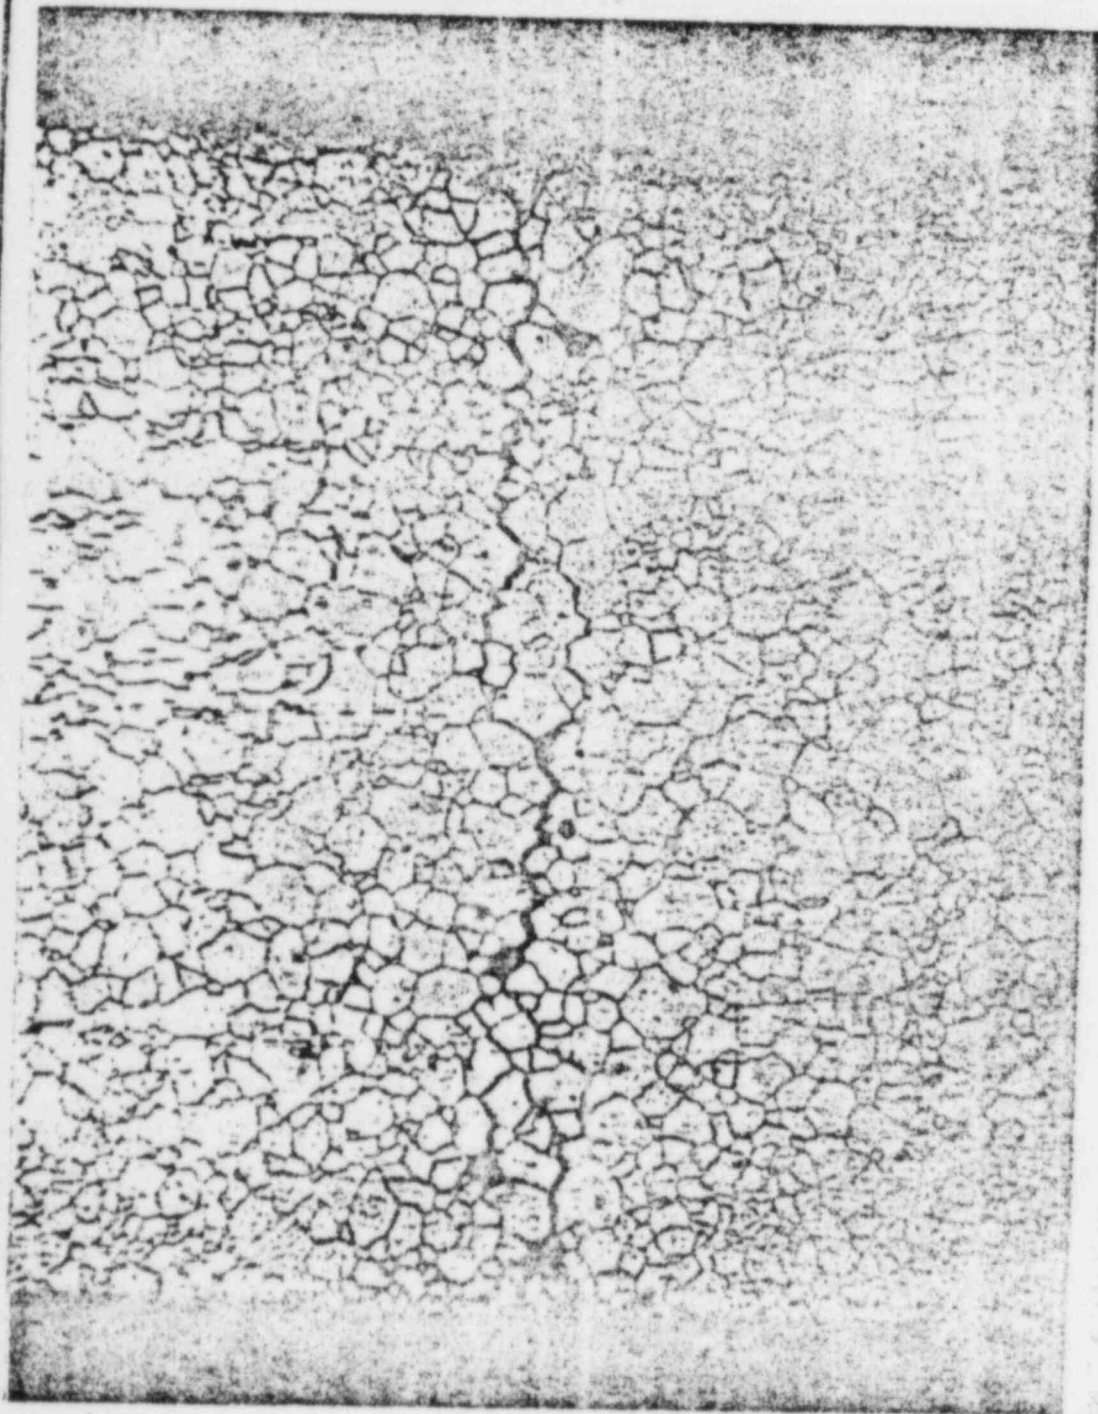
PHOTOMICROGRAPH OF THROUGH WALL IGC IN
SPECIMEN C FROM TUBE A-146-6

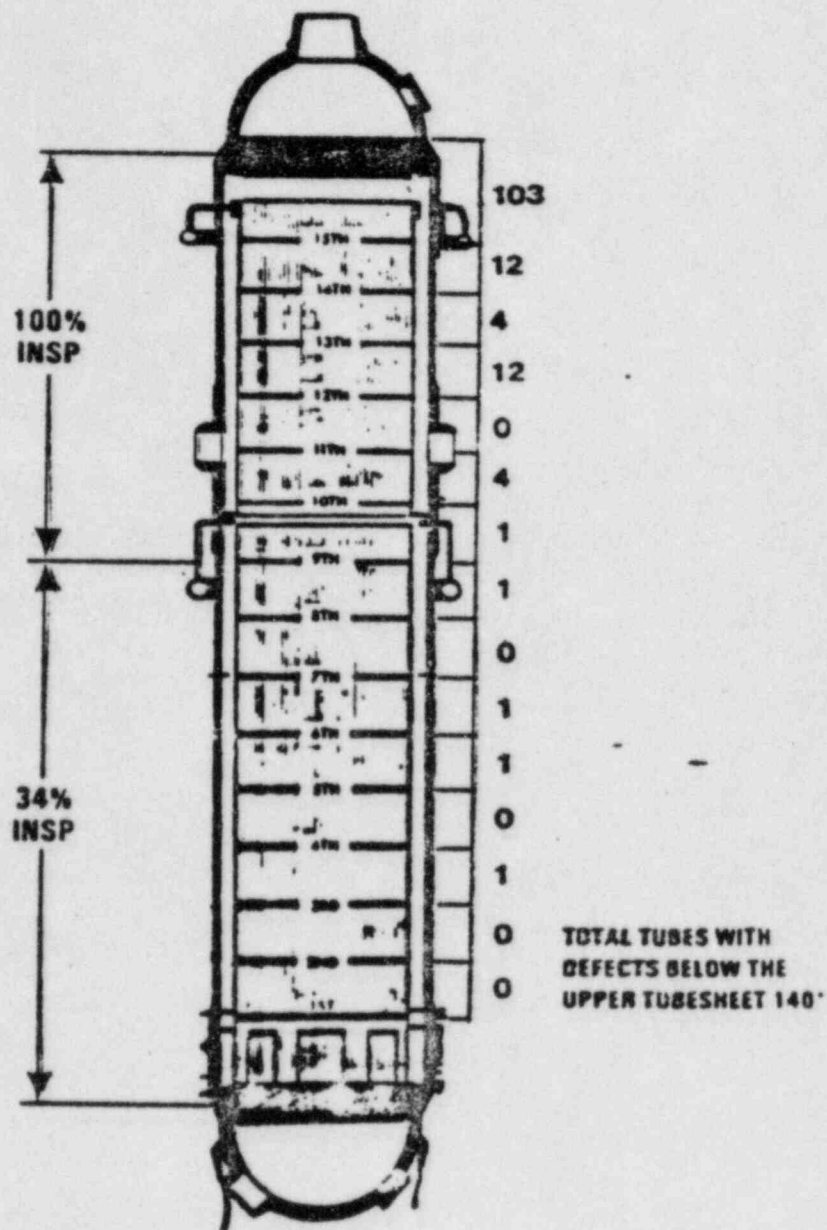
OTSG-A Tubes With Eddy-Current Defect Indications Located Below Upper Tubesheet

*Most tubes contain more than one (1) defect indication. Lowest defect in tube exhibited, only.

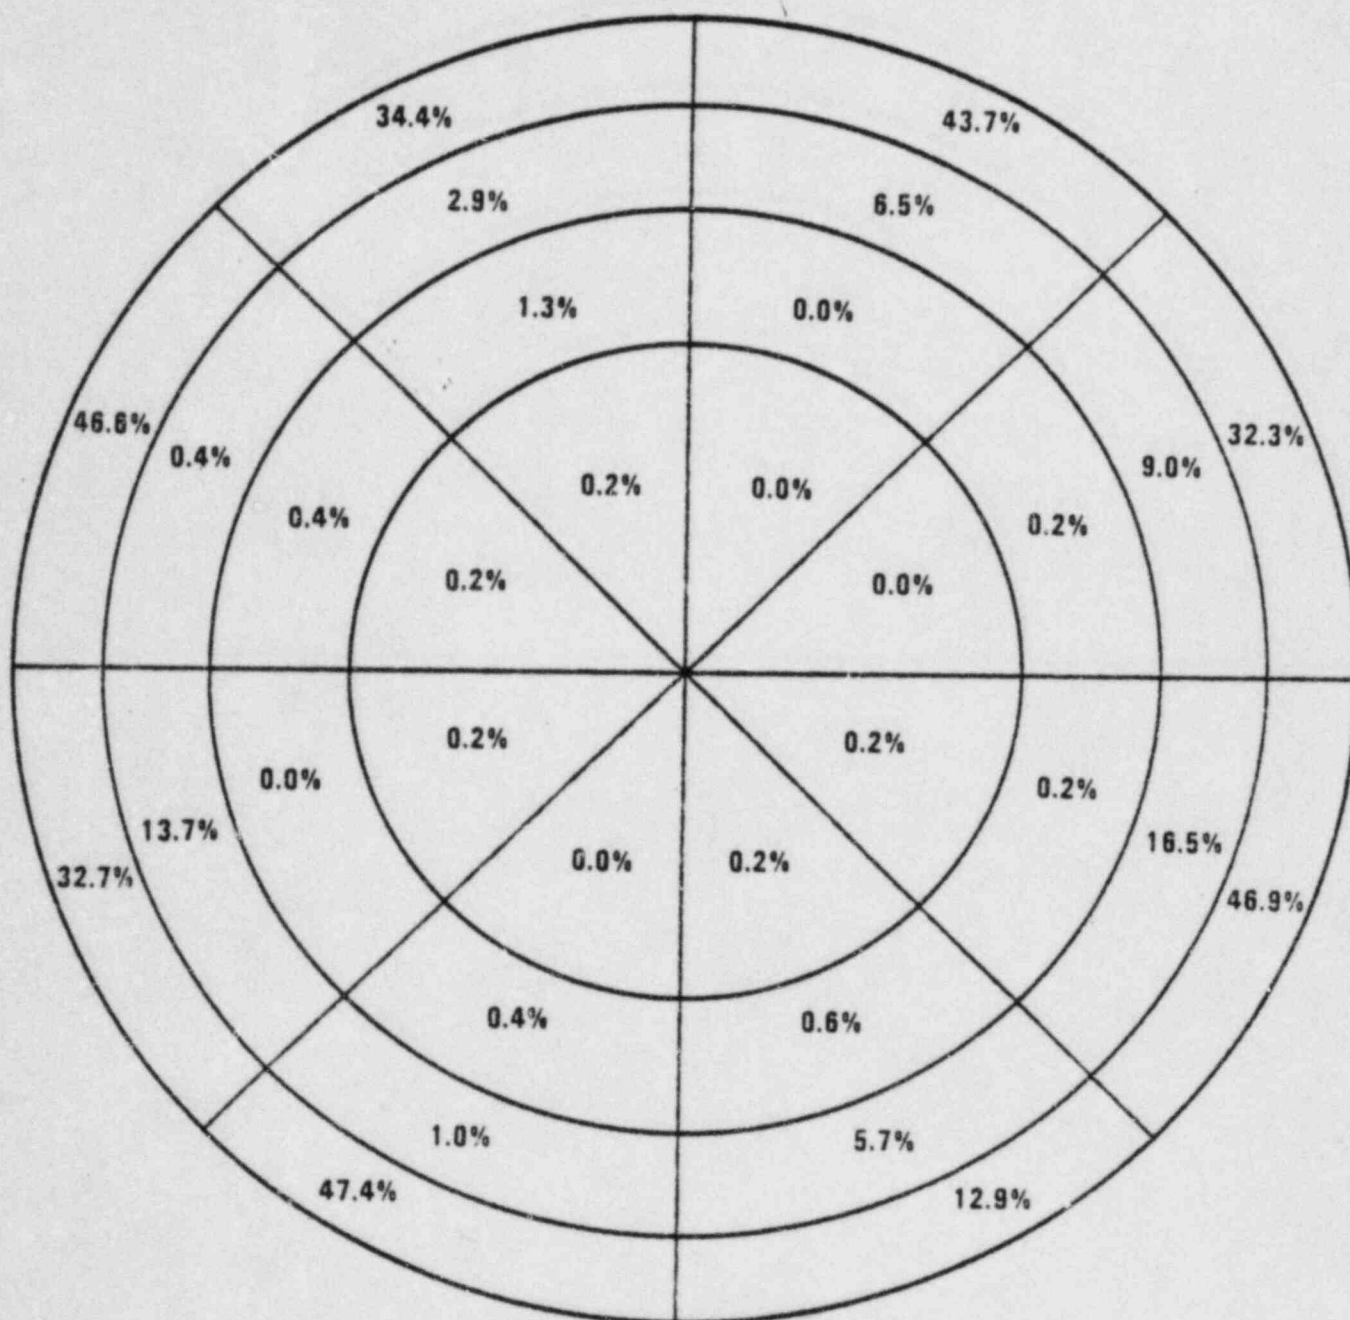
Standard Differential
Eddy Current Results
Percent of Tubes with Defects

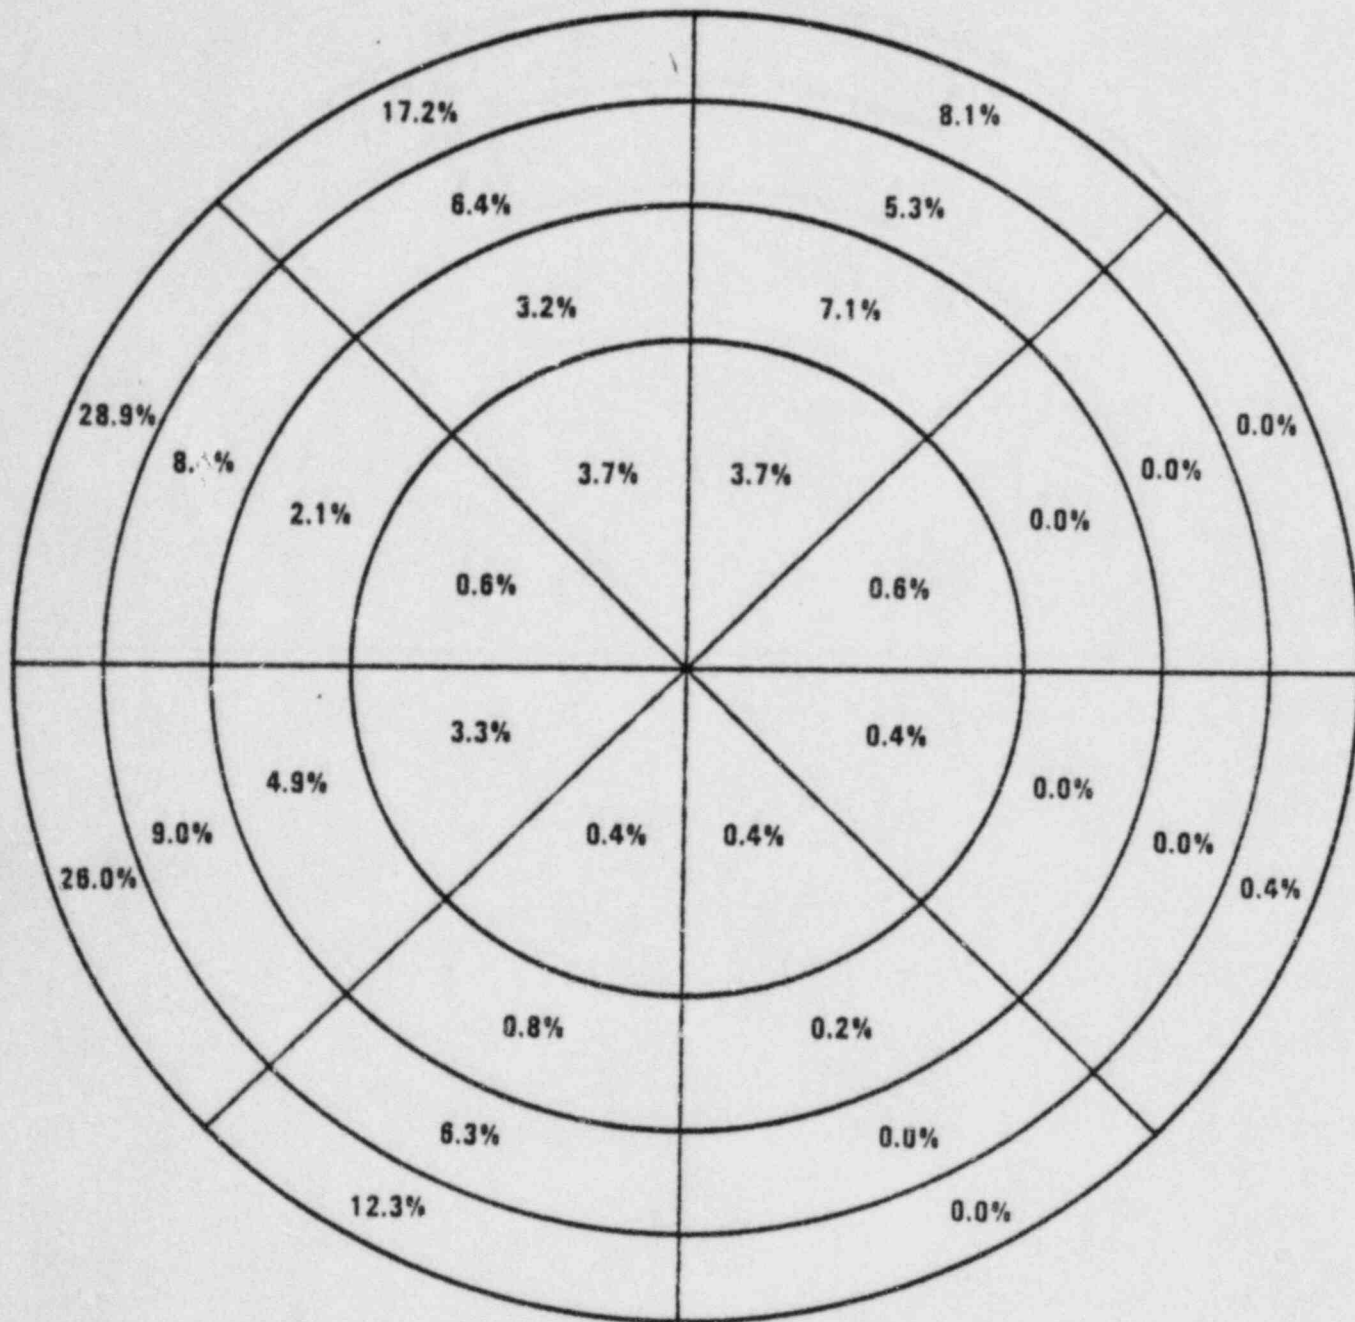
Standard Differential
Eddy Current Results
Percent of Tubes with Defects

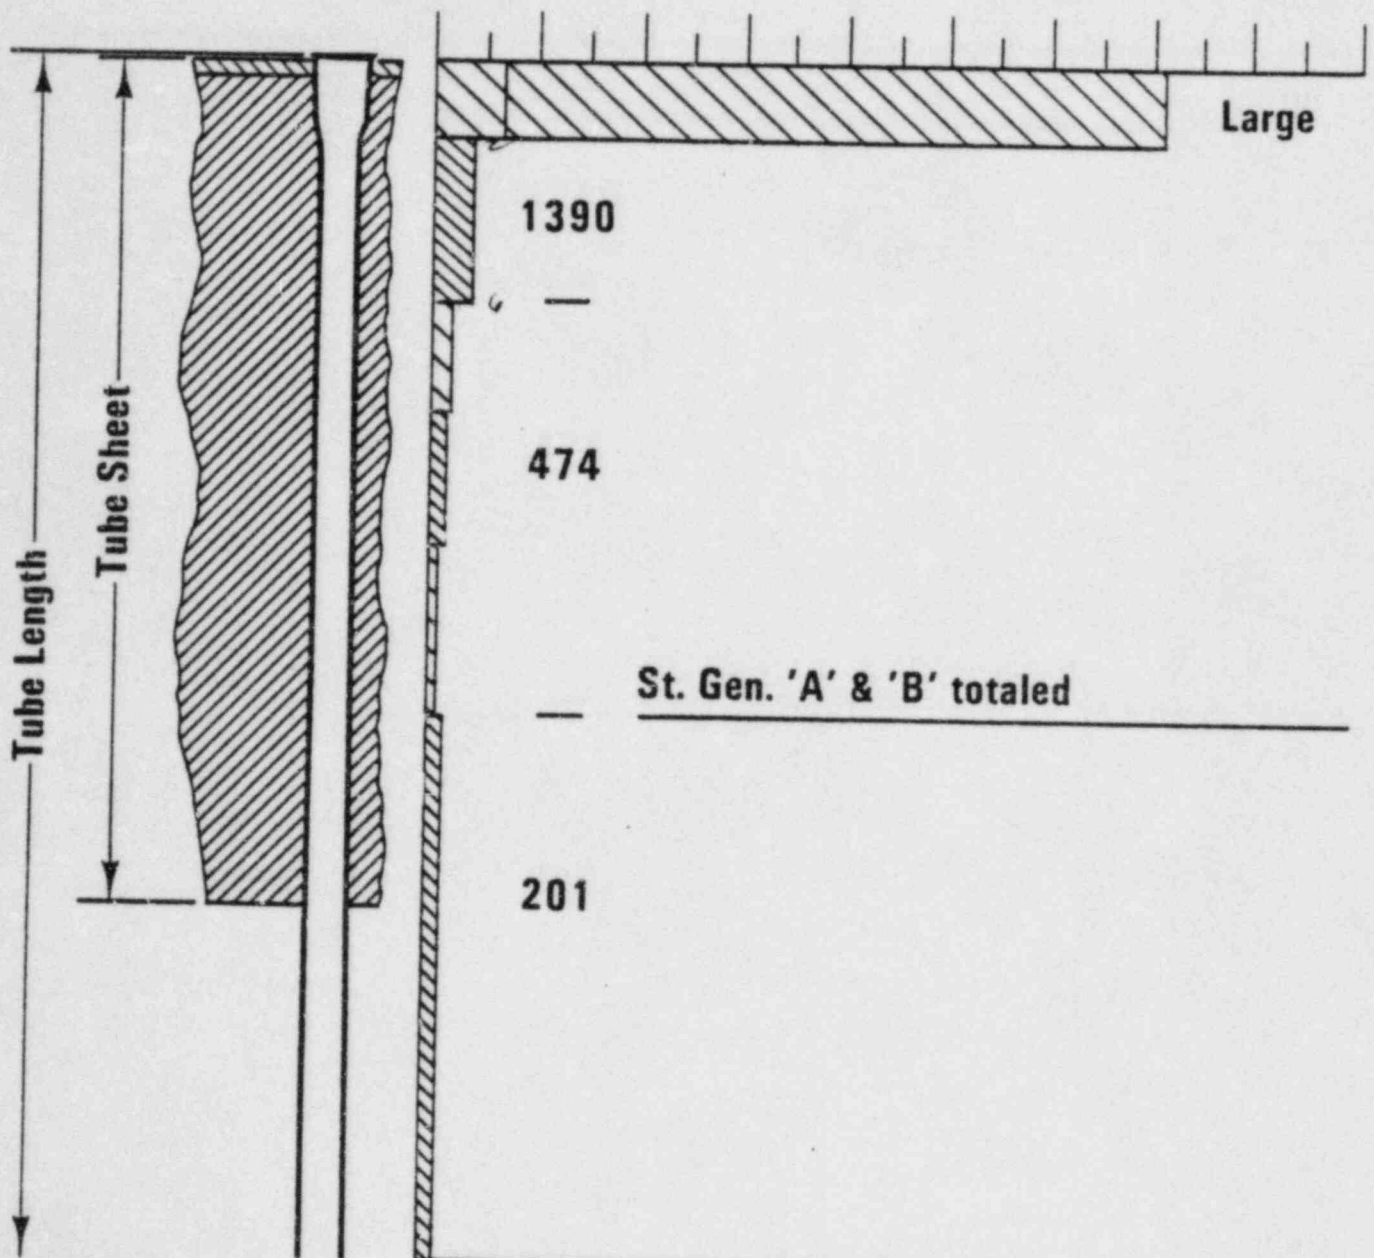
TMI OTSG Tube Defect Distribution

Tubes with multiple indications are categorized into the zone farthest from the tube sheet face

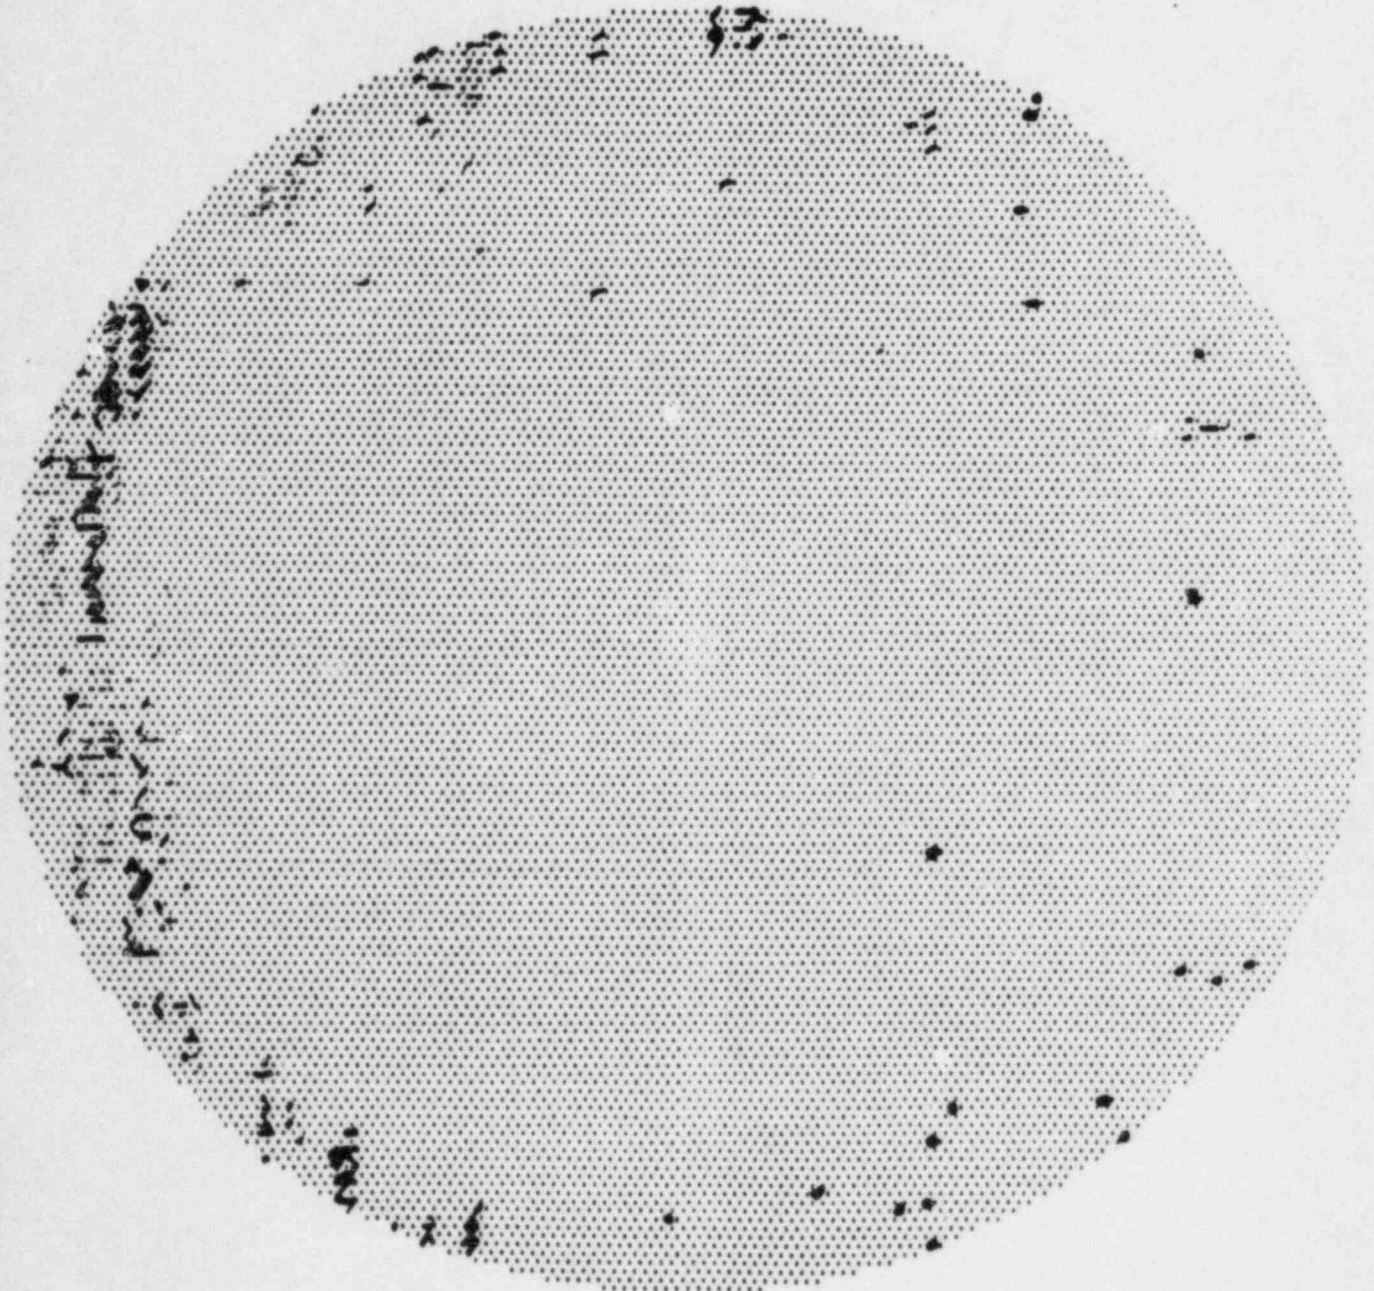
**TMI-1 Steam Generator A
Defective Tube Locations of Four Tube Heats**

- **Tube failures are associated with specific locations in the generator not heat relationships**
- **The defect patterns in the two generators appear to be different and this will need to be explained by a parameter other than heat number**
- **Heats of material exist which have high defect frequencies in bad areas and the same heats will have low defect frequencies in good areas**

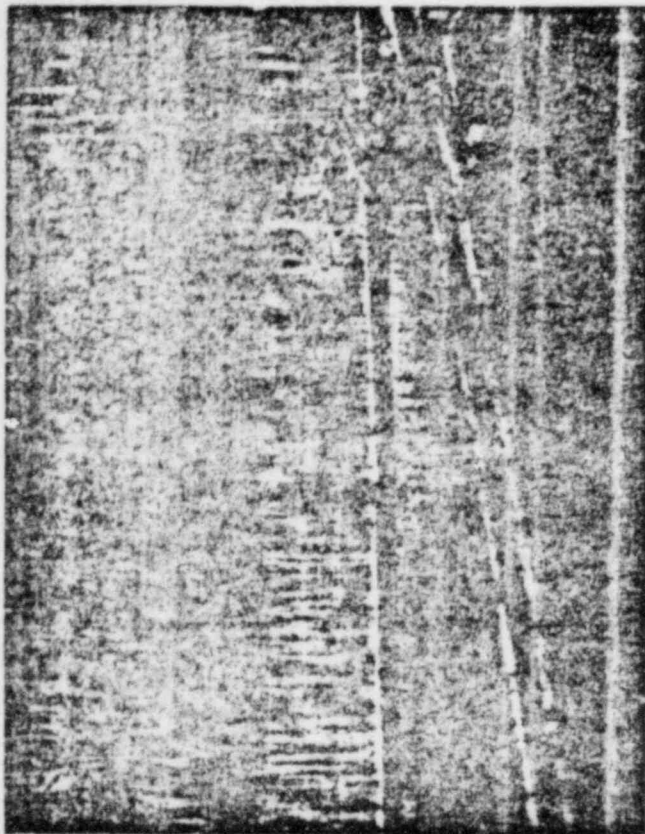
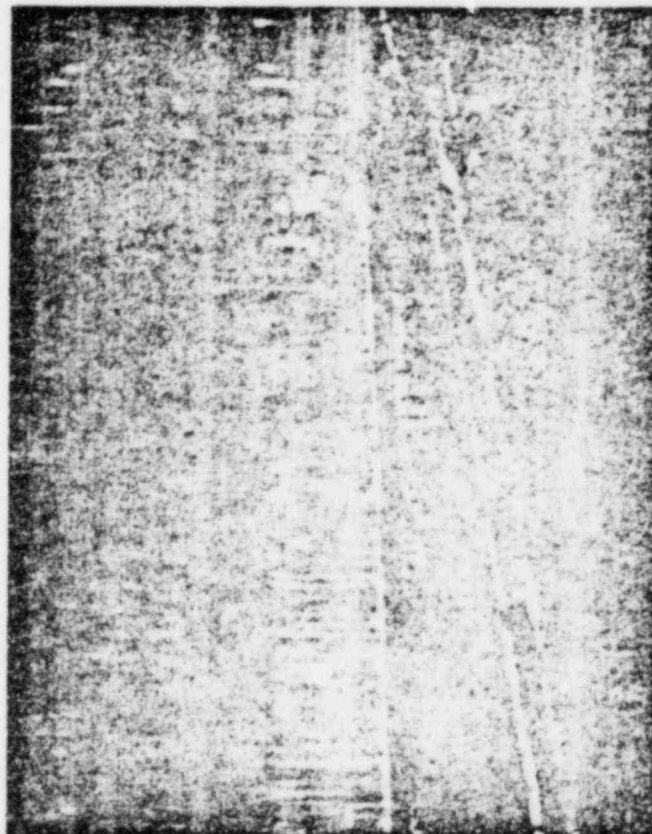
STEREO PAIR

- TMI-1 TUBE #A133-74 (PIECE 2)
UPPER CRACK - 18.1" FROM TOP OF TUBE
- TUBE EXPLOSIVELY EXPANDED - 25 GRAINS/FT
- MAGNIFICATION - 63 X
- ONLY ABOUT 1/3 OF CRACK SHOWS IN PICTURES
