Subject: 10 CFR 21 Report, Generator Failure
Baltimore Gas and Electric - Calvert Cliffs

Subject: 10CFR 21
Calvert Cliffs Nuclear Station
Alternator Failure/Colt Order #205706

SUBJECT Service Trip to Calvert Cliffs Nuclear
Power Plant, Lusby, Maryland

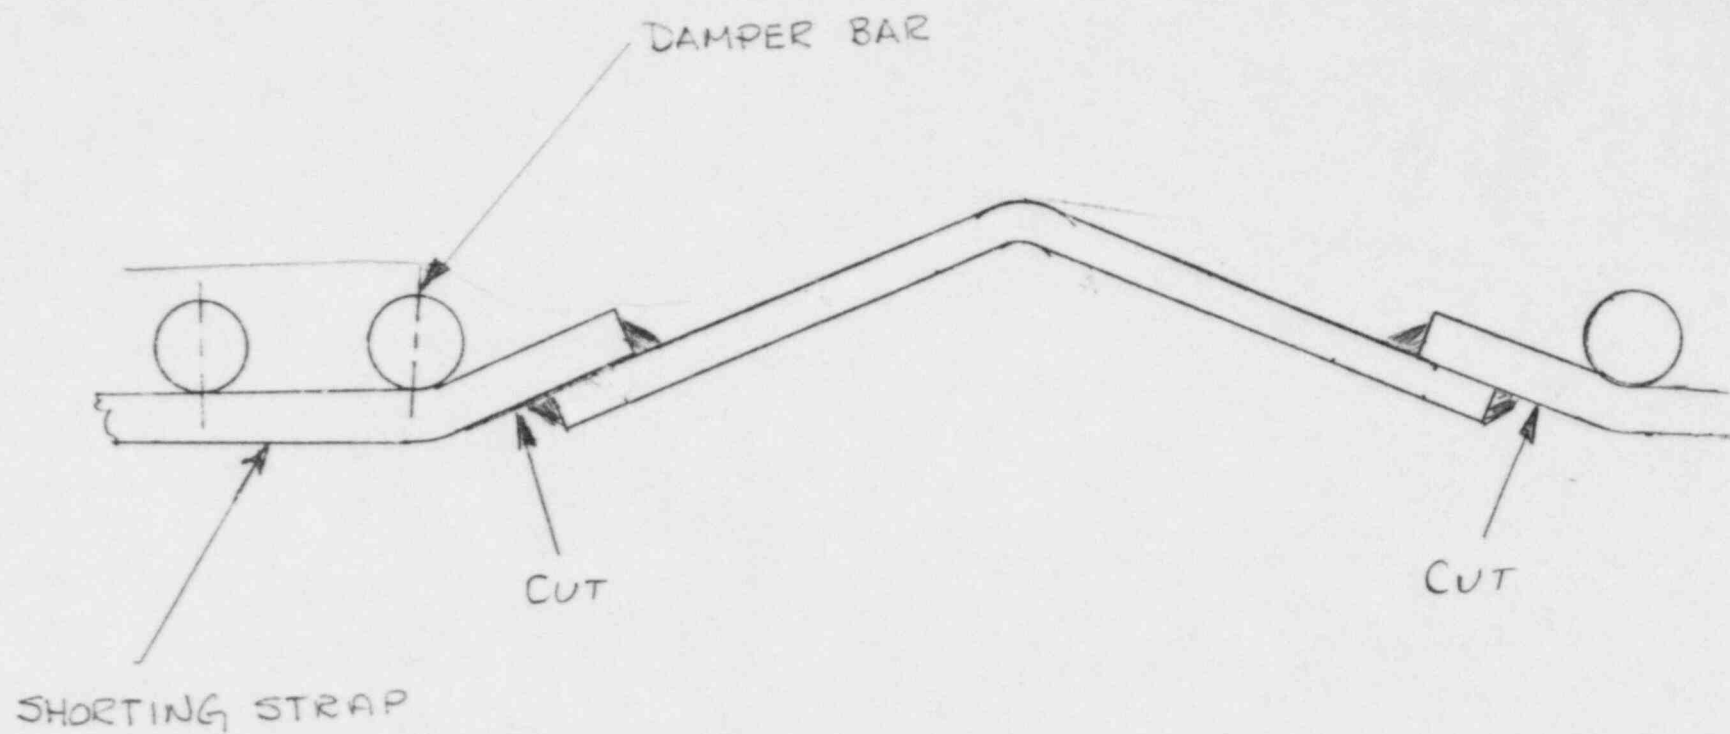
FDG 53085

In our opinion it will be difficult to pin down the exact cause of the failure on the subject unit, however it is probably linked to work hardening of the material at the time of original fabrication of the shorting strap or assembly of the shorting strap to the interpolar connector, however not all are interconnected.

DAMPER BAR, SHORTING STRAP & INNER POLAR
CONNECTOR FORM THE AMORTISSEUR CIRCUIT
OF THE ROTOR

1. Since the shorting strap under the damper bars is made of soft material, it may be possible to reach into the generator with a bolt cutter and cut the connector and part of the shorting bar in two and remove the connector. Care must be taken not to allow chips or slivers from the severed part to drop into the machine.
2. Disassemble the rotor from the unit and proceed with Item 1 above.

Enclosed is a sketch #53085 indicating where the shorting bar should be severed.
