UNITED STATES OF AMERICA
NUCLEAR REGULATORY COMMISSION
ATOMIC SAFETY AND LICENSING BOARD

In the Matter of
LONG ISLAND LIGHTING COMPANY
(Shoreham Nuclear Power Station,
Unit 1)

Docket No. 50-322-OL
LBP-85-18
June 14, 1985

PARTIAL INITIAL DECISION
ON EMERGENCY DIESEL GENERATORS

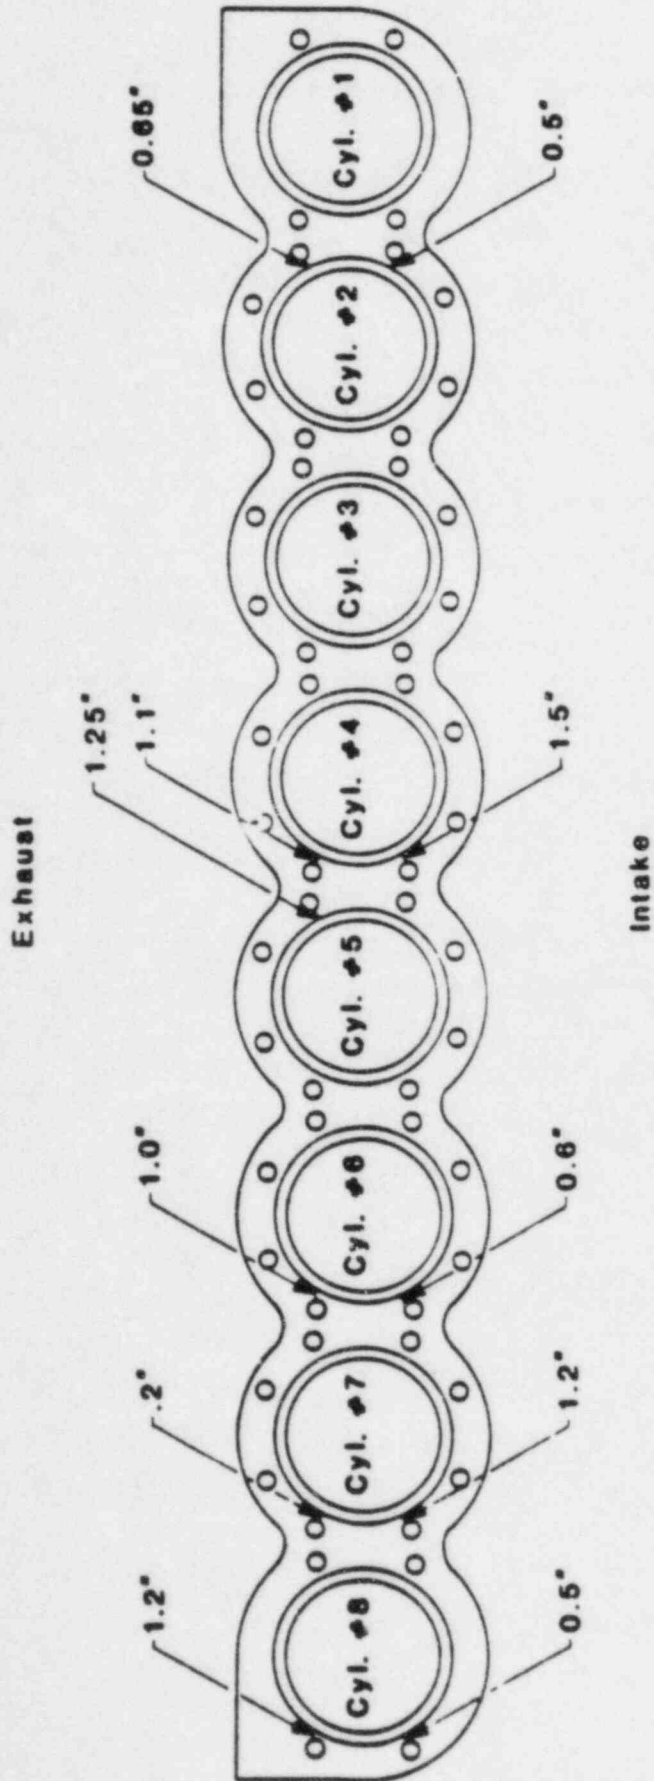
Figure 2.

B-5. The location and depth of the ligament cracks were measured using a series of liquid penetrant, eddy current and visual inspections of the block tops, stud holes and cylinder liner landings. Id. at 13. EDG 101 had 13 ligament cracks, EDG 102 had 18 ligament cracks and EDG 103 had 21 ligament cracks at the time of these inspections. LILCO Exs.

B-16, B-17 and B-18. These cracks varied in depth, with the ones in EDG 103 being the most severe. Id. No ligament crack in EDGs 101 and 102 extended below a depth of 1.5 inches nor on to the liner landing. As of March 11, 1984, the original EDG 103 block had no measured ligament cracks deeper than 1.5 inches. The deepest stud-to-stud crack in the original EDG 103, between cylinders No. 4 and 5, was measured by eddy current to have a depth of 1.4 to 1.6 inches. LILCO Exs. B-16, B-17, B-18; McCarthy et al., ff. Tr. 24,372, at 14, 15; Tr. 28,823-24 (Johnson); Tr. 28,825-27 (Rau). The original EDG 103 also had seven surface "indications" (cracks which were not deep enough to be measurable), five of which occurred in stud-to-stud locations and two of which were located between a stud hole and the outer perimeter of the block top. Id.

Dimensions indicate crack depth

SNPS DG101 crack map.

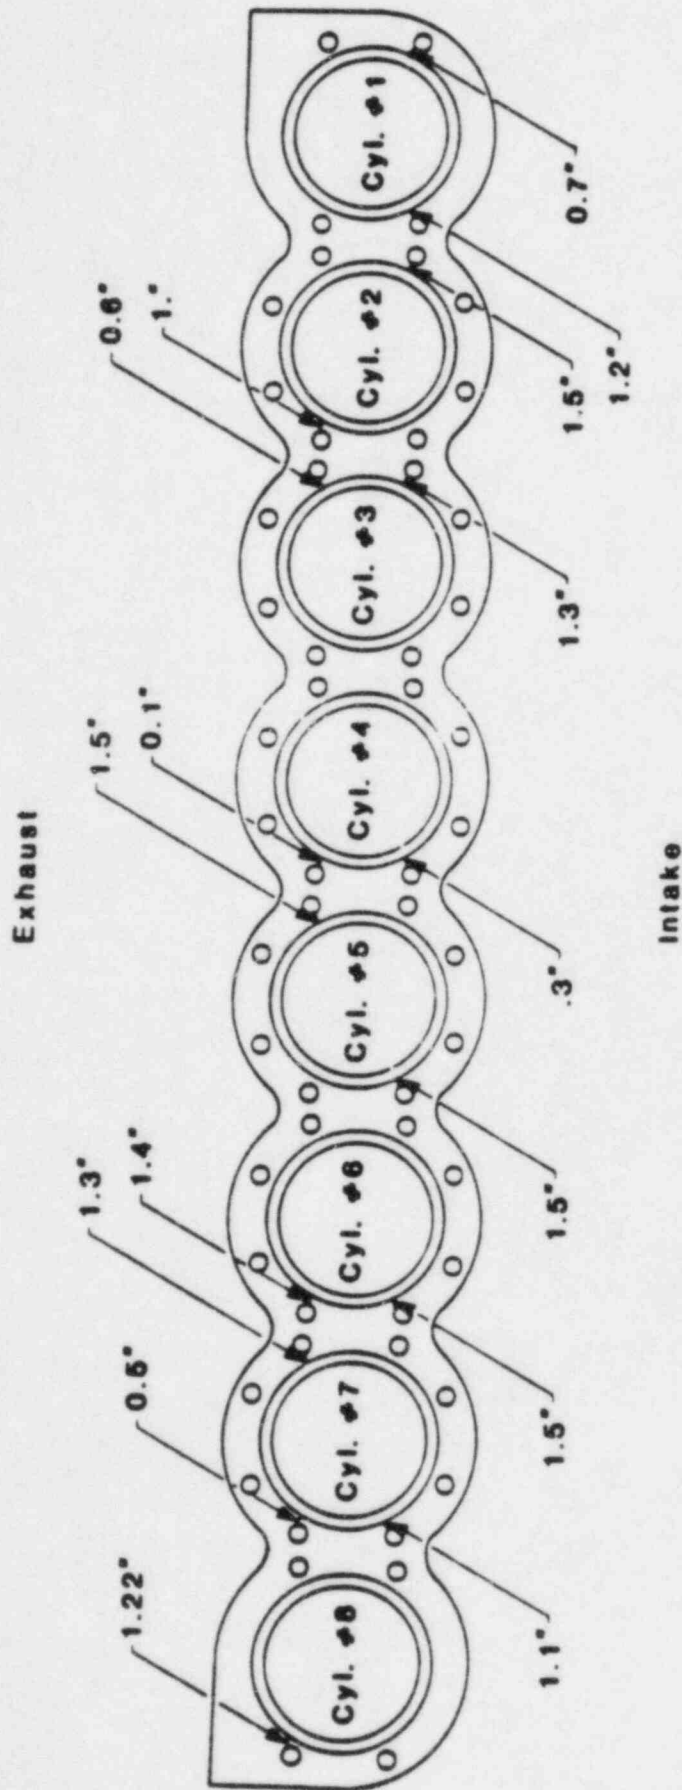
Figure 3.

B-6. Following inspection, EDG 102 was operated through 100 starts to loads greater than 50 percent (i.e., greater than 1750 kw). McCarthy et al., ff. Tr. 24,372, at 15; LILCO Ex. B-21. Based on subsequent eddy current examination, LILCO concluded that there had been no discernible extension of cracks on the 102 block. Id. It appears, however, that this general conclusion was based on eddy current measurements only at cylinder No. 7. See Tr. 24,411 (Johnson); LILCO Ex. B-21. While this may be reassuring, since based on the EDG 102 crack map cylinder No. 7 has the worst cracks, we do not find it conclusive that no crack extension at all took place.

Dimensions indicate crack depth

SNPS DG102 crack map.

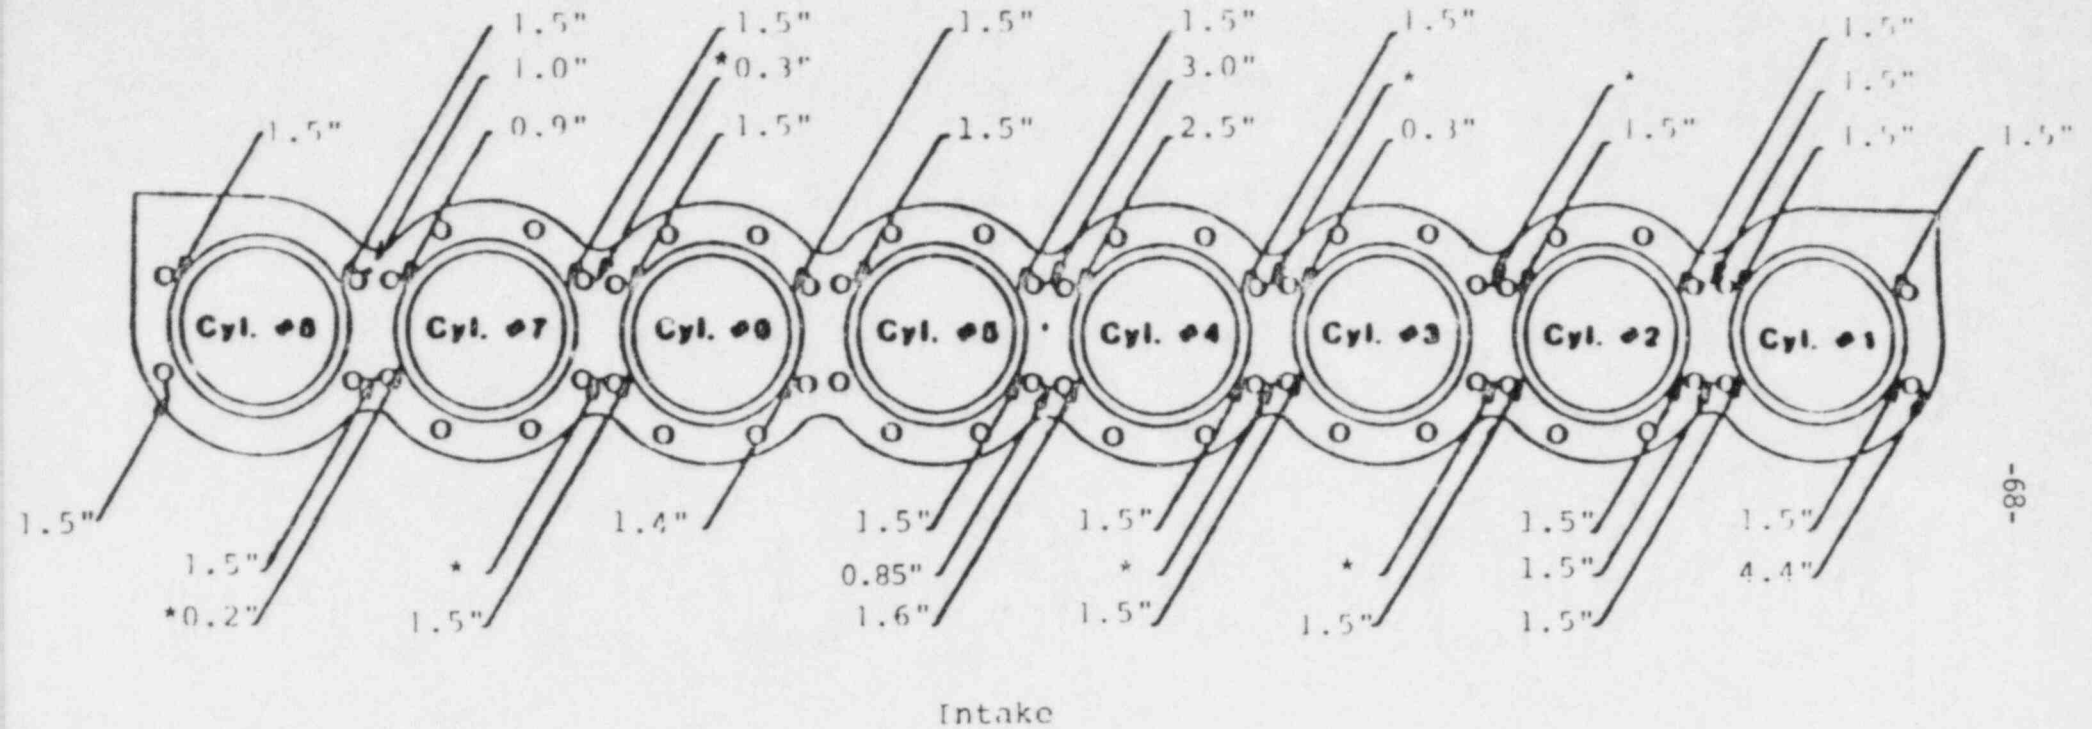
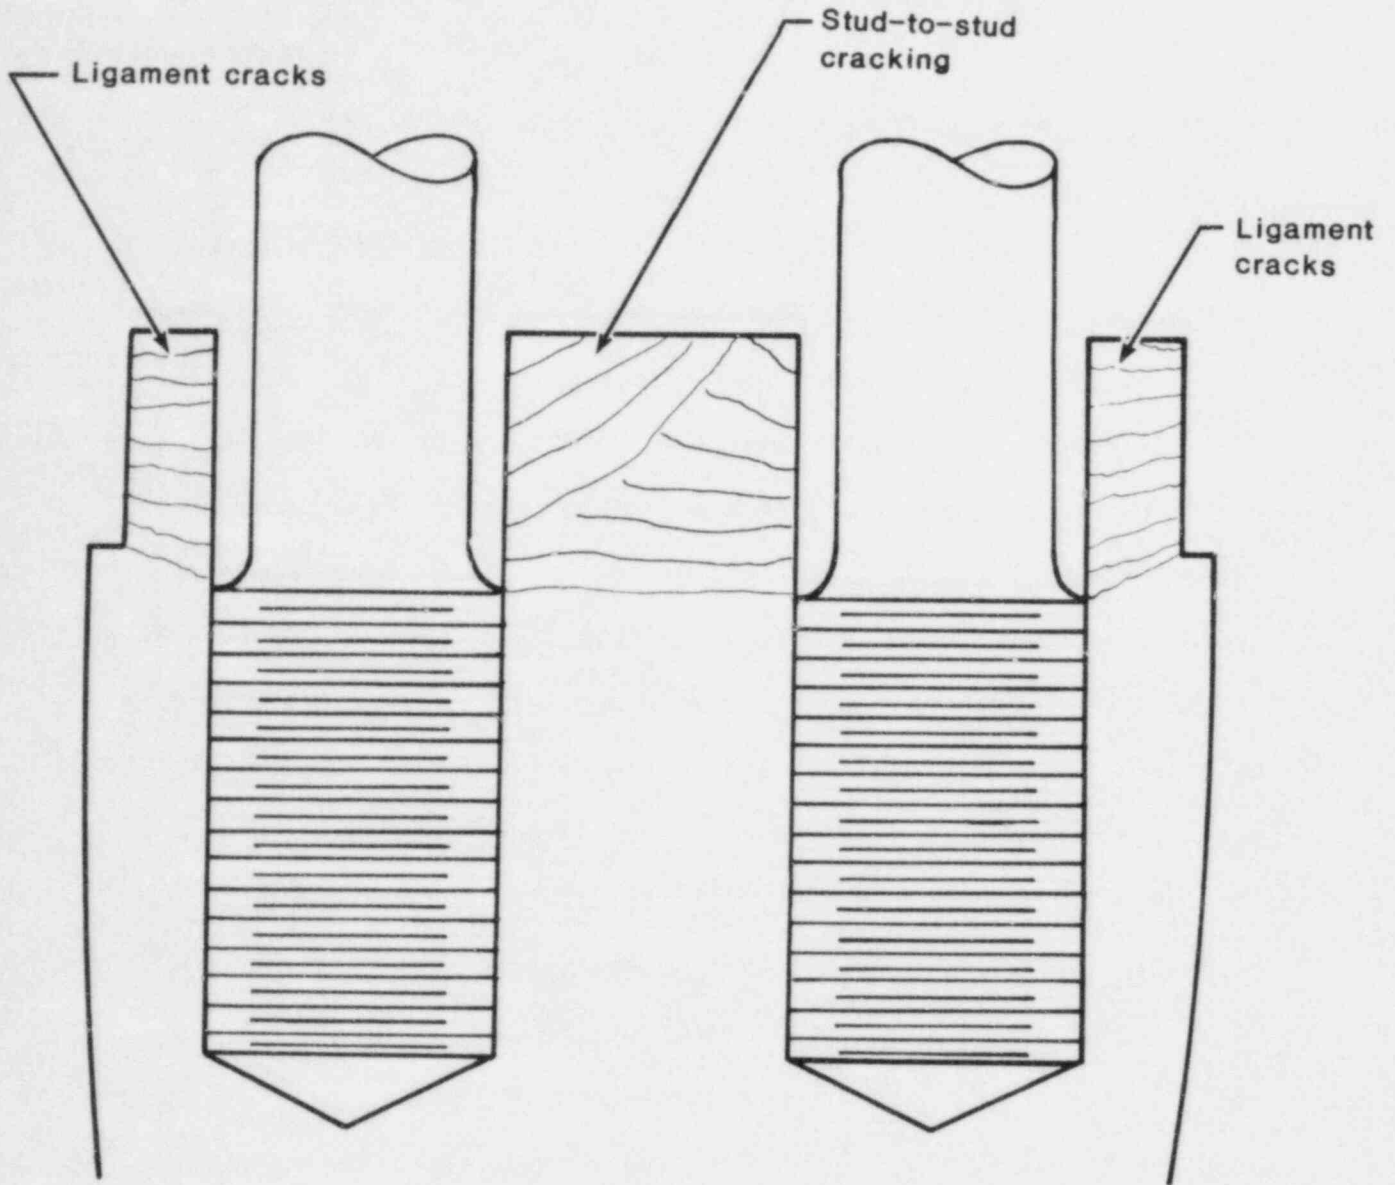
Figure 4.

B-8. After shutdown of the EDG 103 engine on April 14, 1984, inspection of the block revealed that the deepest stud-to-stud crack, located between cylinders No. 4 and 5, had extended from a depth of 1.4 to 1.6 inches to a maximum depth of three inches.^{3/} McCarthy et al., ff. Tr. 24,372, at 18; Tr. 28,823-24 (Johnson); Tr. 28,905-06 (Rau); LILCO Exs. B-18, B-25. Between March 11 and April 14, 1984, additional ligament and stud-to-stud cracks had initiated and propagated at other block top locations; however, none of the ligament cracks extended on to the liner landing. McCarthy et al., ff. Tr. 24,372, at 18-19; Tr. 25,538 (Johnson); LILCO Exs. B-16, B-18, B-25.

Stud-to-stud cracking in SNPS DG103.

NOTE: Cracks are vertical, i.e., approximately parallel to the plane of the page, and not all extend as far as portrayed.

B-9. Based on the lack of confidence that the EDG 103 block could be repaired satisfactorily, LILCO decided to replace it. Tr. 24,665-66 (Youngling). A new block was installed in the EDG 103 in June 1984. Johnson et al., ff. Tr. 28,799, at 5.
