# Radiological and Engineering Assessment

Vicinity Property No.SLC 021

# THE RADIOLOGICAL AND ENGINEERING ASSESSMENT

SL-021

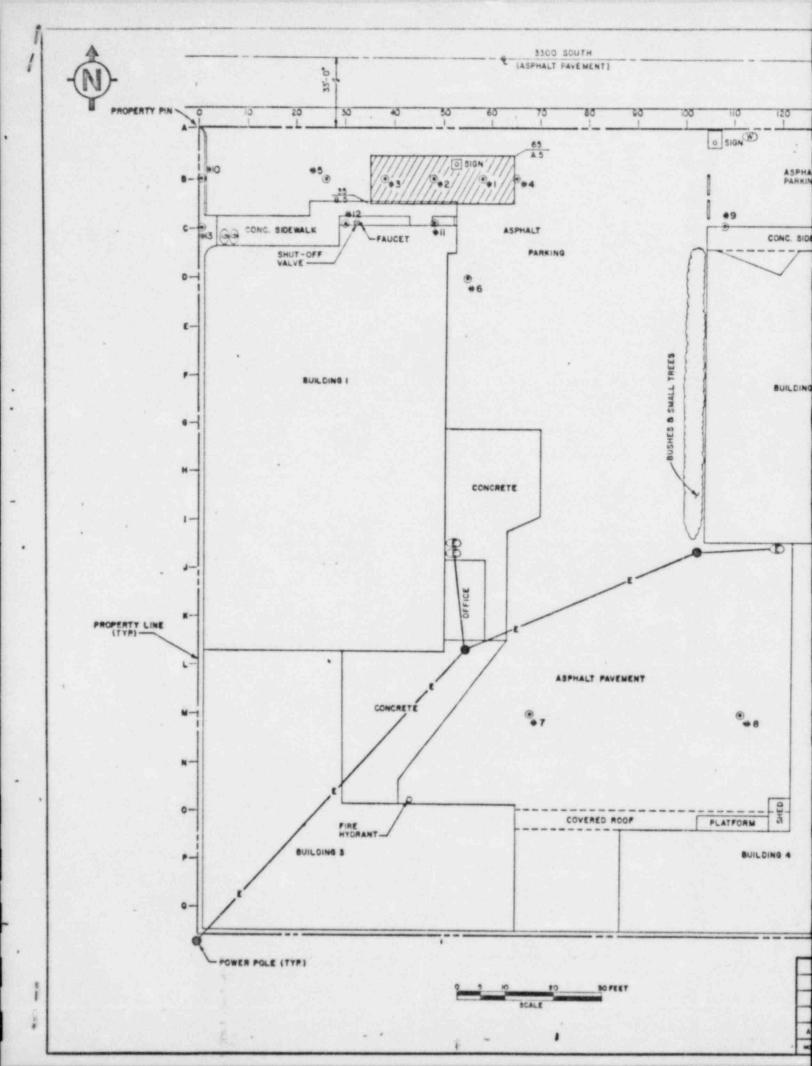
Surface gamma readings on the property, as shown in Figure 3.1, range from 11 to 38 micro R/hr (Table 3.1). This may be compared with the background for the Salt Lake City site of 8 micro R/hr.

Contamination was found in 3 of the 10 outdoor holes augered. The location and depth of the contamination is described in Table 3.2 and is shown in Figure 3.1.

There is one area of contamination on vicinity property SL-021. Borehole survey points in this area show contamination as deep as 36 inches. This area corresponds to the area identified in the inclusion survey.

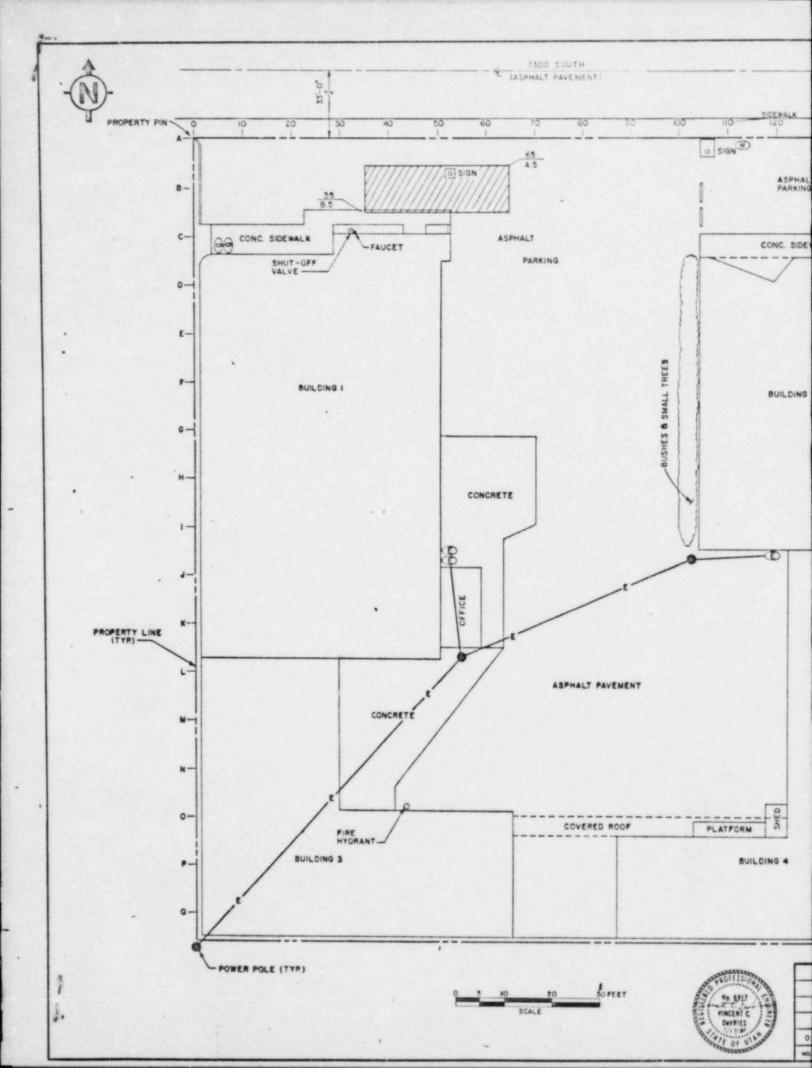
There is only one area of contamination located in front of Building #1 on this property.

Option 2 See Figure 4.1 for the plan of this option which proposes the decontamination of the affected portion of this property as herein described.

Excavate and remove asphalt paving, concrete walk, and contaminated material remove pipe sign support and clean the concrete base, and protect utilities as necessary.

Replace contaminated material with clean compacted fill, replace concrete walk and asphalt paving, reinstall pipe sign support.
