Radiological and Engineering Assessment

Vicinity Property No. SLC 017

FINAL
THE RADIOLOGICAL AND ENGINEERING ASSESSMENT
AND FINAL DESIGN

SL-017

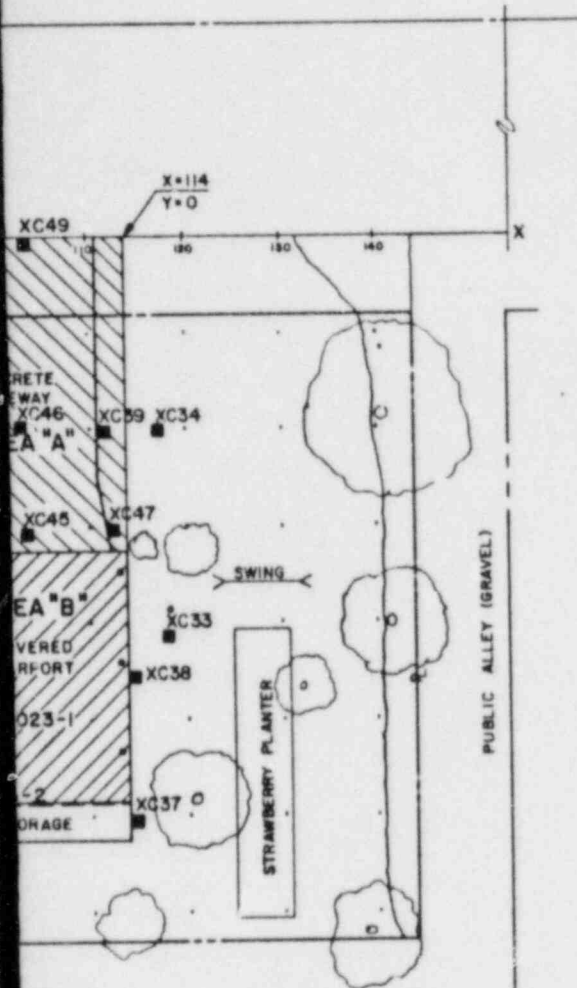
U. S. DEPARTMENT OF ENERGY ALBUQUERQUE, NEW MEXICO	
FIGURE 3.1 RADIOLOGICAL SURVEY DATA SL-017	
SALT LAKE COUNTY, UTAH URANIUM MILL TAILINGS REMEDIAL ACTION PROJECT	
DATE	DOE PROJECT MANAGER
DATE	DOE PROJECT ENGINEER
DATE	DATE
PROJECT NO. DE-AC04-83AL18796	
DRAWING NO. SL-017-010	
REV B

Contamination was found in the hole drilled in the carport but not in the hole drilled in the porch. The location and depth of the contamination is described in Table 3.2 and is shown in Figure 3.1.

Borehole soil samples collected by ORNL during the inclusion survey indicated the presence of contamination in the driveway. Since these holes give a good characterization of this contamination and demonstrate the boundary around the carport, their locations are shown on Figure 3.1 of this assessment and the results are found in Table 3.2.

One area of contamination was identified in the survey. This area consists of the covered carport, the concrete driveway, and a 3-foot wide strip immediately south of the driveway. The estimated depth of the contamination is 12 inches in the driveway and about 36 inches in the carport.
