Subject: PROJECT NOS. 3 AND 5
NRC INSPECTION OF WNP-3 AND WNP-5
DOCKET NUMBERS 50-508 AND 50-509
FINAL REPORT OF POTENTIAL 10CFR50.55(e)
HYDROGEN EMBRITTLEMENT OF 3/4 INCH
LOCKWASHERS

SUBJECT: DETERMINE CAUSE OF FRACTURE OF
3/4-INCH PLATED LOCK WASHERS

Memorandum Report

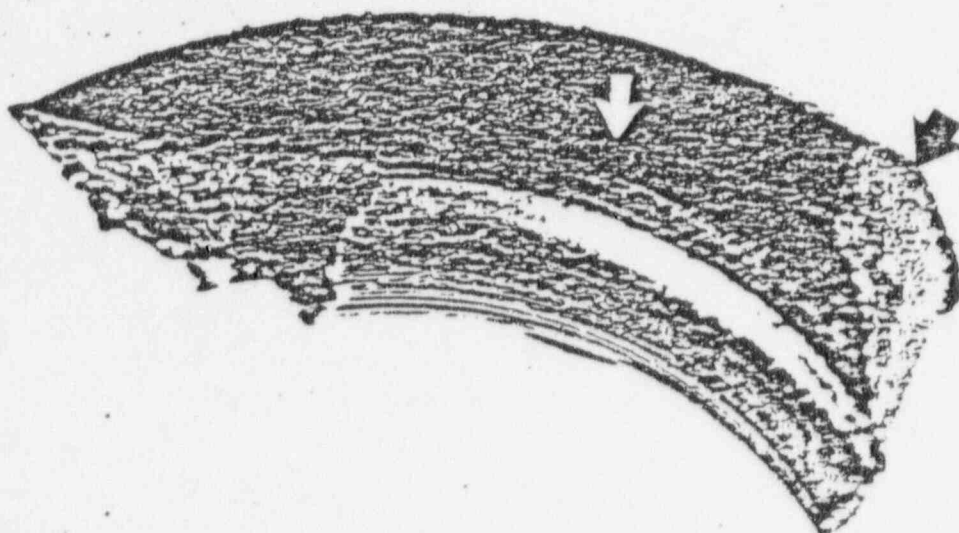
FIGURE 1 (66594)

Figure 1 (66594)

This photograph shows one of the typical examples of the fracture fragment. Many of these fractured lock washers had more than one fracture plane as is evident by this fragment which has both ends fractured. Examination of the fracture surface showed that portions were darkened, as indicated by the right arrow, whereas the remainder of the fracture was a bright crystalline structure. These darkened areas were established as portions of the embrittled structure in which the incipient cracks occurred. An extension of the crack, which caused the transverse fracture across the section of the lock washer, is shown as a crack running parallel to the longitudinal axis of the washer as indicated by the left arrow.

Two metallographic specimens were removed from this fragment for a microscopic examination. They are shown in the next figure.

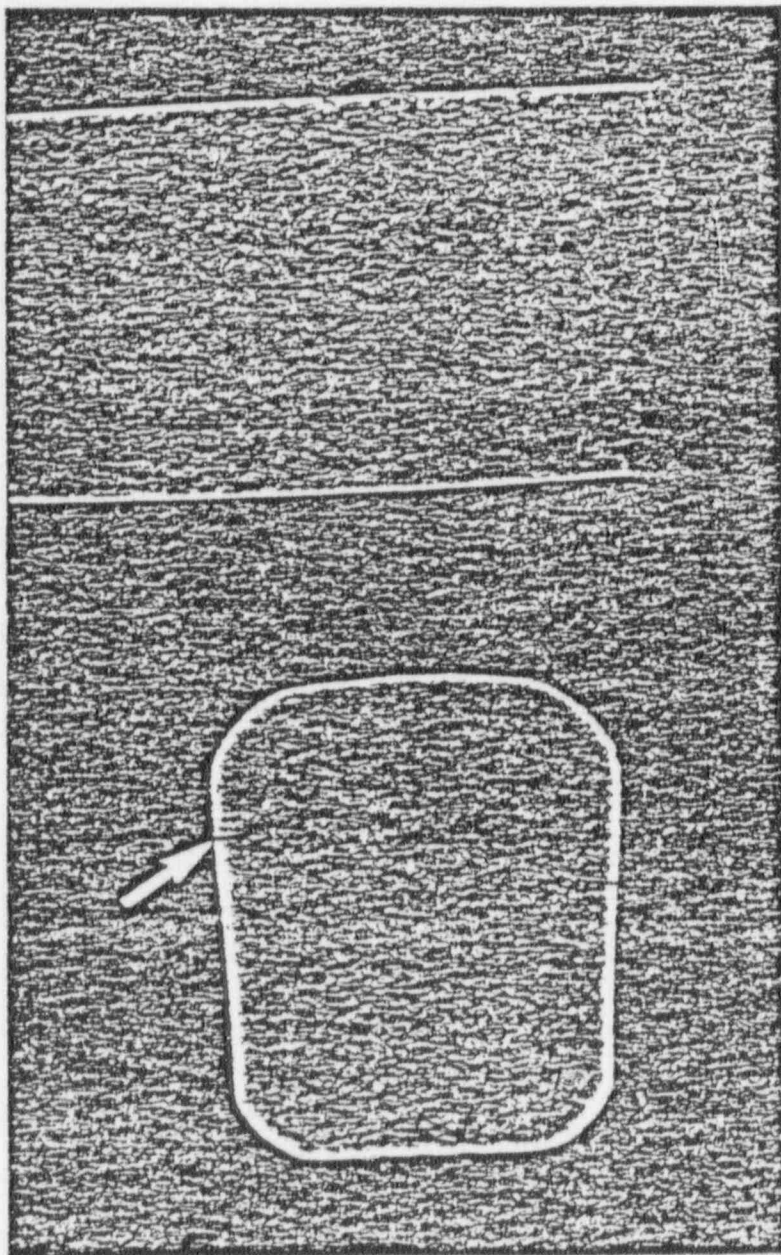
FIGURE 2 (66609)

Figure 2 (66609) 14X Etchant: Picric Hydrochloric Acid

This photomicrograph shows the two metallographic specimens removed from the fractured fragment shown in Figure 1.

The specimen at the top of this photograph was taken parallel to the longitudinal axis of the washer including the fracture surface, which is oriented in this photograph towards the left. The cracks, indicated by the arrow in Figure 1, are evident on the top surface of this specimen.

The specimen at the bottom was taken transversely through the washer. The specimen is oriented so that the inside circumferential surface is towards the top. The compression surfaces of the washer are to the right and left, and the outside circumferential surface is at the bottom. The crack shown by the arrow in Figure 1, is on the left side of this specimen (arrow).

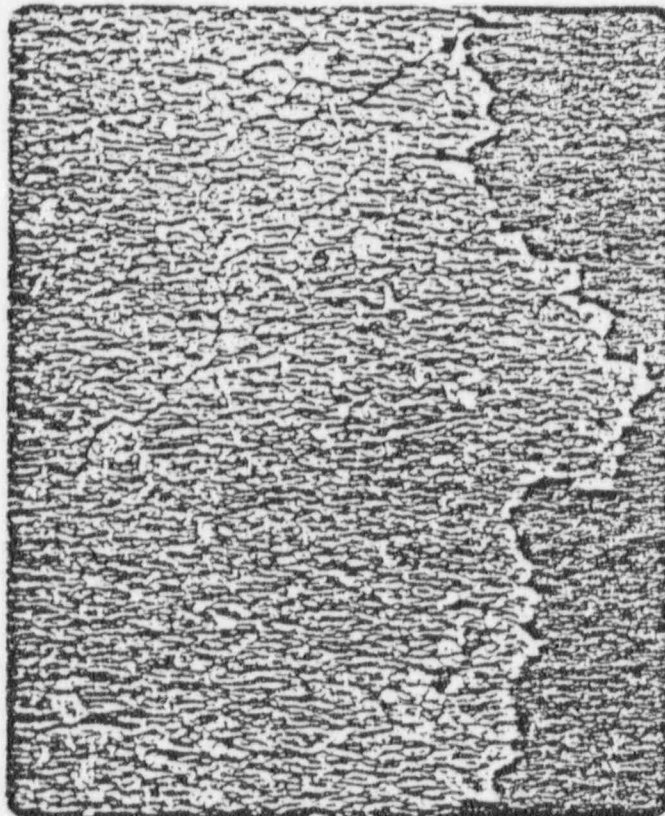
FIGURE 3
(66600)

Figure 3 (66600) 100X Etchant: Picric Hydrochloric Acid

This photomicrograph shows the microstructure along the fracture surface of the washer. This portion of the fracture was dark in color. The embrittled structure was found to be intergranular in its progression and coincided with a high degree of secondary intergranular cracks adjacent to the fracture surface.

The fracture characteristic of the bright crystalline structure was primarily a transgranular cleavage type of cracking as a result of overload on the remaining section. The fracture occurred because of the presence of the incipient embrittled structure.

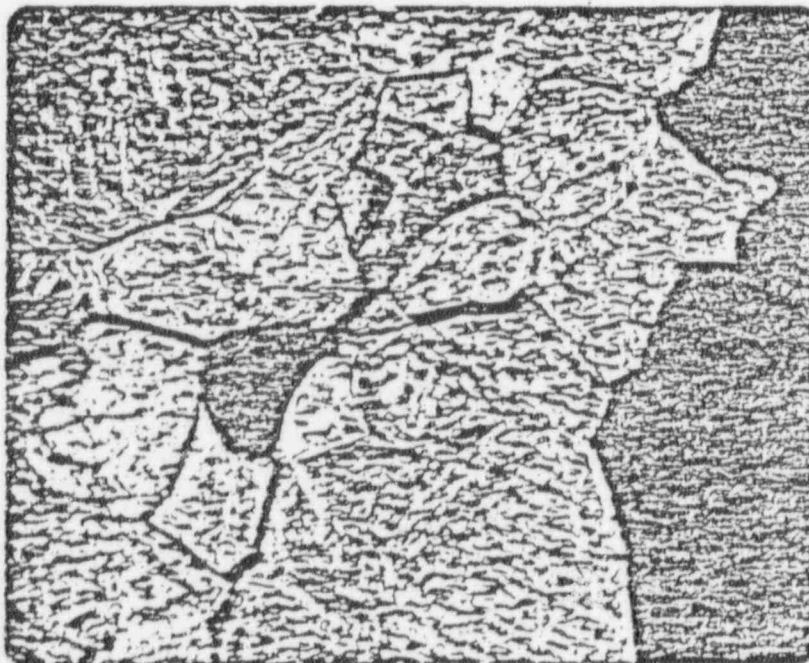
FIGURE 4
(66602)

Figure 4 (66602) 500X Etchant: Picric Hydrochloric Acid

This photomicrograph shows more detail of the microstructure in the fractured washer. The fracture plane along the darkened area of the fracture was primarily intergranular as was the secondary cracking adjacent to this fracture surface. Close examination of these cracks indicated no evidence of significant oxidation or decarburization, as would have been present from the last heat treating process applied to the washers as they were manufactured. The characteristics of these cracks were highly indicative of a hydrogen type embrittlement due to the pickling process which would have occurred at the time the washers were plated.

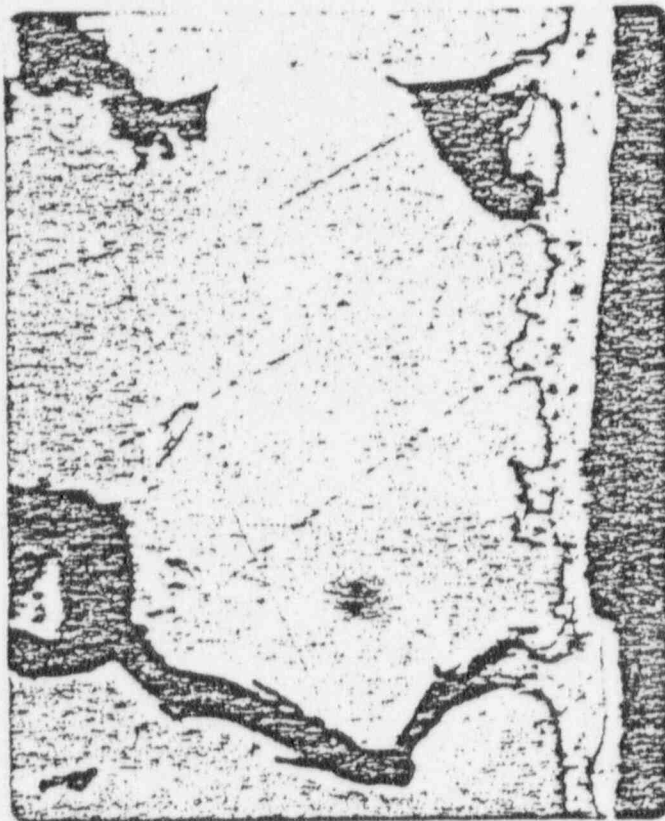
FIGURE 5
(66595)

Figure 5 (66595) 500X Unetched

This photomicrograph shows the surface of the electrozinc plated washer from the transverse specimen shown in Figure 2. Cracks which extended to the surface showed evidence of zinc plating extending down within the crack indicating the crack was present prior to application of the electrodeposited zinc. This confirms the most likely cause for cracking in the pickling or acid wash stages of the electrozinc plating process. No intermediate baking or processing of the washers was reported to us for the electrozinc plating procedure.

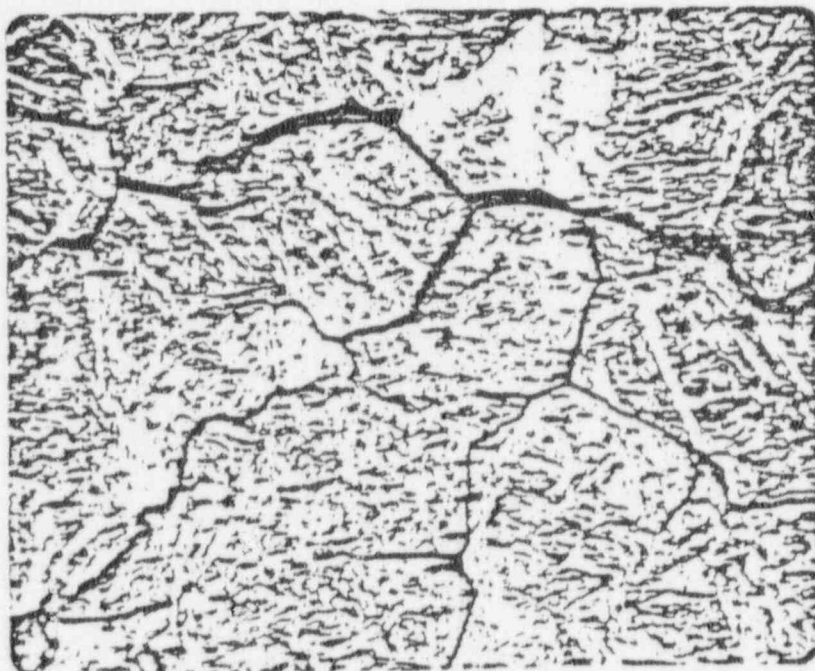
FIGURE 6
(66606)

Figure 6 (66606) 500X Etchant: Picric Hydrochloric Acid

This photomicrograph shows more detail of the microstructure away from the fracture surface. The structure shows a high degree of intergranular embrittlement as well as transgranular branching. The severity of this embrittlement indicates the potential danger for delayed cracking which may occur in washers which had not yet failed.

As a result of our examination, we would recommend that all washers that were electrozinc plated be rejected. Incipient embrittlement could result in failure of those washers which do not yet show evidence of failure by cracking.

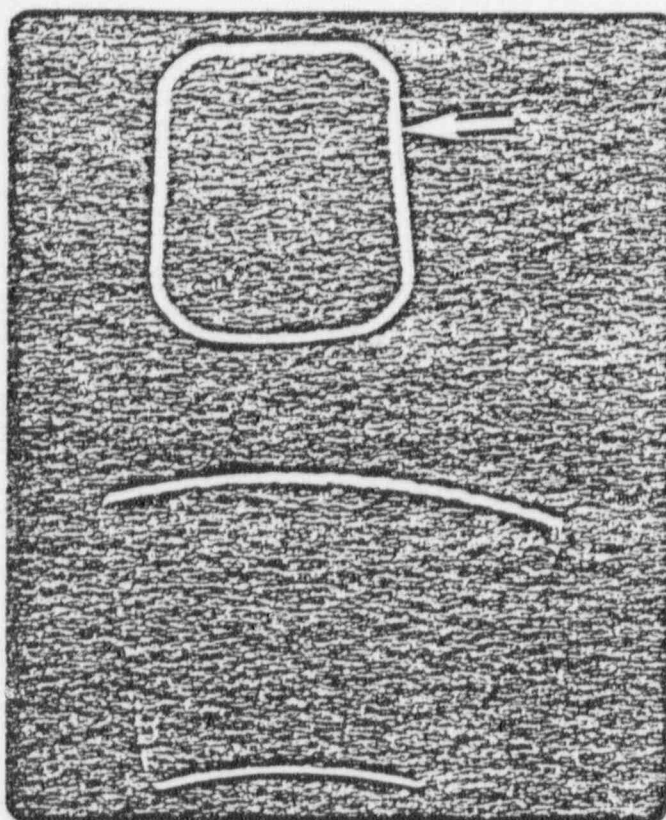
FIGURE 7
(66610)

Figure 7 (66610) 7X Etchant: Picric Hydrochloric Acid

This photomicrograph shows two metallographic specimens removed from a new washer. Approximately 50 new washers were submitted for examination for embrittlement. These washers were inspected by magnetic particle inspection using a wet fluorescent method specified by the American Society for Testing and Materials, Specification E 138. The magnetic particle inspection showed no evidence of surface indications.

A washer selected at random was sectioned and prepared for metallographic examination as shown by the two specimens in this photograph. Metallographic examination of the specimens revealed evidence of embrittled cracking at the surface which was finer than the detectable limits of the magnetic particle inspection (arrow).

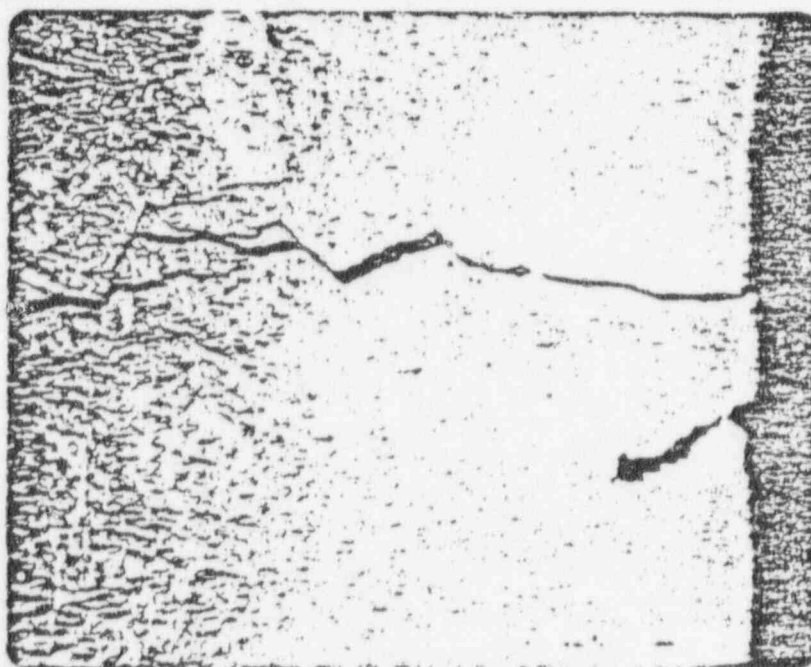
FIGURE 8
(66599)

Figure 8 (66599) 500X Etchant: Picric Hydrochloric Acid

This photomicrograph shows the embrittled structure found in a new washer. Embrittled cracks extended to the surface and showed evidence of secondary branching beneath the surface. The crack shown in this photograph had a total depth of 0.010 of an inch. Cracks of this size were not detected by magnetic particle inspection. Evidence of this cracking on new washers indicates that the entire lot of new washers should be rejected, as delayed cracking potentially can occur even though washers which were installed had not shown evidence of fracture.

The picric hydrochloric etchant used for preparation of this metallographic specimen attacked the zinc coating on the surface. The electrozinc plated layer is not visible in this micrograph.
