SUBJECT: PALO VERDE SALP INPUT

MULTIPLE EQUIPMENT FAILURES FOLLOWING LOAD REJECT
AND REACTOR TRIP
EVENT FOLLOWUP REPORT 89-038
50.72 #14912, 14927, AND 1493E
EVENT DATE- 3/3/89
PLANT-PALO VERDE UNIT 3
PROJECT MANAGER-M. DAVIS
COGNIZANT ENGINEER- J. THOMPSON

TITLE: Atmospheric Dump Valve Deficiencies

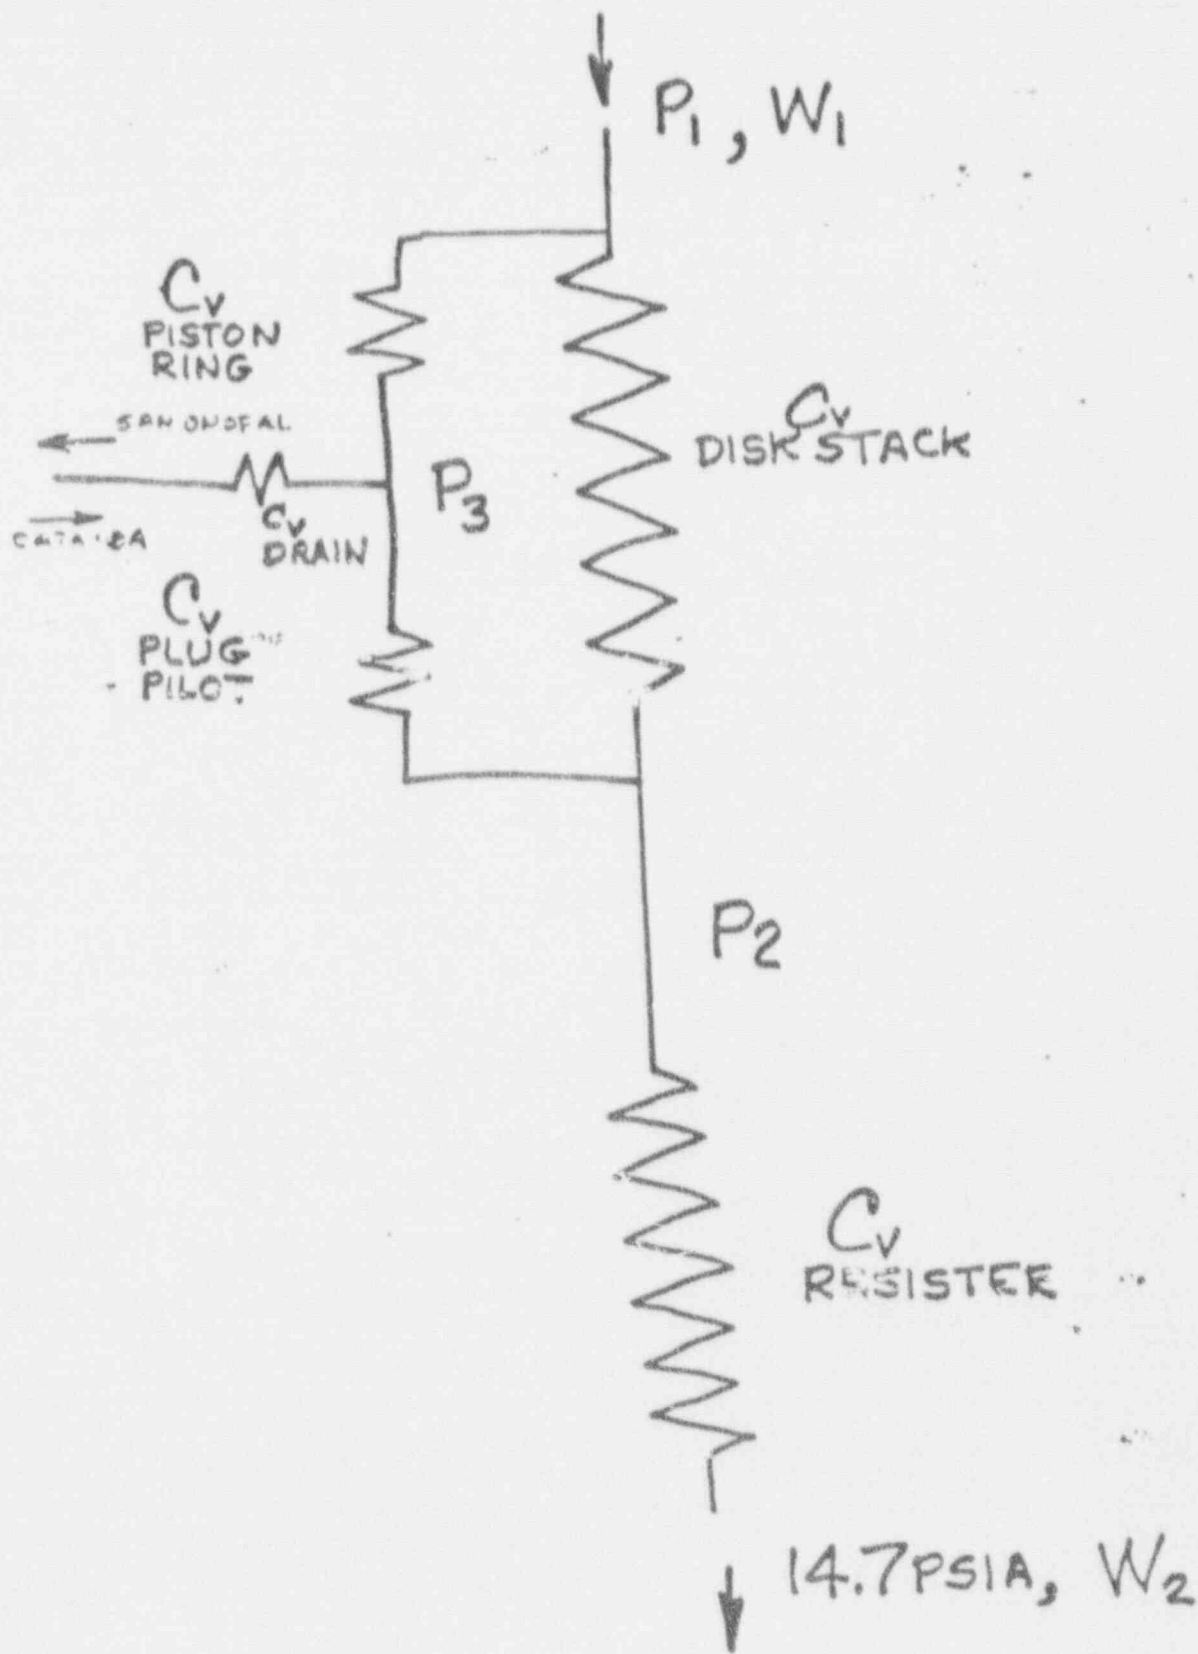
EXISTING
PISTON
RING.

CCI believes that the cause of the valve being able to stroke only to the pilot open position is excessive bonnet pressure due to excessive piston ring leakage. To investigate this hypothesis, CCI fabricated a fixture in order to flow test the 12 inch piston ring. The flow test was conducted utilizing air at 1200 psi. CCI tested the design currently installed at PVNGS for 100 open-shut cycles. During one of the tests, excessive leakage resulting in high bonnet pressure was observed. These tests were performed in late 1986 as a result of erratic performance observed on the non-safety related valves at another nuclear facility. The excessively leaking piston ring condition is random and cannot be predicted.

During further testing, CCI intentionally placed a 0.010 inch high spot on the piston ring to simulate dirt. CCI then measured the leakage flow coefficient (Cv). The measured Cv corresponds to a leak which would be expected to result in excessive bonnet pressure.

- a) Dirt or foreign material such as corrosion products (magnetite) is building up on sealing surfaces of the piston ring when the valve is closed. The piston ring would not be energized due to equal pressures on both sides of the piston ring. When the pilot plug is opened during attempted operations, there is excessive piston ring leakage since the contamination holds the piston ring off the sealing surfaces. Cycling of the ADV's three (3) or four (4) times allows the contamination to "wash" away and the piston ring seal operates properly.

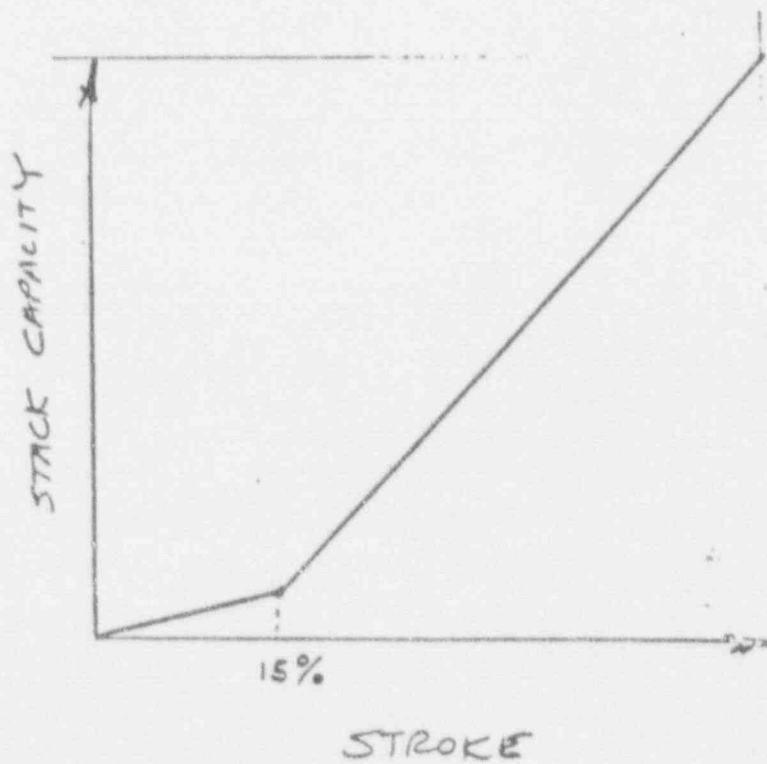
NEW DESIGN
PISTON RING

The main discussion centered on problems arising from failure of the atmospheric dump valves at Palo Verde Unit 3 to open from either the control room or remote shutdown panel on March 3, 1989. Mr. Miller stated that CCI has advised their customers that modifications to their valves could be made to increase the reliability to open by eliminating excessive bonnet pressure. This would be done by use of a more leak-resistant piston ring and a larger flow area to relieve steam above the piston more rapidly. Calculations done by CCI show that, even for worst case analyses, sufficient actuator force should exist to allow the valve to open when these modifications are made. Mr. Miller displayed a modified piston ring which CCI believes reduces leakage.

The licensee has filed a Part 21 report based on the CCI ADV design deficiency. CCI has recommended to their customers (listed in Enclosure 2) that modifications to their valves could be made to prevent excessive valve bonnet pressures preventing the valve actuator from overcoming the pressure forces on the main piston. The high bonnet pressures result from leakage past a piston ring on the main plug. The modification would use a more leak-resistant piston ring and a larger flow area to relieve steam above the piston more rapidly.

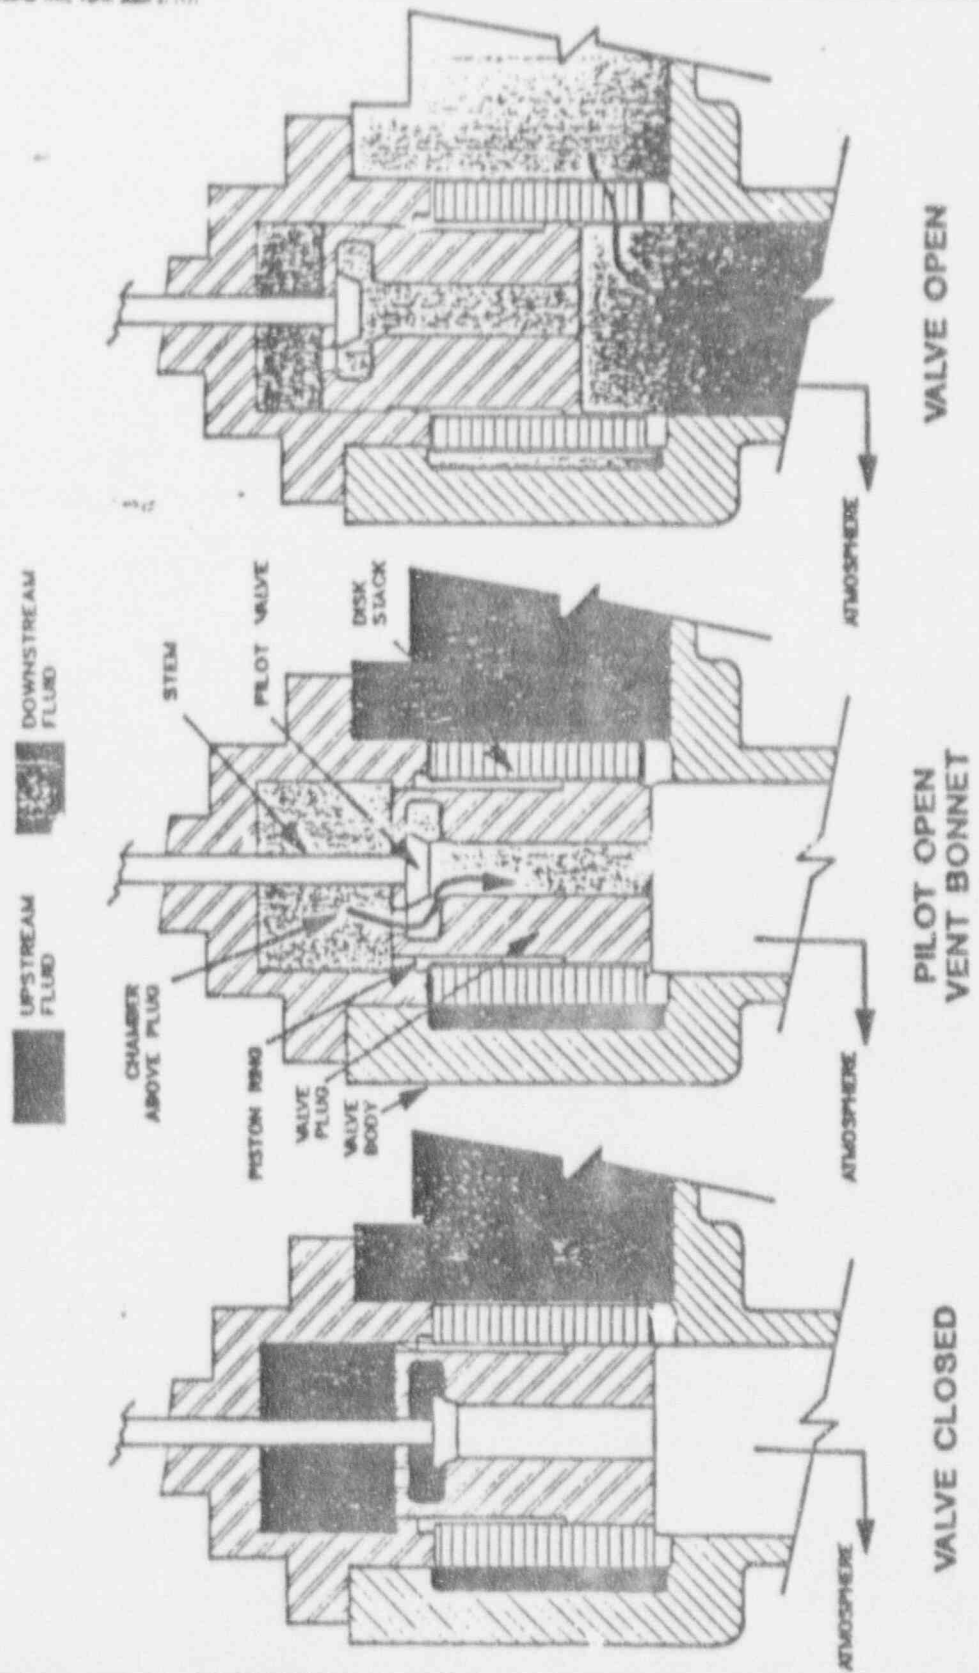
FIGURE 1

With the valve in the closed position, upstream pressure fills the chamber above the plug by way of a controlled leak across the piston ring. This provides a seating load equal to the inlet pressure times the full area of the plug.

When a signal to open the valve is received, the actuator lifts the stem, opening the pilot seat which results in the chamber pressure above the plug equalizing with the downstream pressure. Upstream pressure acts upon the differential plug area and provides an axial biasing force which causes the plug to remain on the main seat.

As the valve stem continues to move in the opening direction, the pilot valve shoulder engages the plug to lift it off the main seat. The axial biasing force causes these opposing faces to remain in contact under all operating conditions.

When a signal to close the valve is received, the actuator moves the stem in the closing direction. The biasing force on the plug causes it to follow the stem until the main seat is contacted. The actuator then seats the pilot section. Controlled leakage by the piston ring then fills the chamber above the plug providing additional seating force.
