SPECIAL PROCESS PROCEDURE

REPAIR, INSPECTION, DOCUMENTATION, AND VERIFICATION
OF
PLACEMENT 499S03-19

WATERFORD SES UNIT NO. 3
CONTRACT NO. W3-NY-4

SPECIAL PROCESS PROCEDURE	PROCEDURE NO. W-SP-16
TITLE: REPAIR, INSPECTION, DOCUMENTATION, AND VERIFICATION	REV. NO. 3 & DATE 5-23-77
PROJECT TITLE: Waterford SES Unit No. 3	
SPECIAL PROCESS PROCEDURE

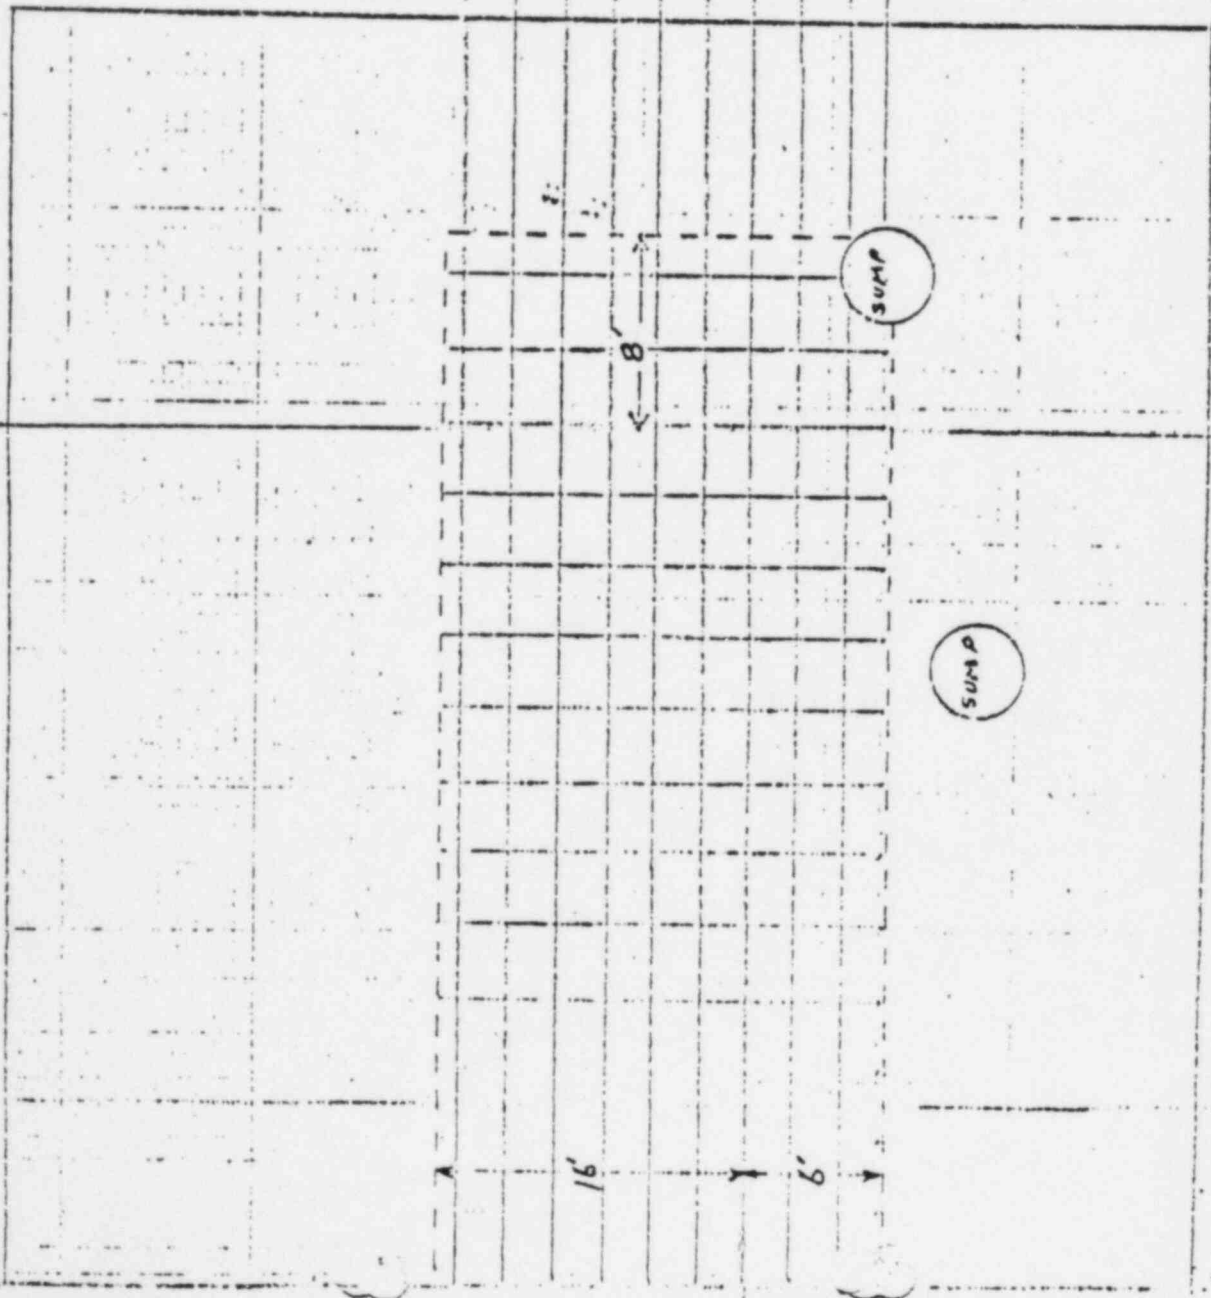
ATTACHMENT "A"
W-SP-16, REVISION 0

NOTE: 2" ϕ CORES
WILL BE DRILLED
AT INTERSECTION
OF HORIZ. AND
VERT. LINES

LOCATION AND
DEPTH OF GROUT
HOLES FOR REPAIR
OF 499503-19
