LICENSEE EVENT REPORT (LER)

FACILITY NAME (1)										DOCKET NUMBER (2)				PAGE (3)	
Catawba Nuclear Station, Unit 1										0 5 0 0 0 4 1 1 3				1 OF 0 1 4

Swap of Nuclear Service Water to Standby Pond Due to Personnel Error

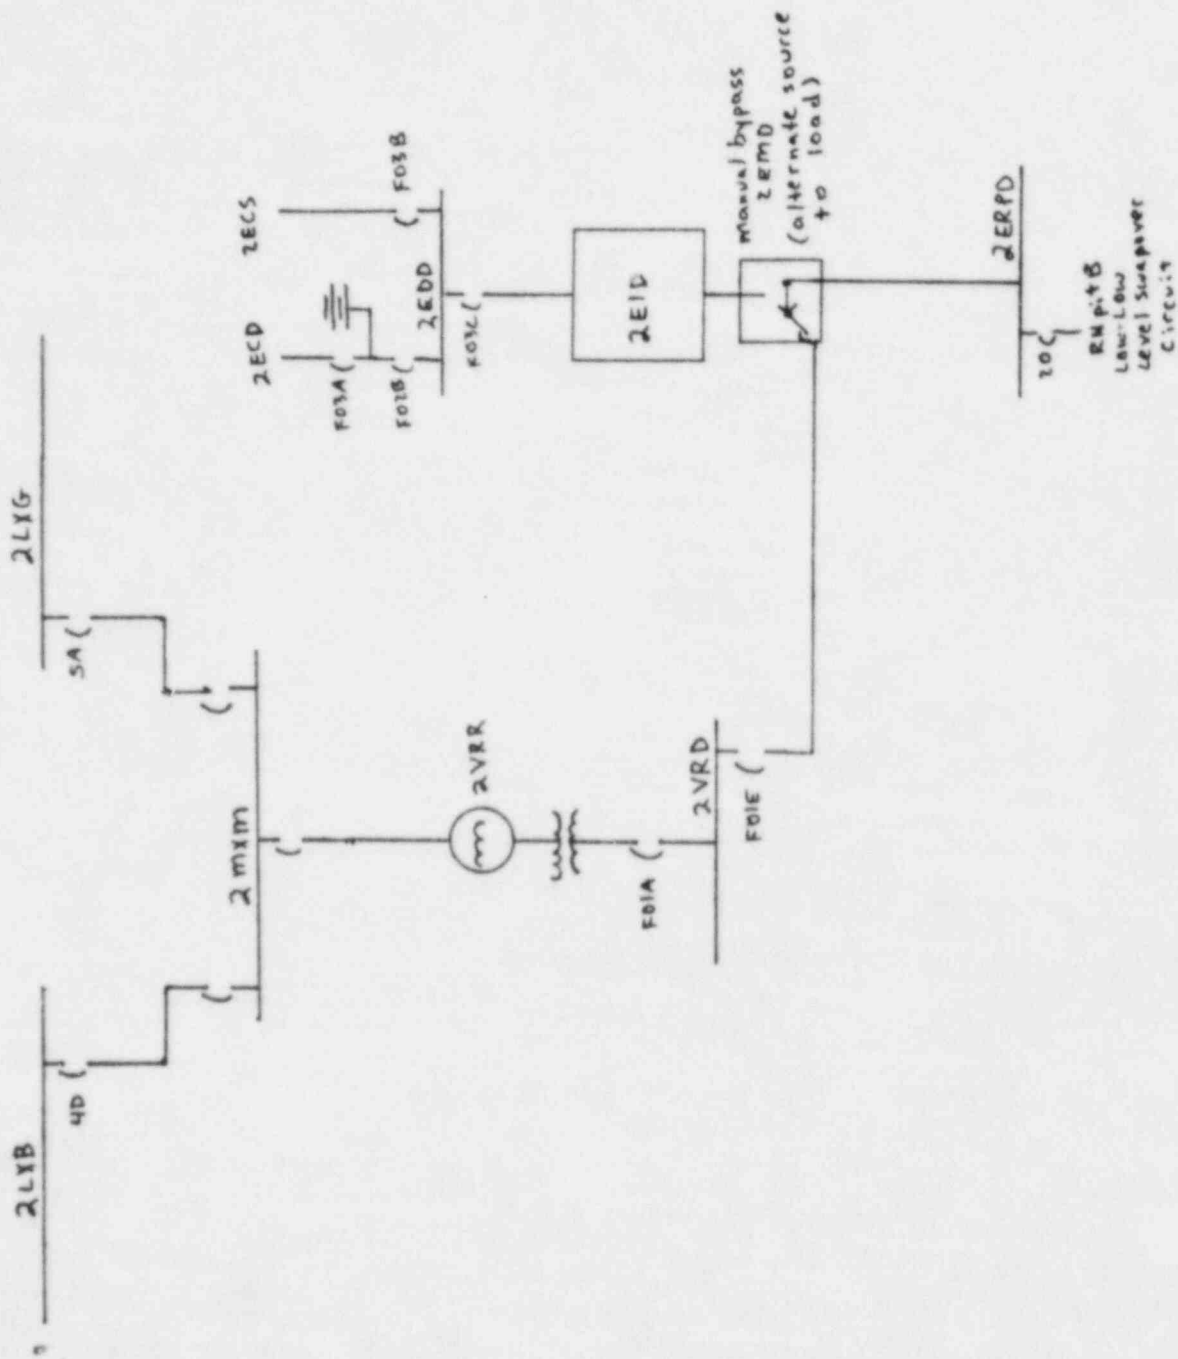
Following completion of the work on the B Train electrical busses, all busses were to be aligned in order to be powered from their normal source. For example, motor control centers fed from load center 2SLXD were swapped to their normal source using a normal dead bus transfer. When a NEO began to align 2MXM back to its normal power source on May 12, 1985, at 2035:42 hours, a dead bus transfer was used, instead of a hot bus transfer as required by Procedure OP/2/A/6350/05. Therefore, 2MXM was de-energized from 2035:42 to 2037:27 hours; a total of one minute and forty three seconds. Because of this loss of voltage to 2MXM, 2VRD and 2ERPD sensed undervoltage (see Enclosure).

RN pit B low-low level circuitry, fed from 2ERPD, falsely sensed a low-low pit B level due to the undervoltage. This caused all the idle RN pumps to start (with the exception of RN pump 2B, as B train essential bus was de-energized), and the suction and discharge of the RN System to align to the SNSWP. All other valves affected by the swapover circuitry also realigned.

1. Motor control center 2MXM was swapped to its normal power source to restore power to the RN pit B low-low level circuitry.
2. RN pumps not needed to support plant operation were shutdown.
3. All valves affected by the swapover from the lake to the SNSWP were realigned.
4. 2ERPD panelboard was swapped from 2VRD to feed from its normal source, inverter 2EID.
5. This incident will be discussed with the personnel involved.
