**Commonwealth Edison**

RLB-93-007

LICENSEE EVENT REPORT (LER)

Facility Name (1) Quad Cities Unit One  
 Docket Number (2) 0 | 5 | 0 | 0 | 0 | 2 | 5 | 4 | 1 | of | 0 | 5  
 Page (3) 1 of 0 5  
 Title (4) 1B Reactor Recirculation Pump Trip While Performing Automatic Depressurization System Logic Testing Due To Personnel Error

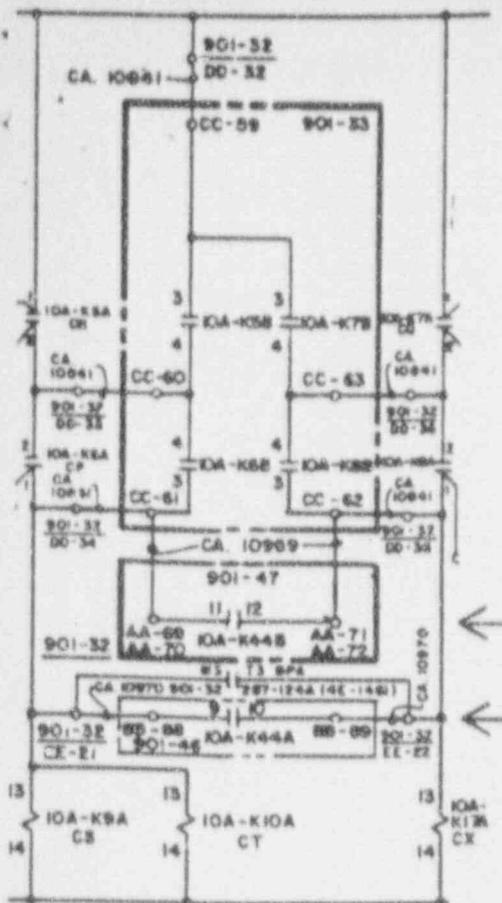
An OE and the Shift Control Room Engineer (SCRE) began to review electrical drawings to determine what blocks would be required to prevent the trips. The logic was traced backwards from the RR system circuitry to the Low Pressure Coolant Injection [BO] (LPCI) loop select logic circuitry. The logic was traced to a point where three sets of two parallel contacts enable the LPCI loop select sequence (Figure 2). One of the two contacts in each set is from the 10A-K17A(b) relays, which are denoted as Vessel Low Level on the drawing. The other contacts in each set are from the 10A-K9A(B) and 10A-K10A(B) relays which are denoted as High Drywell Pressure on the drawing. Since the test simulated only a low-low level, the operating coils for the 10A-K17A(B) relays were located and verified to energize on the simulated signal. All contacts of the 10A-K17A(B) relays were to be blocked to prevent the trip of the RR pumps. However, contacts for the 10A-K44A(B) relays provide an interlock between the operating coils on the 10A-K17A(B) relays and the 10A-K9A(B) and 10A-K10A(B) relays (Figure 1). The 10A-K44A(B) contacts close on low reactor pressure, which was present during the test. Thus, the simulated signal would cause all contacts associated with initiation of the LPCI loop select sequence to close, but only the contacts for the 10A-K17A(B) relays would be blocked. The parallel contacts from the 10-K9A(B) and 10A-K10A(B) relays would initiate the loop select sequence. This interlock was not identified by the SCRE or the OE during their review of the drawings.

FIGURE 1 RESIDUAL HEAT REMOVAL SYSTEM LOGIC (4E-1438C). Contacts of 10A-K44A(B) relay not identified during reviews. Closed contacts cause 10A-K9A(B) and 10A-K10A(B) to energize when 10A-K17A(B) energizes.

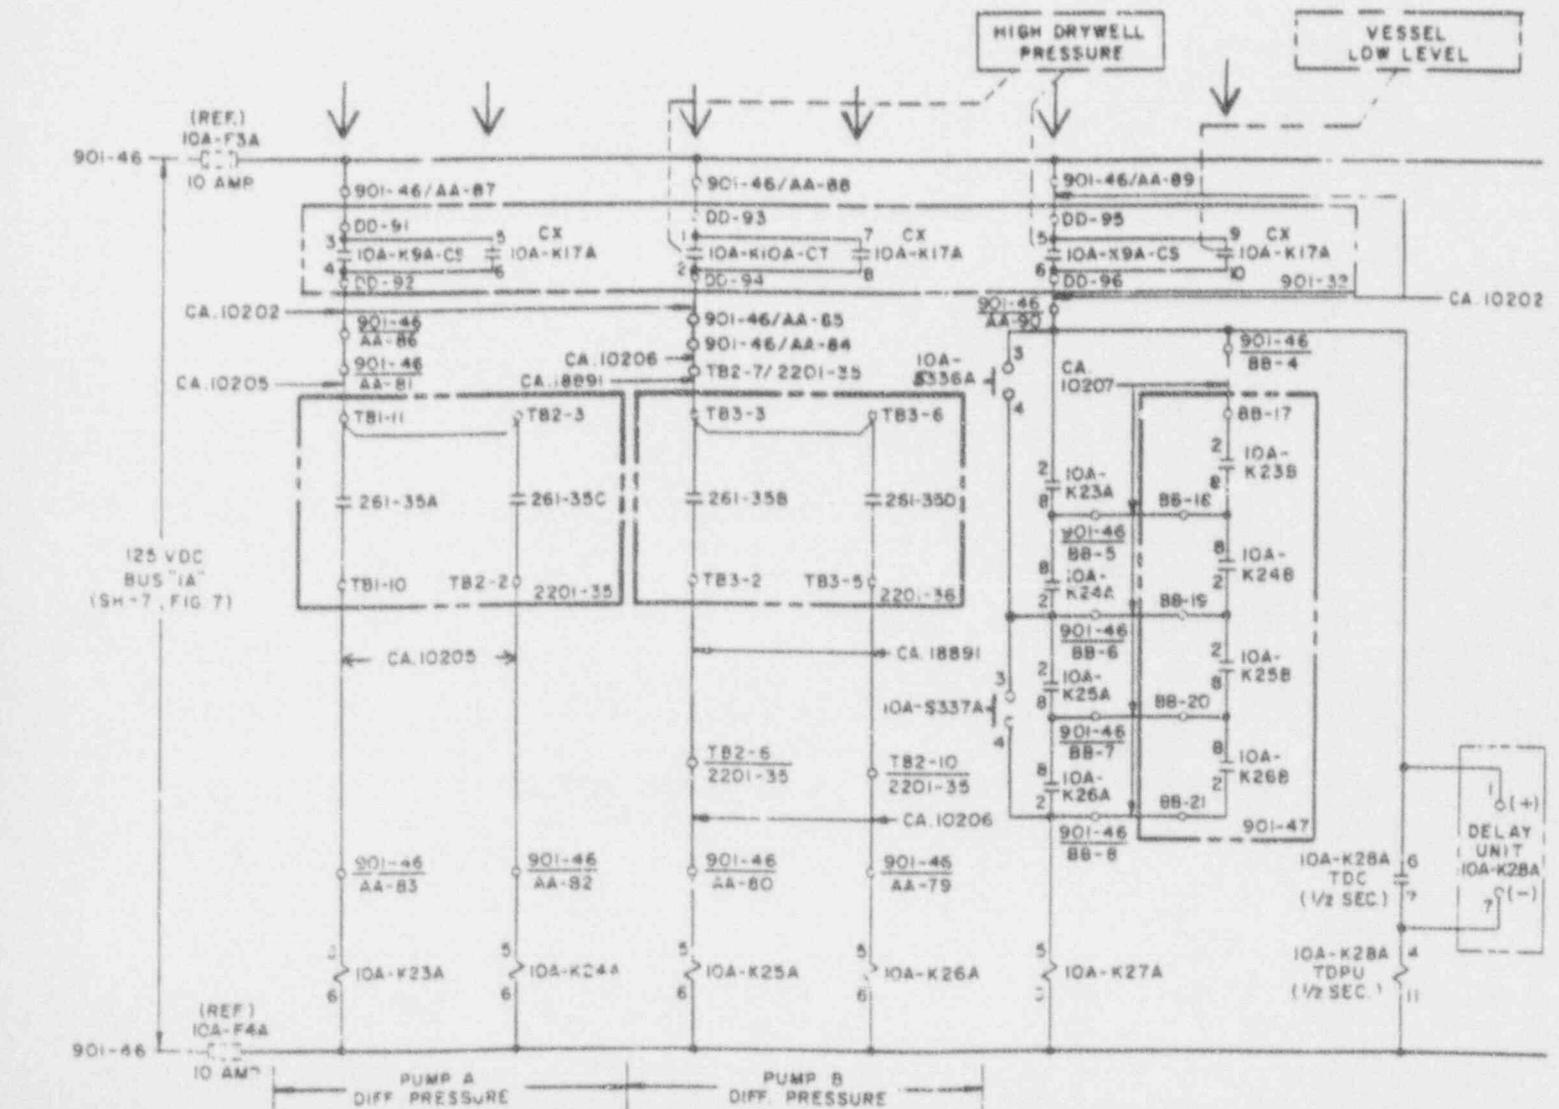
The TS EE verified that the blocks on contacts of the 10A-K17A(B) relays would prevent the initiation of the LPCI loop select sequence. The TS EE also noted the designation on the drawings for Low Vessel Level and High Drywell Pressure associated with the different contacts, and did not expect that the parallel signal path would close. He also assumed that the SCRE and the OE had verified that these contacts would not close. The TS EE then prepared the temporary procedure and turned the information over to the TS test director when he arrived on site.

At 2330 hours on December 12, 1992, the test began. At 0048 on December 13, 1992, step H.2.a, was performed to simulate a low-low level at vessel level instruments 263-72A and 263-72C. At this time, LPCI logic initiated a trip of the 1B RR pump by sending a close signal to the RR discharge valve 1-202-5B. No alarm is received immediately upon a pump trip, and the Nuclear Station Operator (NSO) was observing system actuations and verifying that no grounds had occurred. The signal was then removed from the vessel level instruments. Following this, alarms indicating the pump trip annunciated and the test was suspended. The 1A RR pump did not trip because the simulated level signal was removed before the 1B RR pump coasted down. At 0132 hours, the 1B RR pump was restarted. At 0241 hours, an Emergency Notification System phone notification was made in accordance with 10CFR50.72(b)(2)(ii).

FIGURE 2 LPCI LOOP SELECT INITIATION LOGIC (4E-1438D). Blocks installed on 10A-K17A(B) contacts. Parallel 10A-K9A(B) and 10A-K10A(B) contacts not blocked.

QCTS 310-2 and QTP 110-4, Unit 2 Automatic Pressure Relief Actuation Surveillance will be revised to prevent recurrence of this event. This report will be a reference document listed in the procedure. An option will be included to perform the test with the RR pumps off or to correctly block the LPCI signals from initiating a RR pump trip (NTS# 2542009214202).
