LICENSEE EVENT REPORT (LER)

FACILITY NAME (1) Fort St. Vrain, Unit No. 1	DOCKET NUMBER (2) 0 5 0 0 0 2 6 7	PAGE (3) 1 OF 1
---	--------------------------------------	--------------------

TITLE (4)
Reactor Scram On High Count Rate, Startup Channel 1

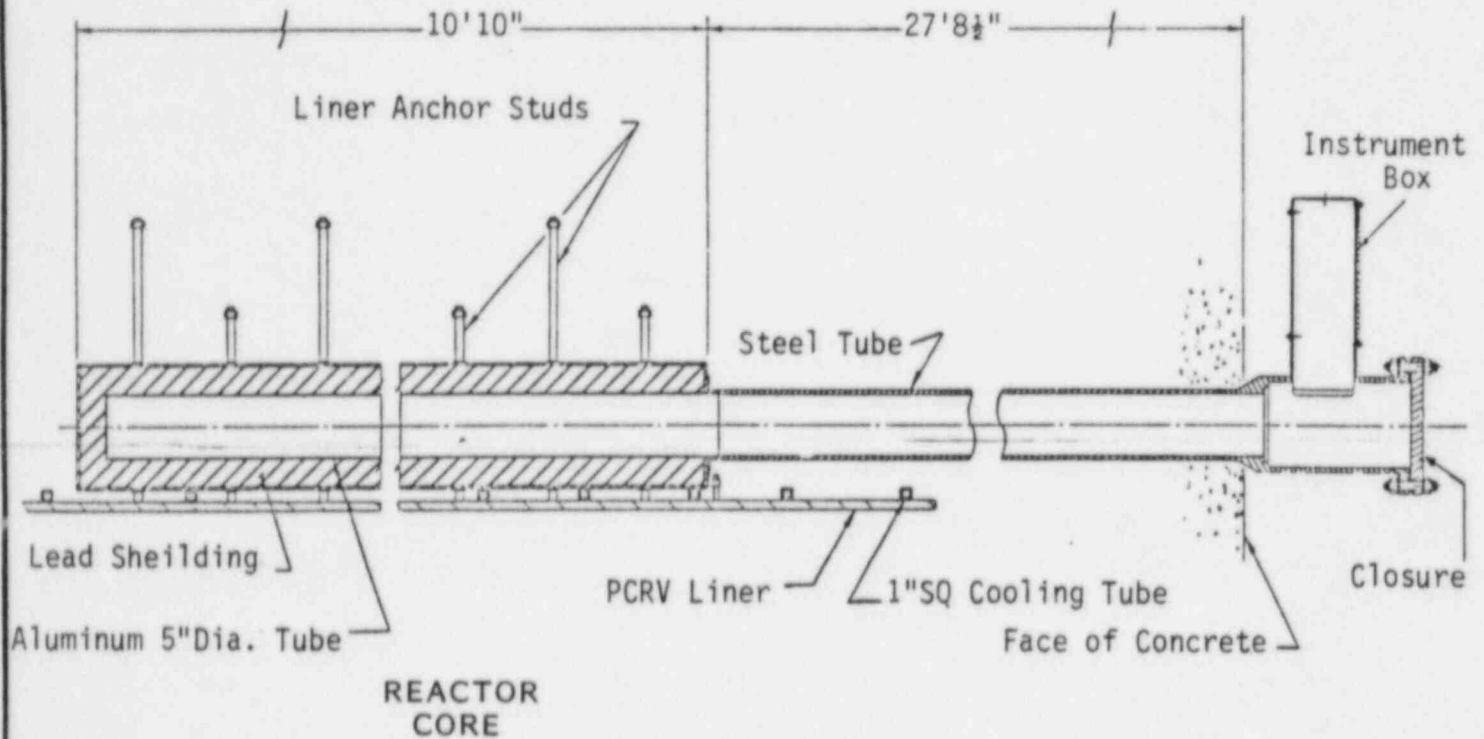
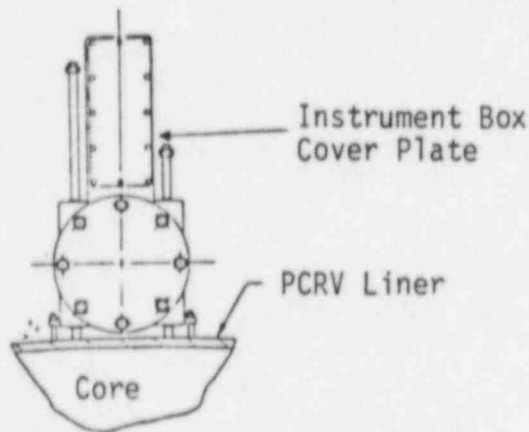
FIGURE 1.

The startup channel neutron detectors are located in wells in the prestressed concrete reactor vessel (PCRV) and extend horizontally inward to a position over the core (see Figure 4). A neutron detector well is illustrated in Figure 1. These wells extend to within a few inches of the cavity liner but do not penetrate the liner nor communicate with the primary coolant system. The preamplifier and various cable connections are located inside an instrument box which is part of the well assembly (see Figure 1 and 2b).

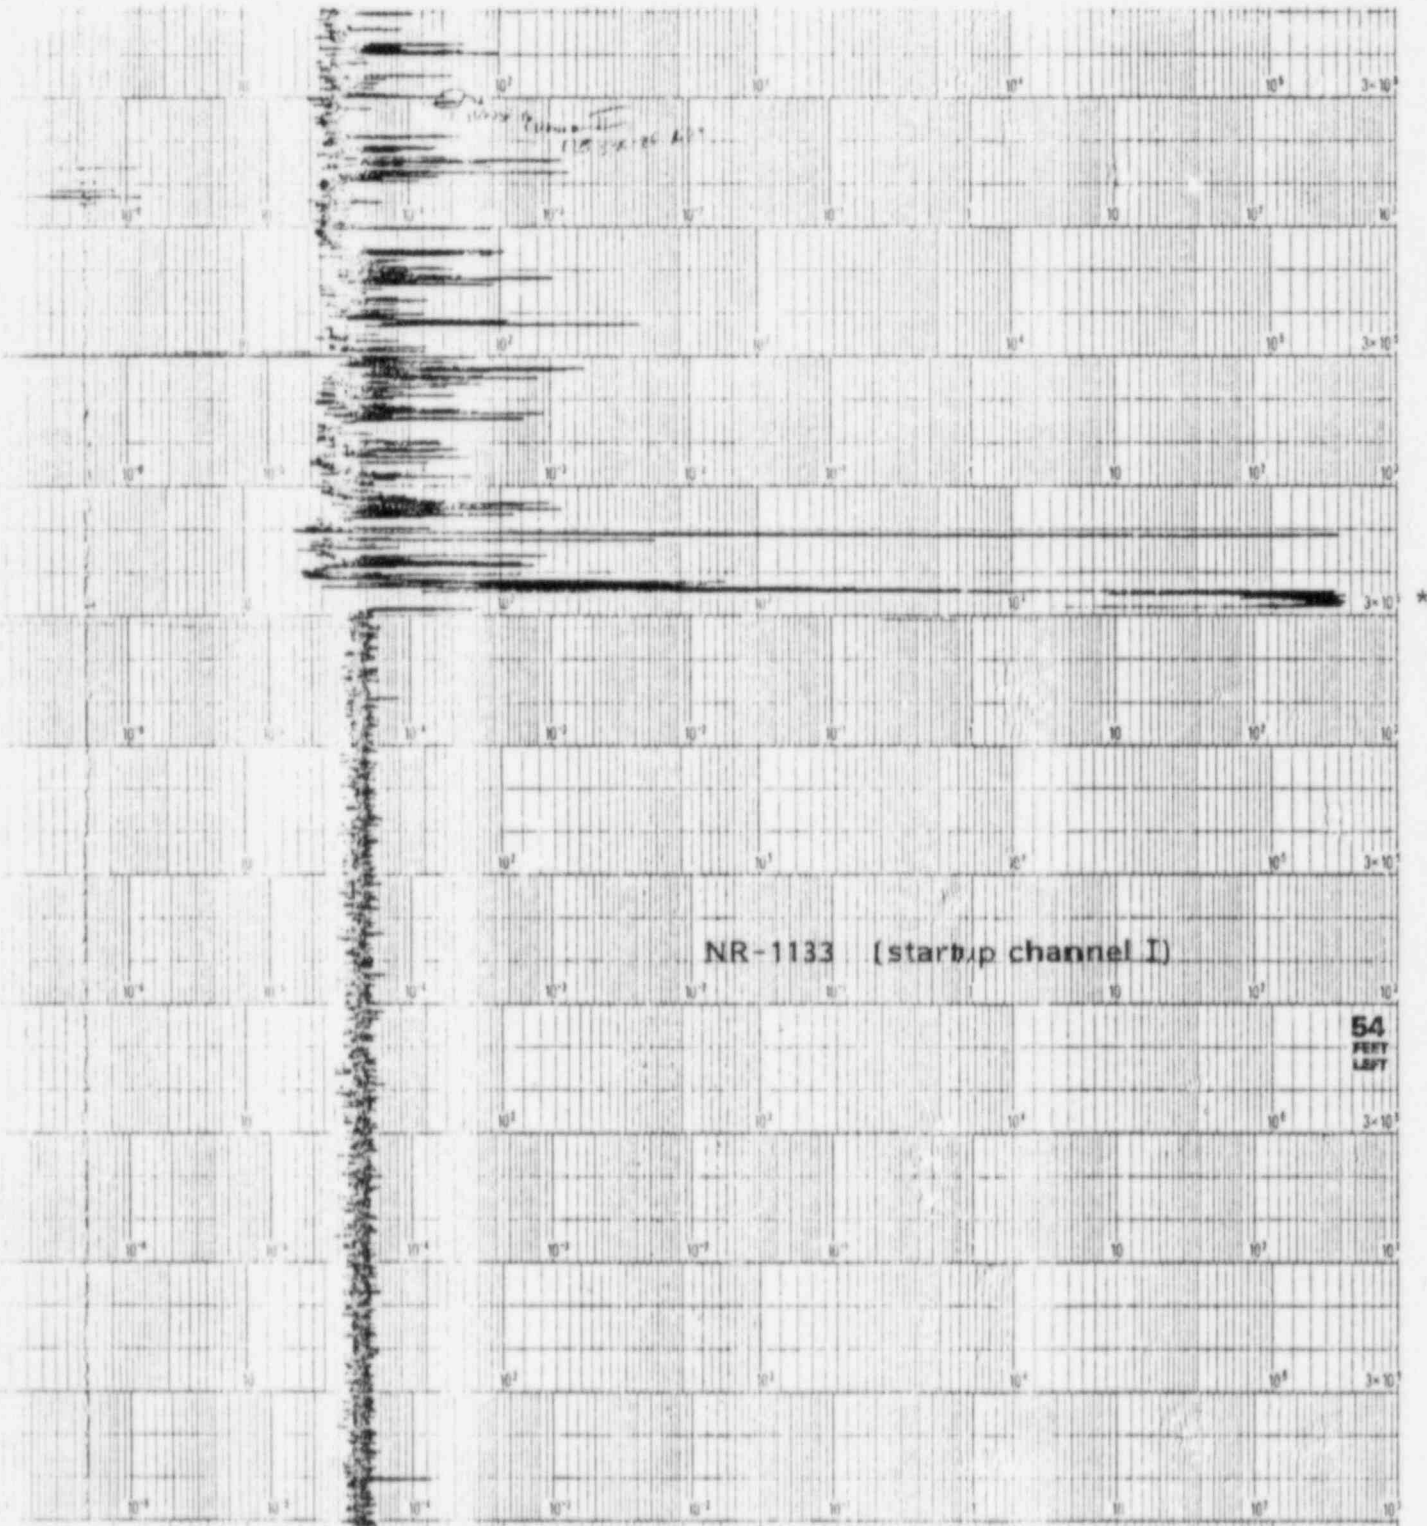
FIGURE 3.

* Approximate time of scram

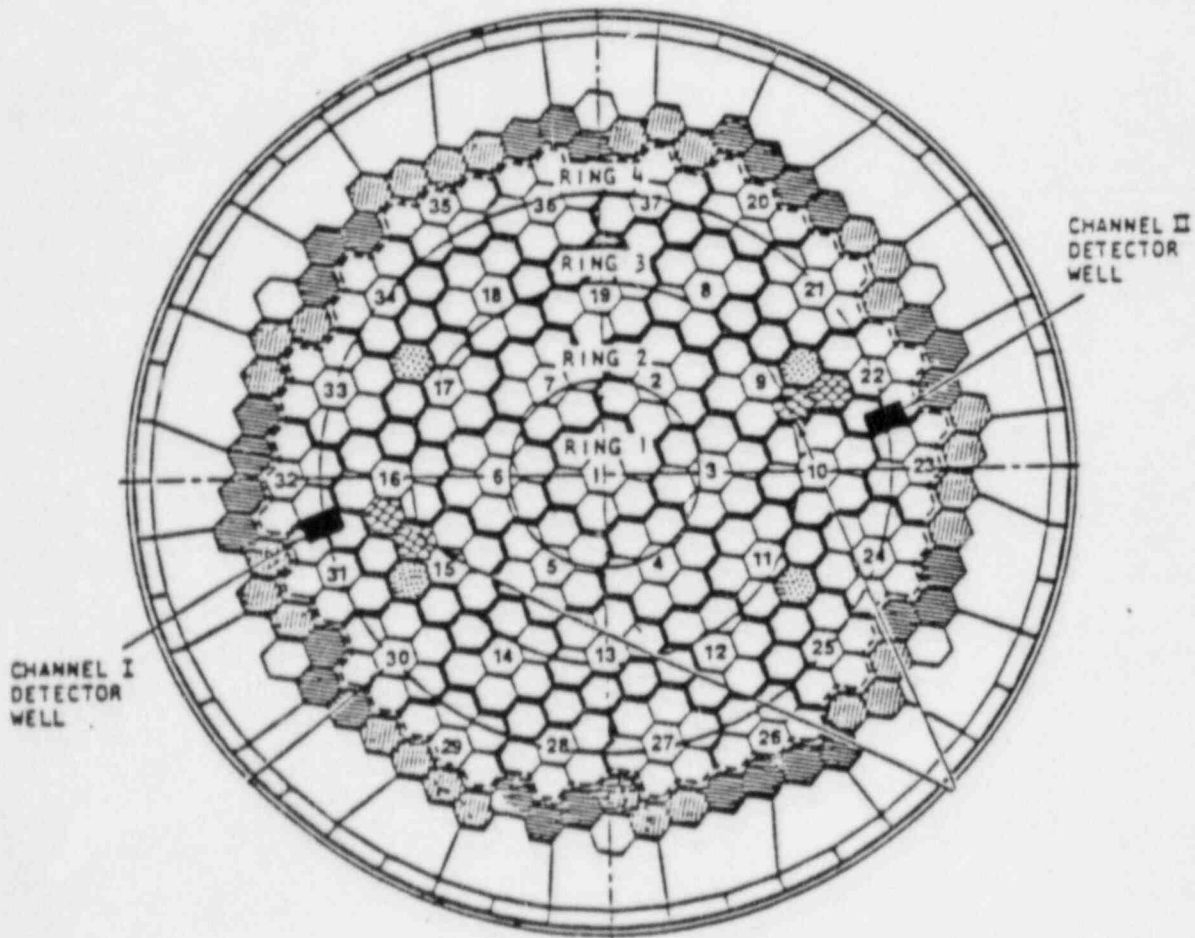
FIGURE 4.

(Top View Of Reactor)
