LICENSEE EVENT REPORT (LER)

FACILITY NAME (1) Point Beach Unit 1	DOCKET NUMBER (2) 0 5 0 0 0 2 6 6	PAGE (3) 1 OF 0 4
---	--------------------------------------	----------------------

TITLE (4)
Failed Fuel Clad in One Rod of Assembly H9

DOCKET NO. 50-266
LICENSEE EVENT REPORT NO. 85-002-00
FAILED FUEL CLAD IN ASSEMBLY H9, POSITION D12, CYCLE 12
POINT BEACH NUCLEAR PLANT, UNIT 1

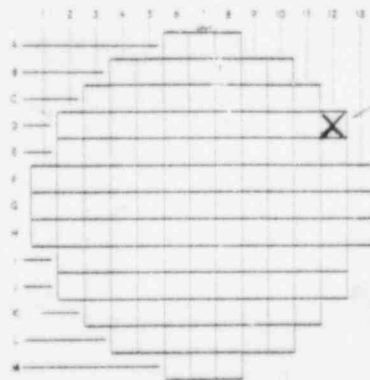
FIGURE 1

During the April 27, 1985, routine inspection of discharged fuel after the completion of Cycle 12 for Point Beach Nuclear Plant, failed fuel rod cladding in assembly H9 was discovered. The fuel rod cladding appears to have failed due to vibration of the rod against the grid and grid springs. This vibration is believed to have been caused by water impingement through a joint gap in the core baffle discovered on May 15, 1985. Assembly H9 was located in position D12 during Cycle 12. This is an outside position of the core next to a core baffle plate corner. No fuel pellets escaped from the fuel rod.

See Figure 1, Page 4, for position location.

The inspections noted that a section of cladding on rod No. 14 (the outside corner rod next to the baffle joint) immediately behind grid No. 2 (the second grid from the top of the assembly) had failed. The fuel inside the rod was visible. No fuel pellets escaped from the fuel rod. The same rod was found to have a torn grid spring at grid No. 3 and another cladding failure with the grid spring showing at grid No. 1. Rod No. 14 was touching the bottom nozzle. All other rods were in their normal off-the-bottom position. Fuel assembly H9 was placed in the reactor in location D12 such that rod No. 14 was located in the southwest corner of the fuel assembly during Cycle 12.

An inspection was performed of the corner joint of the core baffle plate forming the southwest corner of position D12 of the core. This joint is a simple butt joint with the line of the joint running north-south. The baffle plate joint is a bolted joint. During an inspection of the full length of the joint forming the southwest corner of the baffle at D12, two areas were found which indicated possible flow (baffle jetting) through the baffle joint.

The inspection of the joint revealed indications of a possible 4 to 7 mil gap in the baffle plate joint between the rows of cap screws indicating the second and third, and third and fourth baffle radial supports. These indication locations correspond to the location of the fuel damage on assembly H9.
