EVALUATION OF LEAK IN
OYSTER CREEK CORE SPRAY SYSTEM

TR-092
(REV 0)

January 15, 1993

GPU Nuclear
1 Upper Pond Road
Parsippany, New Jersey 07054

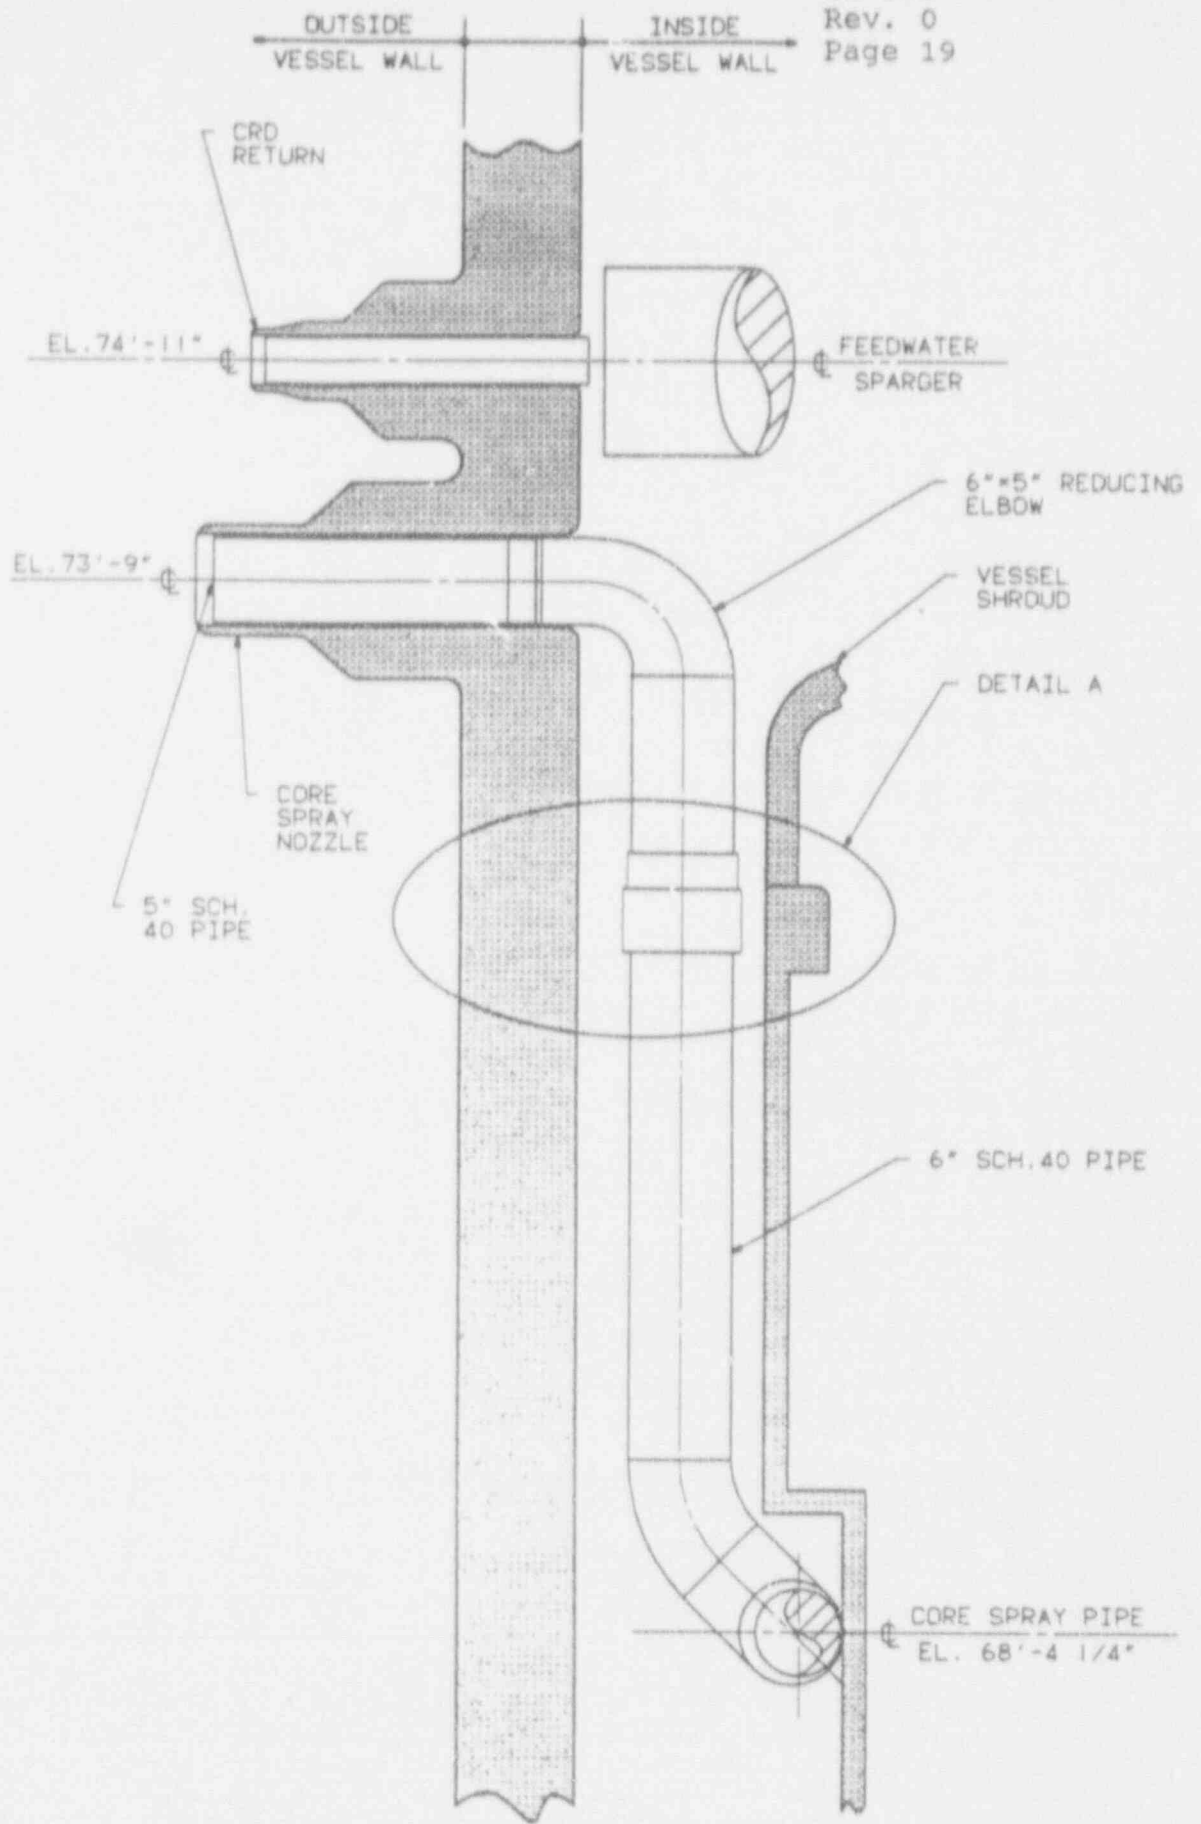
During the 14R outage air test of system I, a steady stream of air bubbles was observed from the annulus piping. The leak is located in a coupling that connects two ends of the 6" schedule 40 pipe in the down leg between the reactor vessel penetration and the circumferential pipe run. A closer video examination determined that the leak was from the weld joint identified as L-3A. Additional visual examinations were performed to better locate and characterize the leakage. This additional inspection confirmed that the indication in the L-3A fillet weld was circular and approximately one-eighth of an inch in diameter. Weld L-3A was 100% VT-1 inspected per reference 2 and was determined to be acceptable except for the 1/8" diameter round weld defect believed to be from the original construction which is now leaking³.

FIGURE 2 CORE SPRAY PIPING DOWNLEG

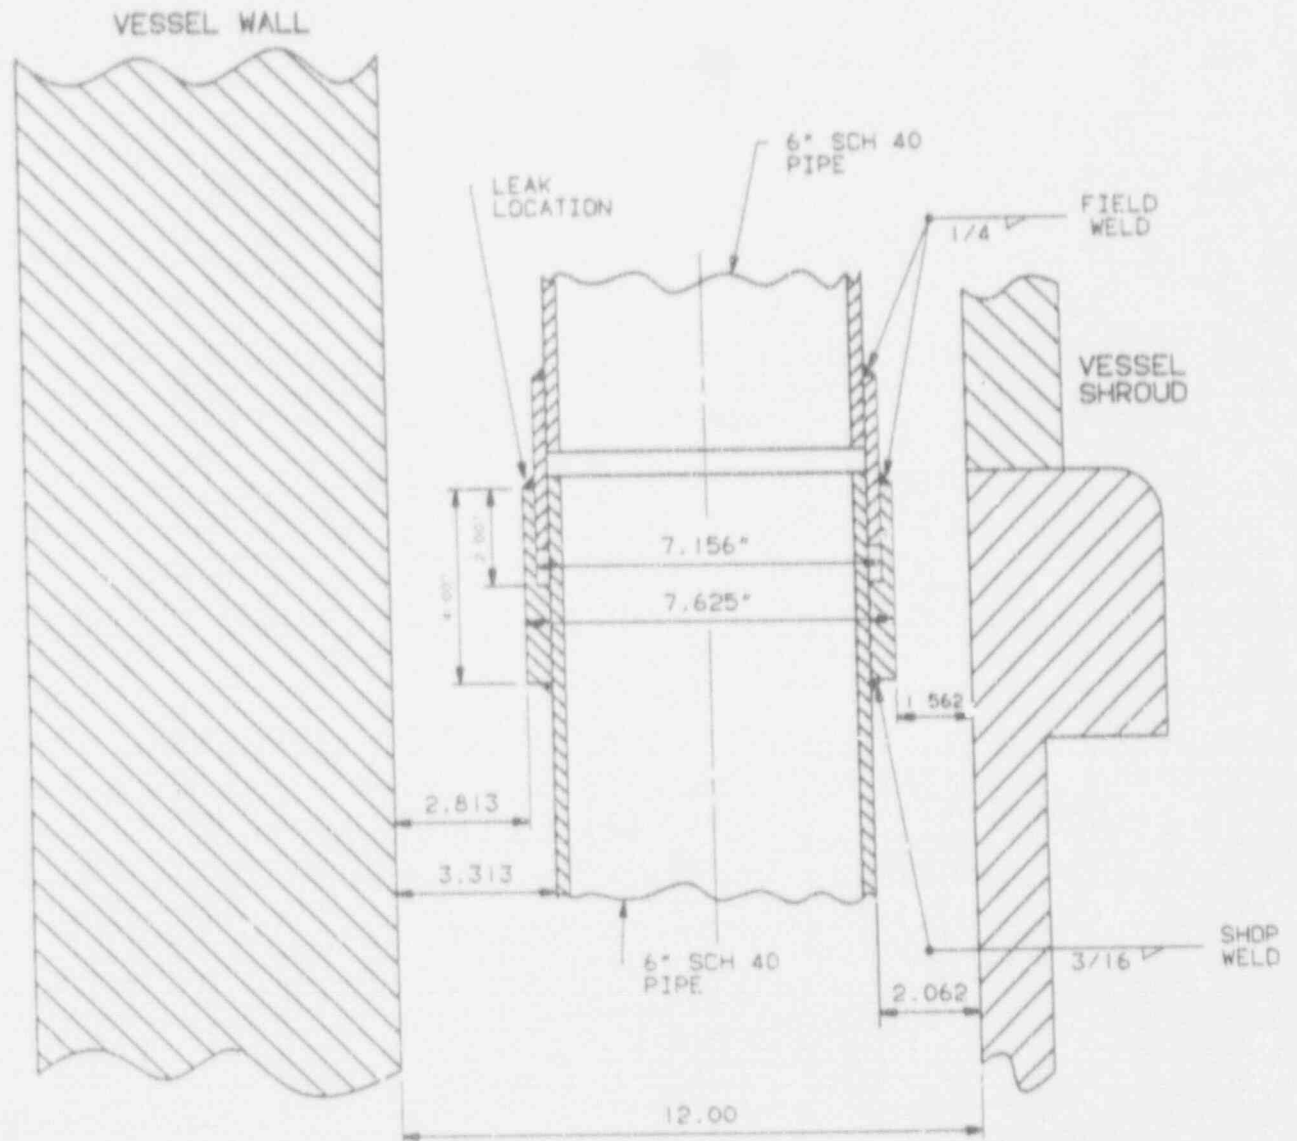
FIGURE 3

(Figure 3) was used to allow the field installation of annulus piping to the penetration connection. This was accomplished by allowing for vertical adjustments and final fit up field fillet weld. The leak was observed from this field weld.

The overriding factor in the structural evaluation of the core spray annulus piping is that the axial load capacity of the coupling is controlled by a 3/16 inch shop weld on the lower coupling sleeve (Figure 3). Thus, the 3/16 inch weld controls the axial strength of the coupling for all normal and postulated accident loads. Because of the weld size and diameter differences, the 1/4 inch weld with the leak could lose approximately 31 percent of its circumference (e.g., about 7 inches) and not reduce the axial capacity of the coupling.

CORE SPRAY PIPE COUPLING

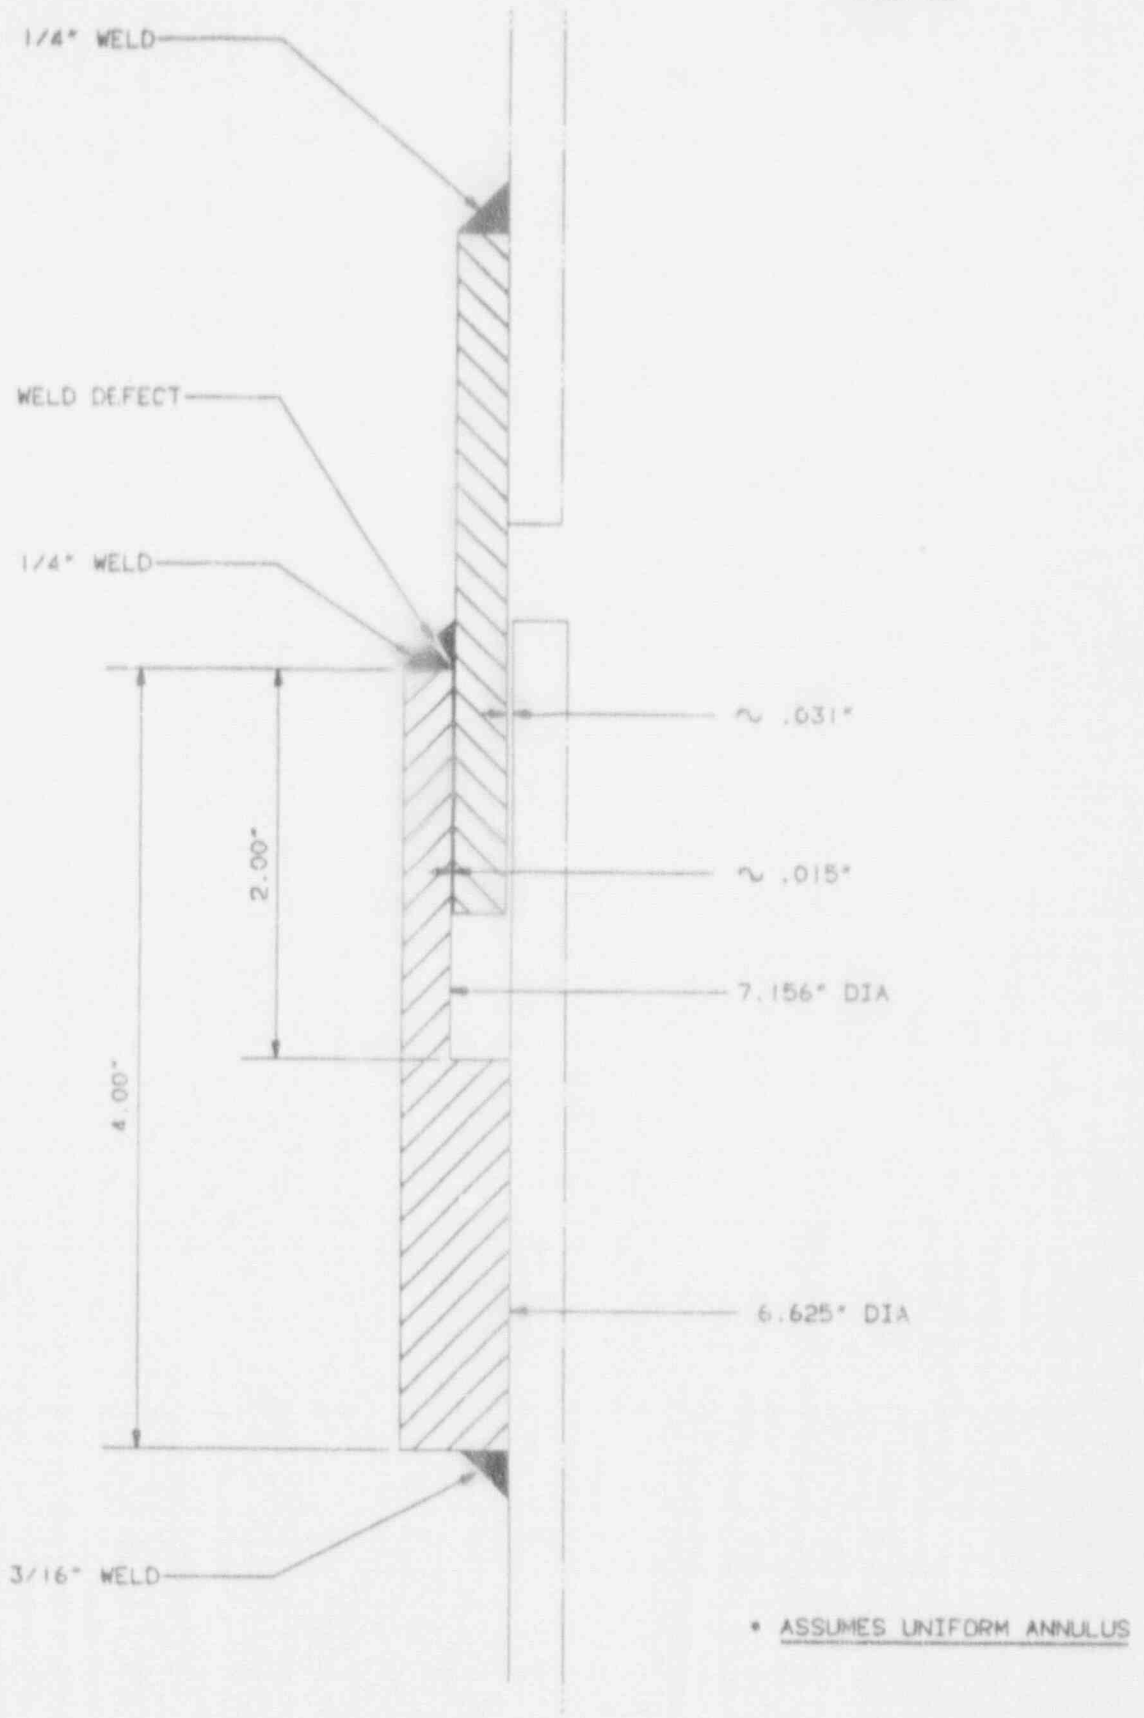
FIGURE 5

The visual inspection of the defect in weld L-3A shows it to be a rounded hole in the 1/4 inch fillet weld in the core spray annulus pipe coupling. The weld is a field weld and the defect appears in an area of limited access where the coupling is closest to the reactor vessel wall. The air test showed that the defect bubbled at a relatively high rate, consistent with a fairly open leakage path completely through the weld such as might occur if a slag inclusion was cleared out to create a leak path. The leak path is shown in Figure 5.

The characteristics of the defect are consistent with a weld defect in a portion of the weld that was difficult to access. The defect likely contained slag and/or lack of fusion and opened up after approximately twenty years service with normal cyclic stresses. This is the most probable cause for the leak.

LEAK PATH FOR WELD DEFECT

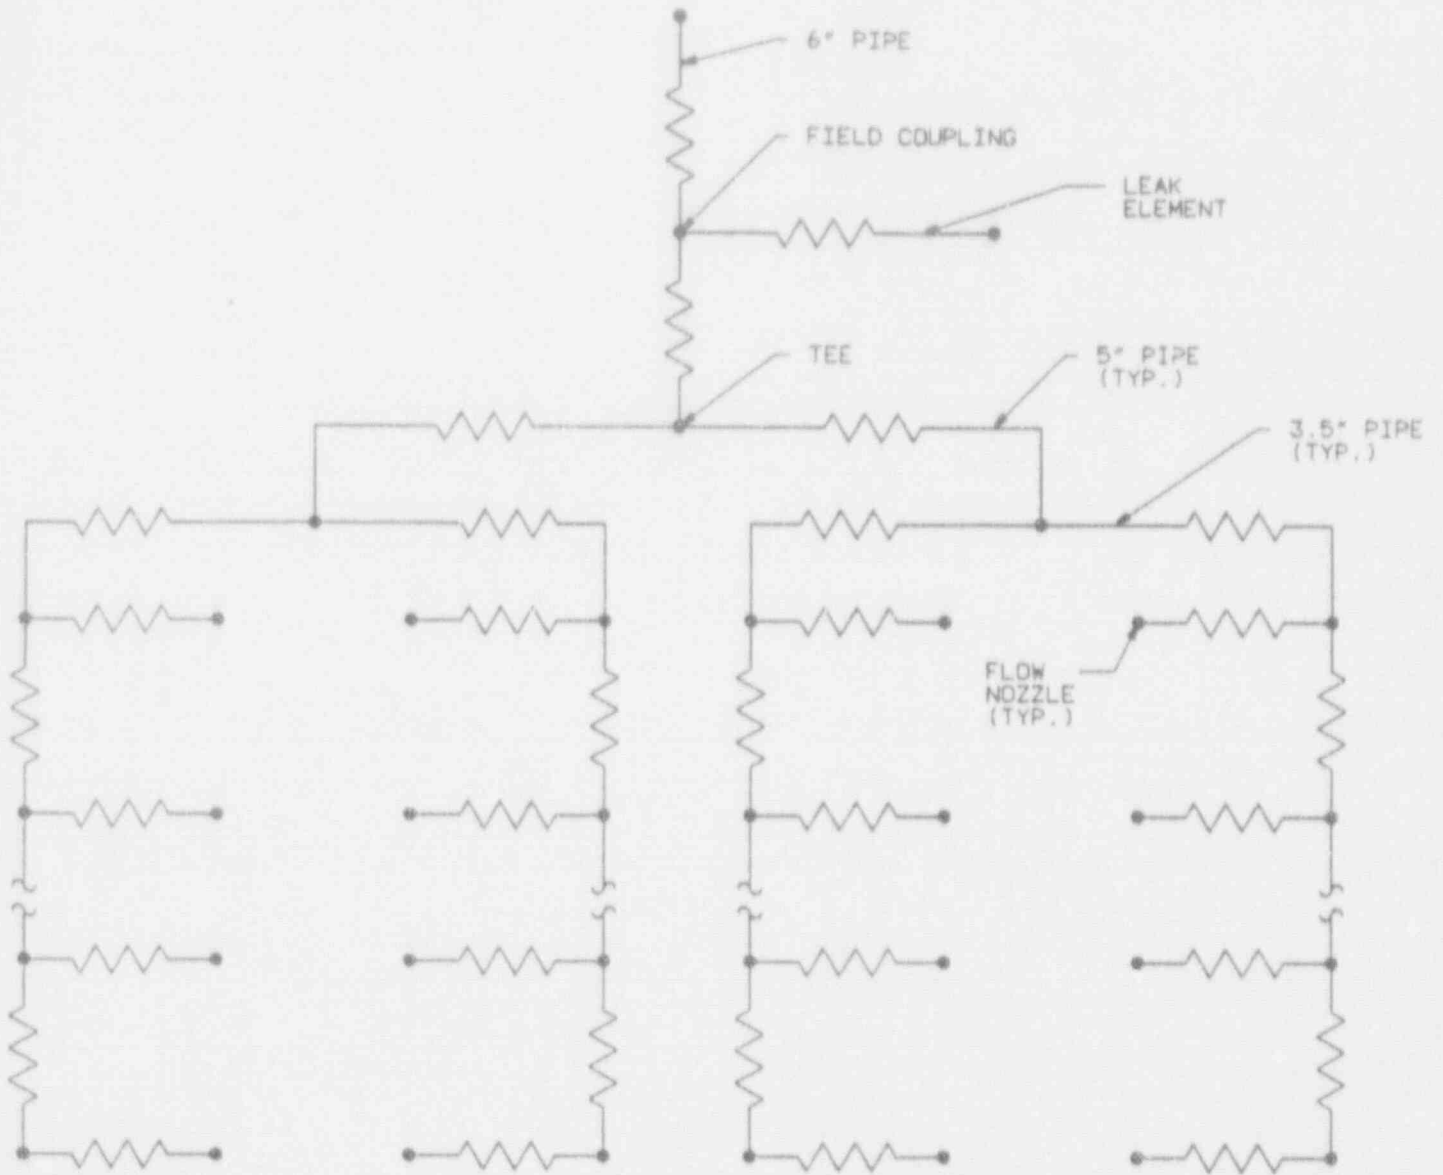
FIGURE 6

A hydraulic resistance model of the core spray annulus piping, sparger, and flow nozzles was developed (Figure 6). Calculations were performed at the design basis flow rate of 3400 gpm with an exit pressure of 110 psig for various cases as summarized below.

As shown in Table 2, the calculated flow losses are small compared to the available margin in core spray System I (500 gpm). Therefore, the flow loss through the observed defect in the 1/4 inch fillet weld, as well as worst case scenarios, is considered acceptable.

HYDRAULIC MODEL OF CORE SPRAY
INLET PIPING AND SPARGER
