LICENSEE EVENT REPORT (LER)													
Facility Name (1)										Docket Number (2)	Page (3)		
SAN ONOFRE NUCLEAR GENERATING STATION, UNIT 2										0 5 0 0 0 3 6 1 1	of 1 0		
Title (4)													
MIS ALIGNMENT OF UNIT 2 SALT WATER COOLING PUMP P112 EMERGENCY SEAL WATER SUPPLY ISOLATION VALVE													
EVENT DATE (5)			LER NUMBER (6)			REPORT DATE (7)			OTHER FACILITIES INVOLVED (8)				
Month	Day	Year	Year	Sequential Number	Revision Number	Month	Day	Year	Facility Names	Docket Number(s)			
0 6	1 4	9 2	9 2	0 0 9	0 1				SONGS, UNIT 3	0 5 0 0 0 3 6 2			
OPERATING MODE (9)			THIS REPORT IS SUBMITTED PURSUANT TO THE REQUIREMENTS OF 10CFR (Check one or more of the following) (11)										
POWER LEVEL (10)	1	20.402(b)	20.405(c)	50.73(a)(2)(iv)	73.71(b)

SAN ONOFRE NUCLEAR GENERATION STATION UNIT 2	DOCKET NUMBER 05000361	LER NUMBER 92-009-01	PAGE 2 of 10
---	---------------------------	-------------------------	-----------------

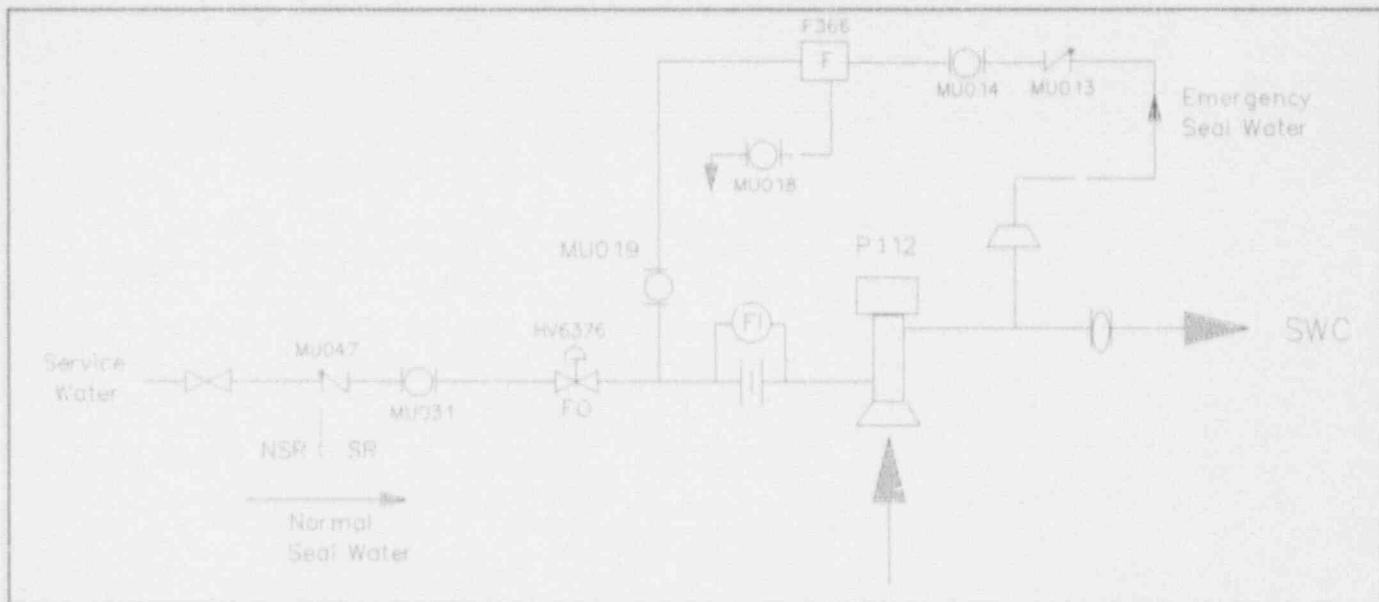
Figure 1 - SWC Pump P112 Seal Water System

The SWC pump seals [SEAL] and bearings are normally cooled and lubricated by the service water system (domestic water). Seal water flow normally ranges from 7 gpm to 15 gpm. In the event the service water system becomes inoperable, (e.g., due to maintenance or in the unlikely event of a design basis earthquake (DBE) which renders it unavailable), emergency seal water to the SWC pump is automatically provided by the SWC pump discharge (refer to Figure 1). The emergency seal water supply is provided at a pressure lower than that of the service water system, such that loss of service water pressure passively results in the supply of emergency seal water to the operating pump.

At approximately 2330 on June 14, 1992, with Unit 2 in Mode 1 at 100% power, a plant operator (utility, non-licensed) identified that SWC Pump P112 emergency seal water isolation valve MU019 was in the "closed" position, rather than "open" as required. The operator identified this discrepancy while installing a maintenance order tag on an unrelated piece of equipment in the Unit 2 SWC pump room. The valve was opened at 0030 on June 15, 1992, thus restoring the emergency seal water supply to SWC pump P112. At 0220, a SWC system flow path alignment was performed for both Units 2 & 3 SWC pumps to determine if other SWC seal water valves were similarly mis-aligned. No other valves were found mis-aligned.

Although the cause and duration of the mis-alignment of MU019 cannot be definitively determined, SCE has concluded that the mis-alignment most likely occurred during the performance of the MU013 quarterly check valve test performed on May 28, 1992. This conclusion is based on a review of SWC P112 seal water supply flow data, which is sensitive to the position of valve MU019 (as well as to other seal water system valve and parameter changes). The flow data appears to indicate that MU019 was most likely in the "open" position when the data was taken on May 28, 1992, and may have been in the "closed" position on May 30, 1992. This conclusion is based on a step change increase of 3.5 gpm (from 10 gpm to 13.5 gpm) in the recorded P112 seal water flow between the 28th and the 30th. This step increase in seal water flow was not regarded by Operations as an anomaly since seal water flow typically varies from 2-5 gpm between SWC pumps and P112 seal water flow remained well within the normal limits of 7 gpm to 15 gpm. In hindsight, this step increase is consistent with a mispositioning of MU019 during this time frame.

Although the cause and duration of the mis-alignment of MU019 cannot be definitively determined, SCE has concluded based on our investigation, that the valve mis-alignment most likely occurred on May 28, 1992 during the performance of MU013 quarterly check valve test. A thorough investigation of this incident was performed which considered three possible causes; unauthorized manipulation, inadvertent repositioning of the valve (e.g., accidental bumping which was not recognized), and possible failure to reclose the valve after opening it for an authorized work activity.

- a. Once identified, MU019 was re-opened, restoring emergency seal water supply to SWC Pump P112 such that all of its operability requirements were satisfied.

- b. Engineering Procedure SO23-V-3.5.4 was enhanced as follows; 1) the check valve testing valve alignment was modified such that it will not be necessary to remove the emergency seal water supply from service (i.e., rather than closing MU019, the enhancement requires the closing of the normal seal water supply system isolation valve (MU031) for the purpose of testing the check valve), 2) a sign-off step was provided for the operator manipulating the valve during the testing, and 3) an independent verification sign-off step was added to ensure that MU031 was re-opened following the test.
