HOPE CREEK GENERATING STATION
DOCKET NO. 50-354
UNIT NO. 1
LICENSEE EVENT REPORT 92-012-00

LICENSEE EVENT REPORT

TITLE (4): Operation prohibited by Plant Technical Specification 5.3.7.11. North plant vent Rad monitor was determined to be inoperable for a period of time longer than allowed by Technical Specification.

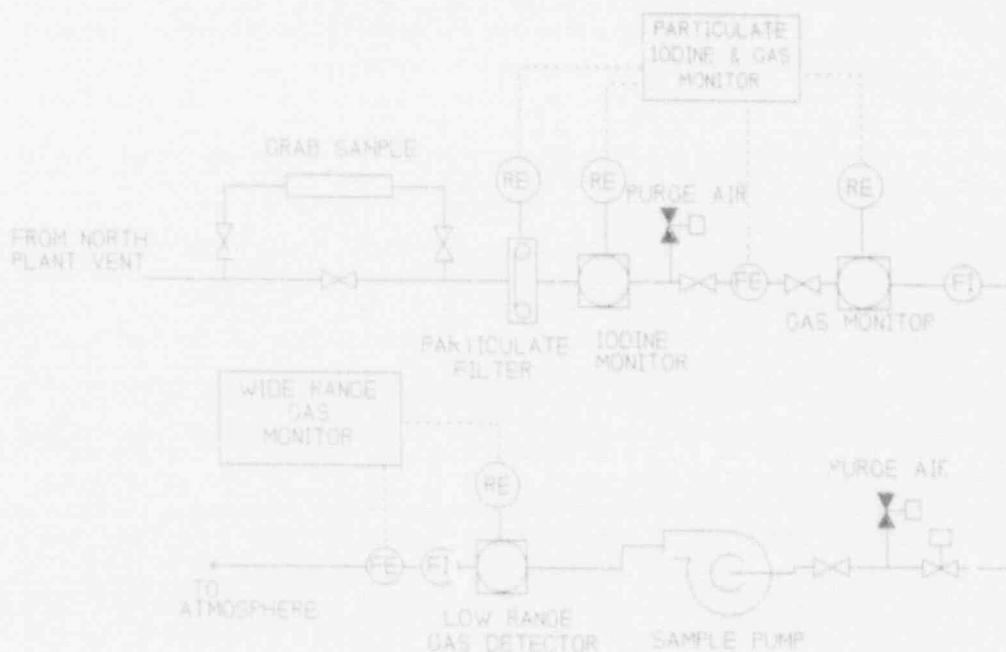
The North Plant Vent Radiation Monitoring Skid provides for continuous indication of NPV effluent as well as, sample collection and high range indication during accident conditions. The skid is comprised of two sections, a particulate, iodine and noble gas monitor section (PIG) and a wide range gas monitor section (WRGM). The wide range gas monitor is required to be operable at all times. The monitor provides the start signal for the medium and high range monitors for post accident monitoring requirements. The sample is routed from the north plant vent stack through the particulate, iodine and noble gas monitor, through the sample pump and through the wide range detector. Two independent flow elements monitor sample flow conditions at the PIG and WRGM. If a low flow is detected, only the radiation monitoring detectors associated with flow element sensing the low flow will indicate trouble. The radiation monitoring system processes all information through a computer network which provides indication of each rad monitors status. The system will indicate when a monitor is inoperable based on self test capability, sample flow rate monitors and power availability. When all measured parameters are in expected ranges, the computer will indicate a detector as being operable.

Initial operability determination was based on the computer indications that the WRGM was operating properly. Adequate sample flow was indicated at the WRGM and no obvious reason for the sample flow discrepancy between the WRGM and the PIG, other than a failed sensor, was readily apparent. Subsequent investigation performed on 10/23/92 revealed the sample pump was not operating properly, and the skid was again declared inoperable. The sample skid employs a diaphragm type vacuum pump to draw the sample gas through the skid. One of the two diaphragms on the sample pump had failed which allowed air to be drawn into the system thereby creating an insufficient adequate flow condition for the WRGM detector downstream of the pump. The diluted sample stream had the affect of increasing the WRGM alarm point by approximately 80%. The alarm response procedure for the PIG or WRGM low sample flow alarms does not identify the type of failure mode experienced during this event.

The review of the RMS skid operation also determined that the flow monitoring instruments may provide erroneous sample flow indication if a leak were to develop on the skid. As a major portion of the skid operates at negative pressure, room air will enter the sample stream if a leak were to develop on the system. Due to the location of the flow sensing elements it is possible for a diluted sample to go undetected by the sample flow rate monitors.

The root cause of this event is design deficiency. The location of the sample flow rate monitors does not ensure a valid sample is being monitored by the radiation detectors. The alarm response procedure not identifying system inleakage as a possible cause for low flow indications also contributed to this event.

1. The sample pump was repaired and returned to service.
2. Alarm response procedures for the RMS skid will be revised to declare the entire skid inoperable when either low flow alarm associated with the RMS skid annunciates.
3. Engineering will review the feasibility of relocating one of the flow elements to enable detection of system inleakage.
4. Engineering will evaluate the need to perform periodic leakage testing of the RMS skid.
5. This report satisfies the 14 day written report requirement of Technical Specification 3.3.7.5.
