UNITED STATES
 NUCLEAR REGULATORY COMMISSION
 REGION II
 101 MARIETTA STREET, N.W.
 ATLANTA, GEORGIA 30303

Report No.: 50-395/85-27

Facility Name: Summer

Inspection Conducted: May 14 - 16, 1985

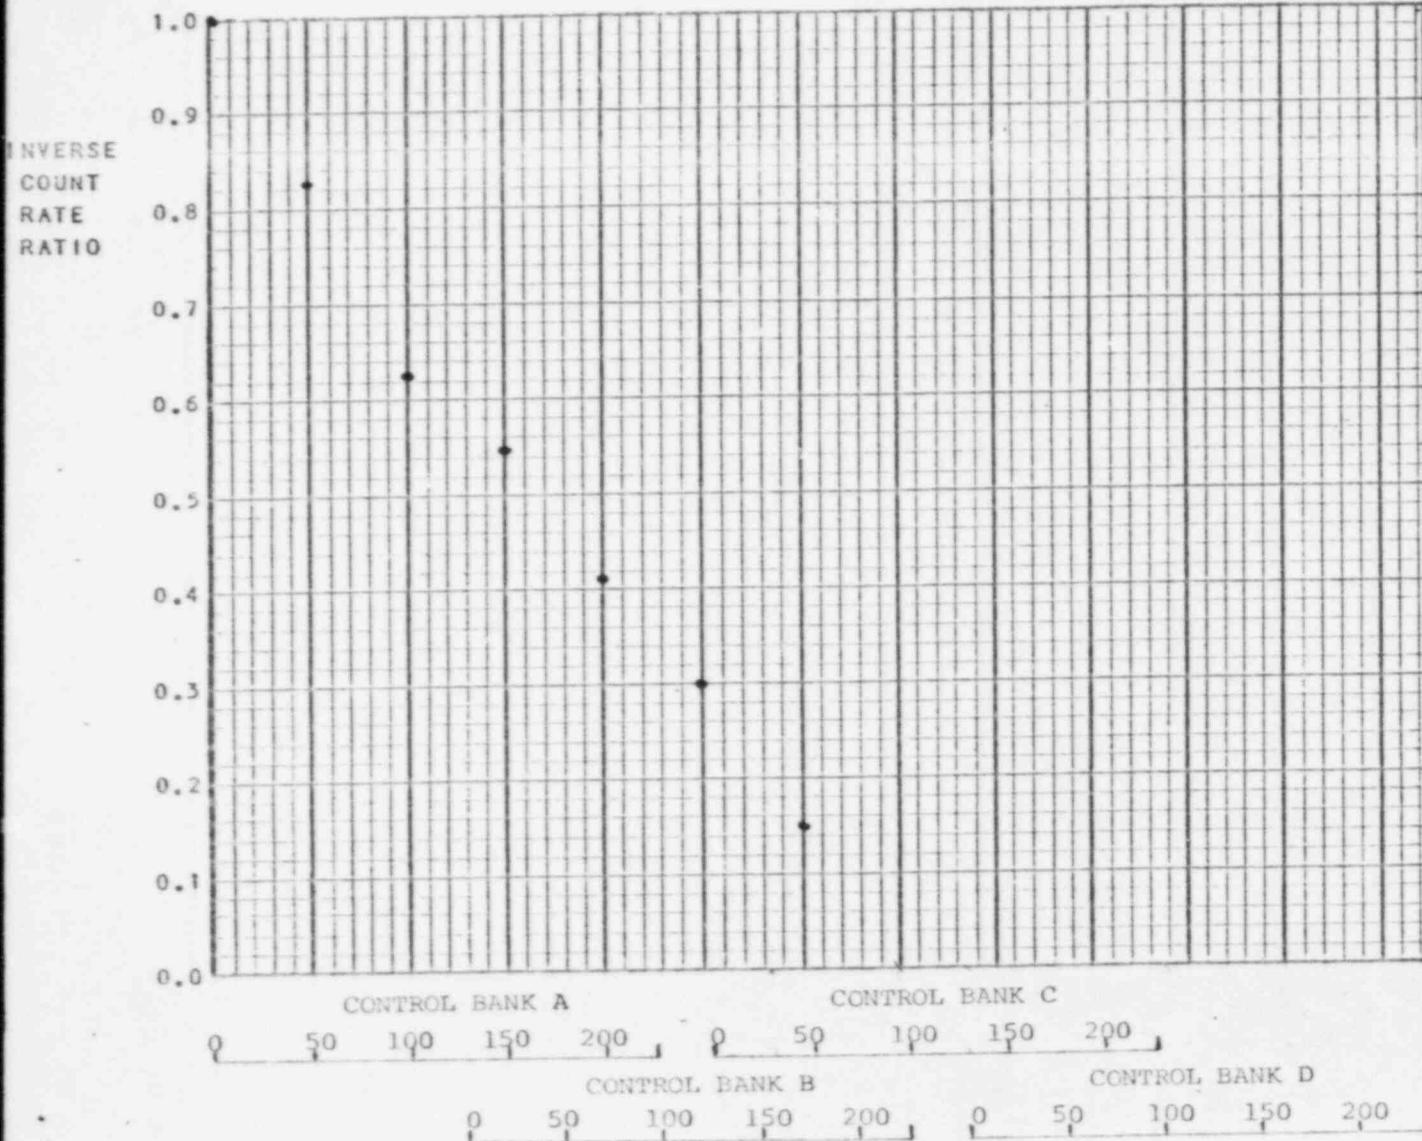
FIGURE 395/85-27-01
INVERSE COUNT RATE RATIO PLOT

Because the rods are operated in overlap, rod position was indicated along a double line rather than a single line (see figure 395/85-27-01). It is clear from the records, of which figure 395/85-27-01 is an annotated copy, that the STA did not properly extrapolate the plotted data to critical rod position. The procedure requires that for each extrapolation a line should pass through the last two plotted points to the horizontal, zero-value, axis. From that point a vertical line should have been drawn down to the predicted critical rod position. Instead the STA continued along the same slope of the line schematically representing rod position as if using a nomograph. Hence, the recorded predictions were neither consistent nor meaningful. Proper performance of the procedure should have prevented the event.

CALCULATED ECP
BANK D AT 65 STEPS

ACTUAL CRITICAL HEIGHT
BANK C AT 69 STEPS

* ACTUAL ICRR ECP IF THE PLOT IS CORRECTLY READ
