**ENRICO FERMI ATOMIC POWER PLANT
UNIT NO. 2
EVALUATION OF
CONTAINMENT COATINGS**

EVALUATION OF
CONTAINMENT COATINGS

REPORT NO. DECO-12-2191
REVISION 4

MULTIPLE DYNAMICS CORPORATION
29200 SOUTHFIELD, SUITE 103
SOUTHFIELD, MICHIGAN 48076
(313) 557-7766

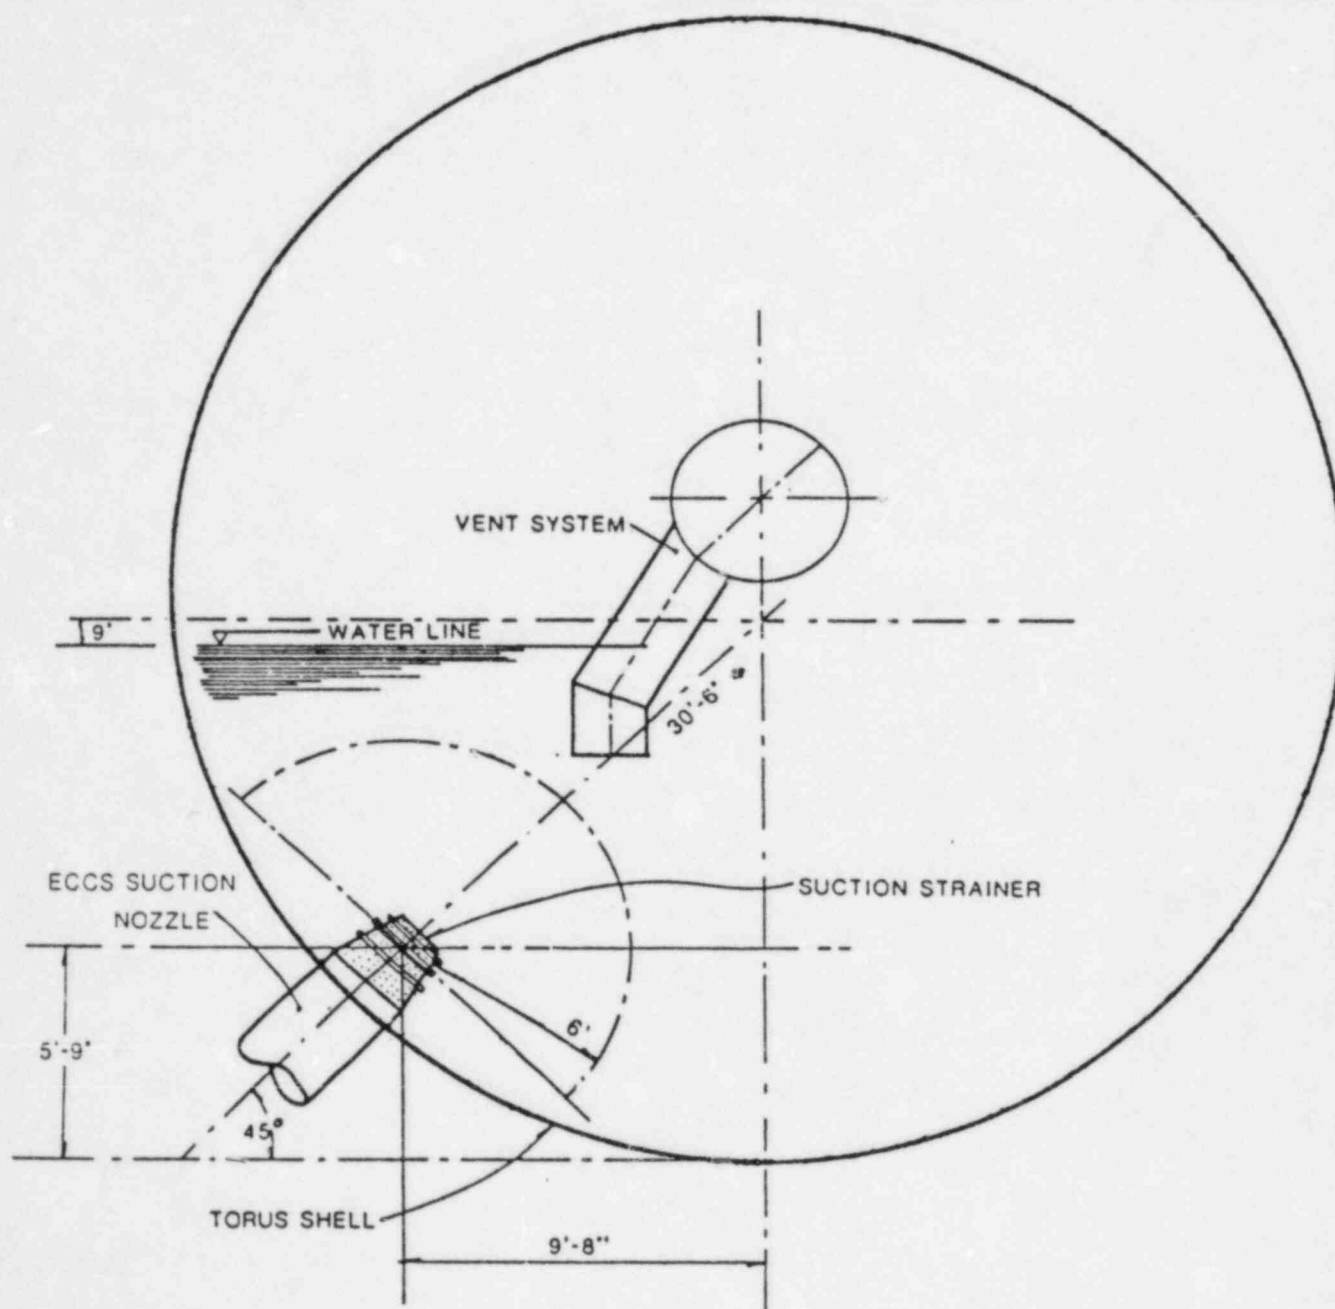
FIGURE 1

ECCS SUCTION STRAINER LOCATION
