RADIOLOGIC AND ENGINEERING ASSESSMENT

DOE ID NO.: GJ-13012-VL  
ADDRESS: 237 NORTH SPRUCE STREET

JUNE 1985

BENDIX FIELD ENGINEERING CORPORATION  
P.O. Box 1569  
Grand Junction, Colorado 81502

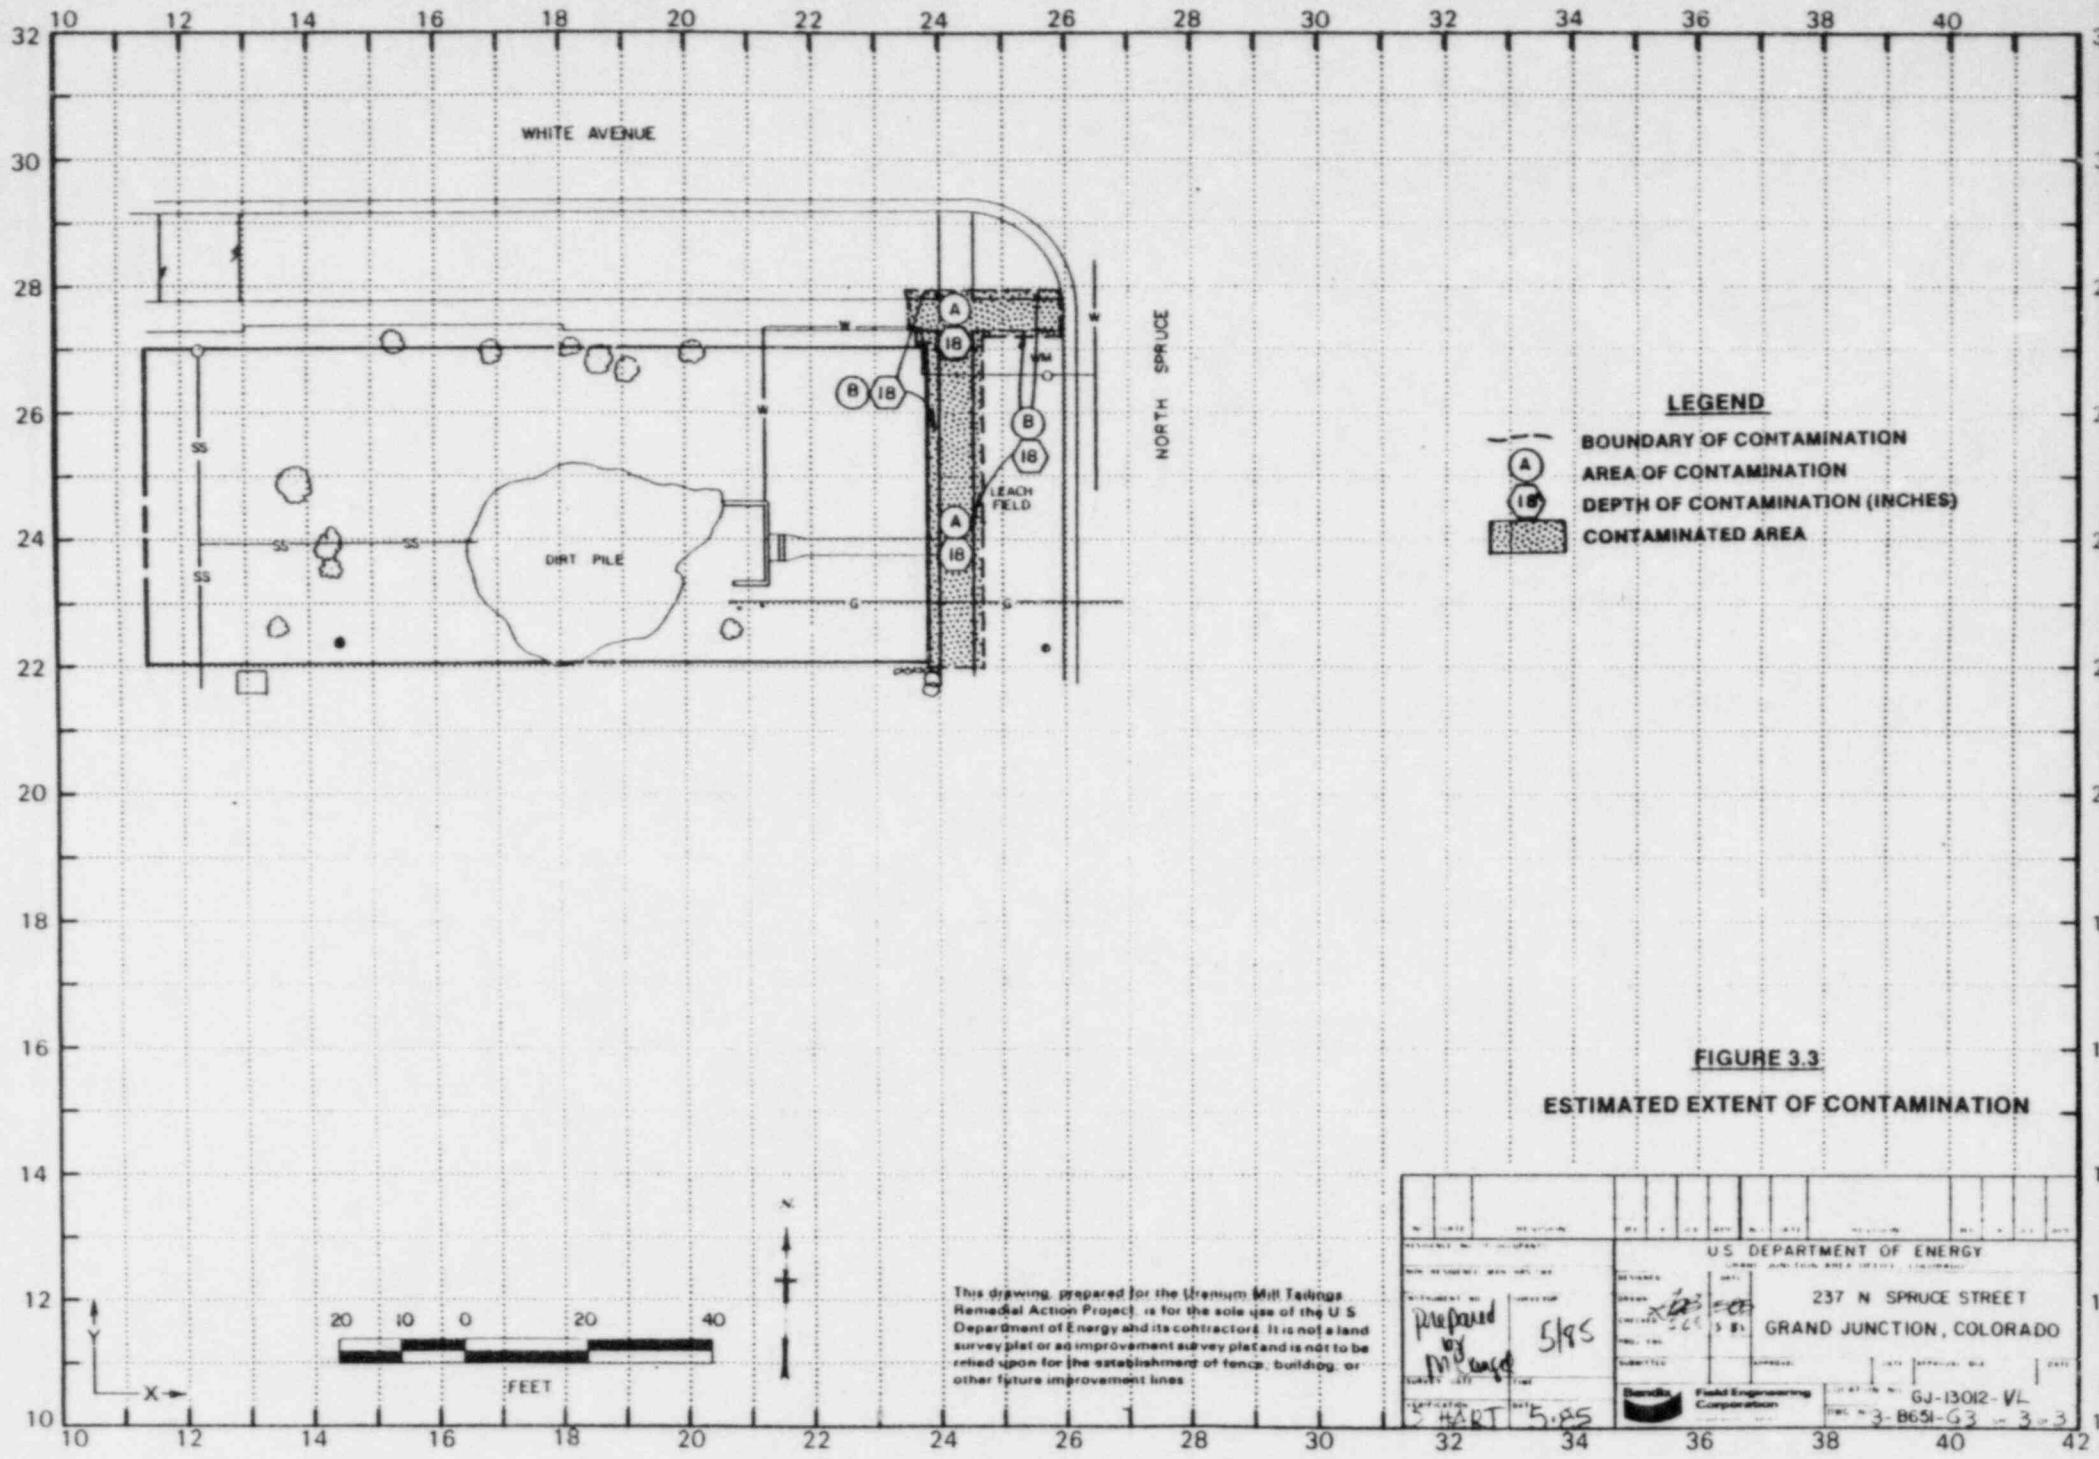
**FIGURE 3.3**

Appendix Figure 3.3 shows identified areas and estimated depths of contamination on this property, based on assessments of all measurement taken. As noted in this figure, areas recommended for

remedial action that contain identified residual radioactive materials are:

- (AREA A) Along North Spruce Street, under the 4-inch-thick sidewalk, there is contamination extending to a total depth of 18 inches (approximately 395 sf).
- (AREA B) On both sides of the contaminated sidewalk, contamination extends to a depth of 18 inches (approximately 345 sf).

The recommended remedial action for this property, DOE ID No. GJ-13012-VL, includes removal of all areas identified as containing radioactive material (as discussed in Section 3.4 and shown in Appendix Figure 3.3) and transport of removed material to the disposal site.

After remedial action is completed, the areas involved will be restored to original condition in accordance with the Bendix drawings, Vicinity Properties General Construction Specification (Bendix Field Engineering Corporation, 1984), and Statement of Work for Construction Subcontractor.

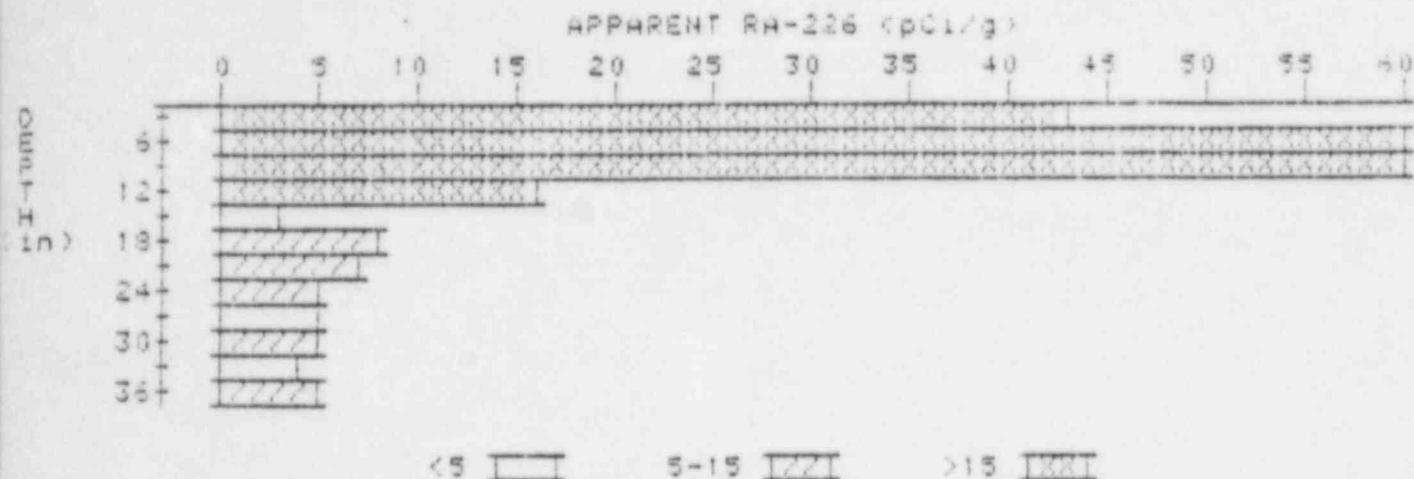
PROPERTY NUMBER: GU-13012-VL  
HOLE NUMBER: 7  
LOCATION: 244239

Two cores were drilled in the city sidewalk. Contamination seems to be from the fill beneath the sidewalk.

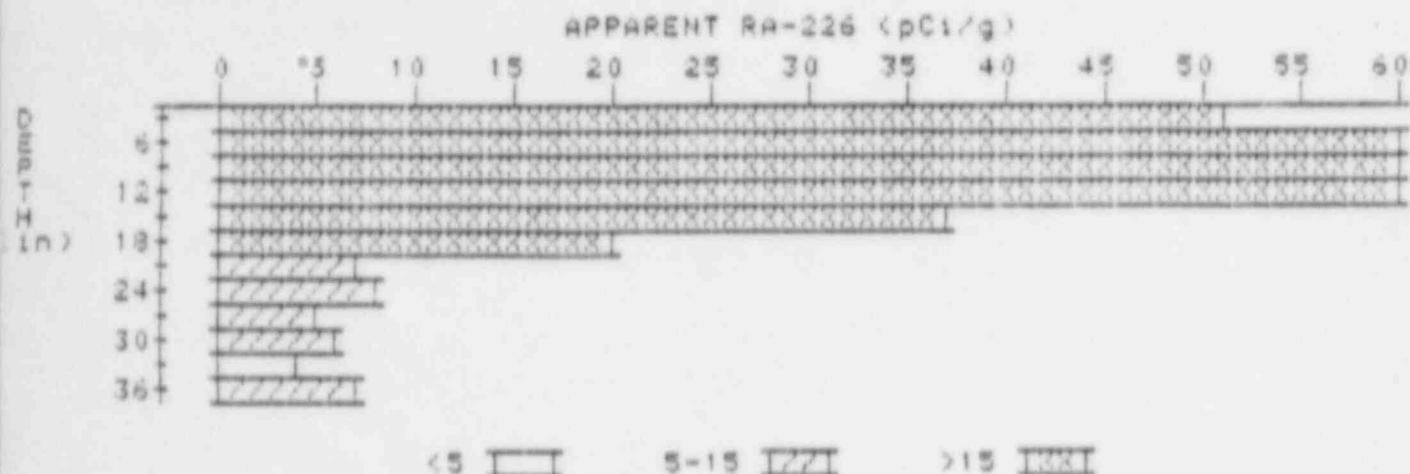
PROPERTY NUMBER: GJ-13012-VL  
 HOLE NUMBER: 10  
 LOCATION: 255276

Loc #	Grid Location	Depth (in.)	In Situ Ra-226			Comments
			Meas. Type	Tot. Ct	Chem Ra-226 (pCi/g)	
10	255276	00-04	SS			Concrete core
		04-10	SS			Moist
		03	TC	50.5	*	City sidewalk
		06	TC	90.1	*	
		09	TC	103.3	*	
		12	TC	89.7	*	DC = 18 inches
		15	TC	56.6	*	
		18	TC	34.3	*	Based on the
		21	TC	20.1	*	deconvolution graph
		24	TC	13.2	*	
		27	TC	9.3	*	
		30	TC	7.6	*	
		33	TC	6.8	*	
		36	TC	7.3	*
