Draft Radiological and Engineering Assessment

DURANGO PROPERTY

DU-076

March 13, 1985

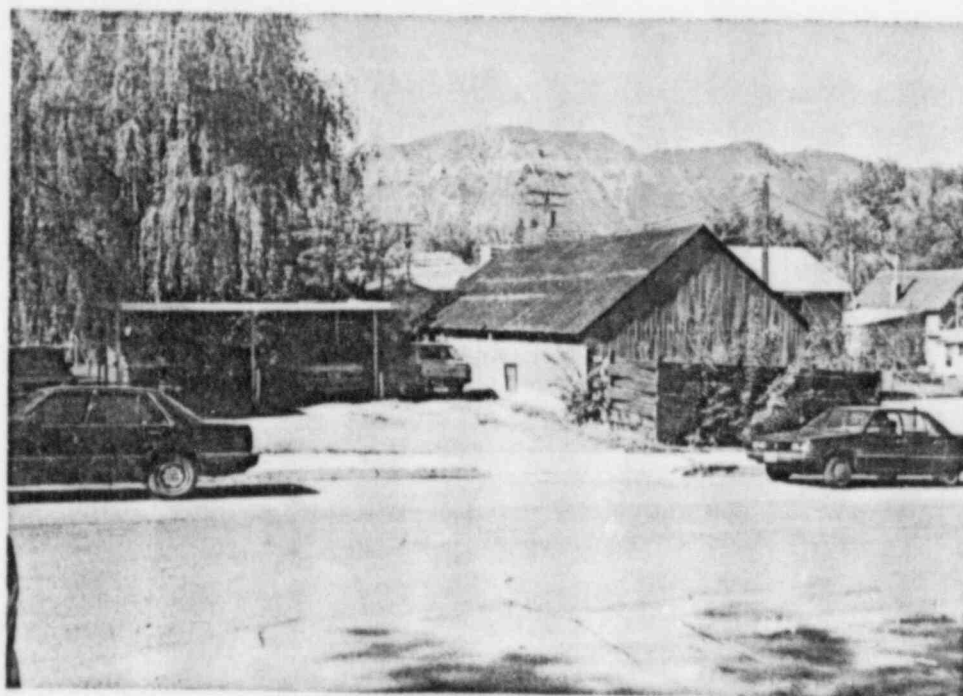
Fenced Storage Area Looking West

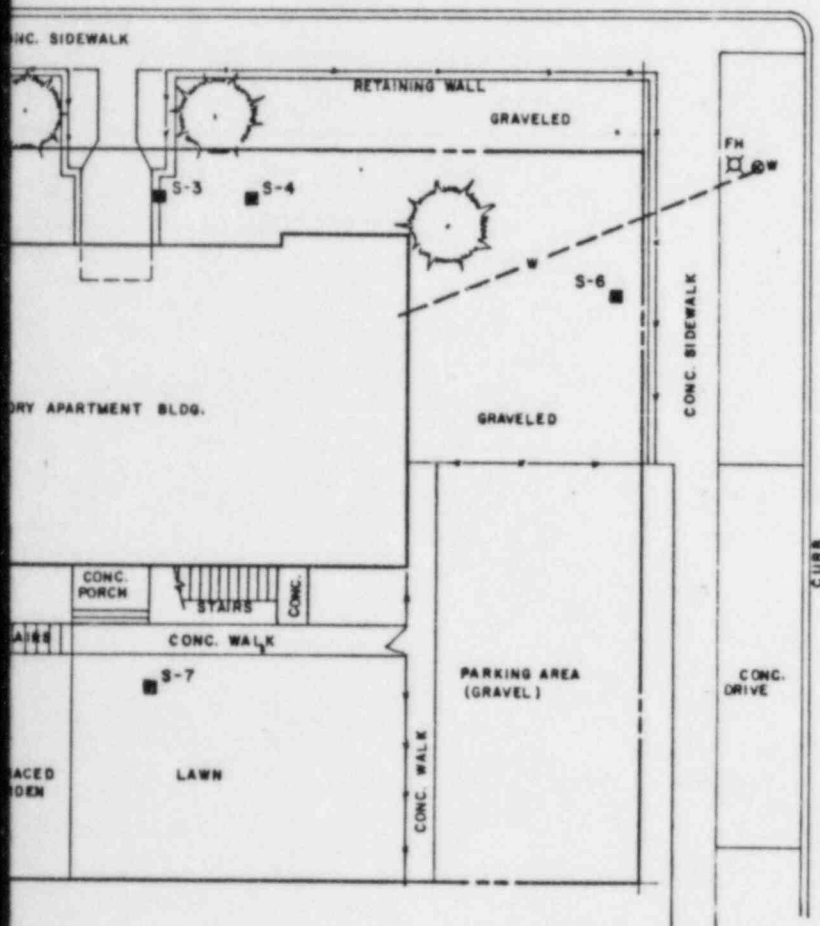
FIGURE 3.1

Contamination was found in 2 of the 4 outdoor holes augered. The location and depth of the contamination is described in Table 3.3 and is shown in Figure 3.1. Contamination was also found in one of the 7 shovel holes. Table 4 describes the location and depth of the contamination and of all shovel holes; these holes are shown in Figure 3.1.

One area of contamination was identified in the survey. Large rocks prevented drilling deeper than 18 inches; contamination is present at least to that depth.

HOLE	LOCATION	CONTAMINATION DEPTH
1	(0+85,10R)	None
2	(0+80,02R)	0-6"
3	(0+80,6R)	0-18"+
4	(0+82,25R)	None

HOLE	LOCATION	CONTAMINATION DEPTH
S-1	(0+76,05R)	0-6"
S-2	(0+40,40R)	None
S-3	(0+70,100R)	None
S-4	(0+70,110R)	None
S-5	(0+85,00R)	None
S-6	(0+60,148R)	None
S-7	(0+20,100R)	None

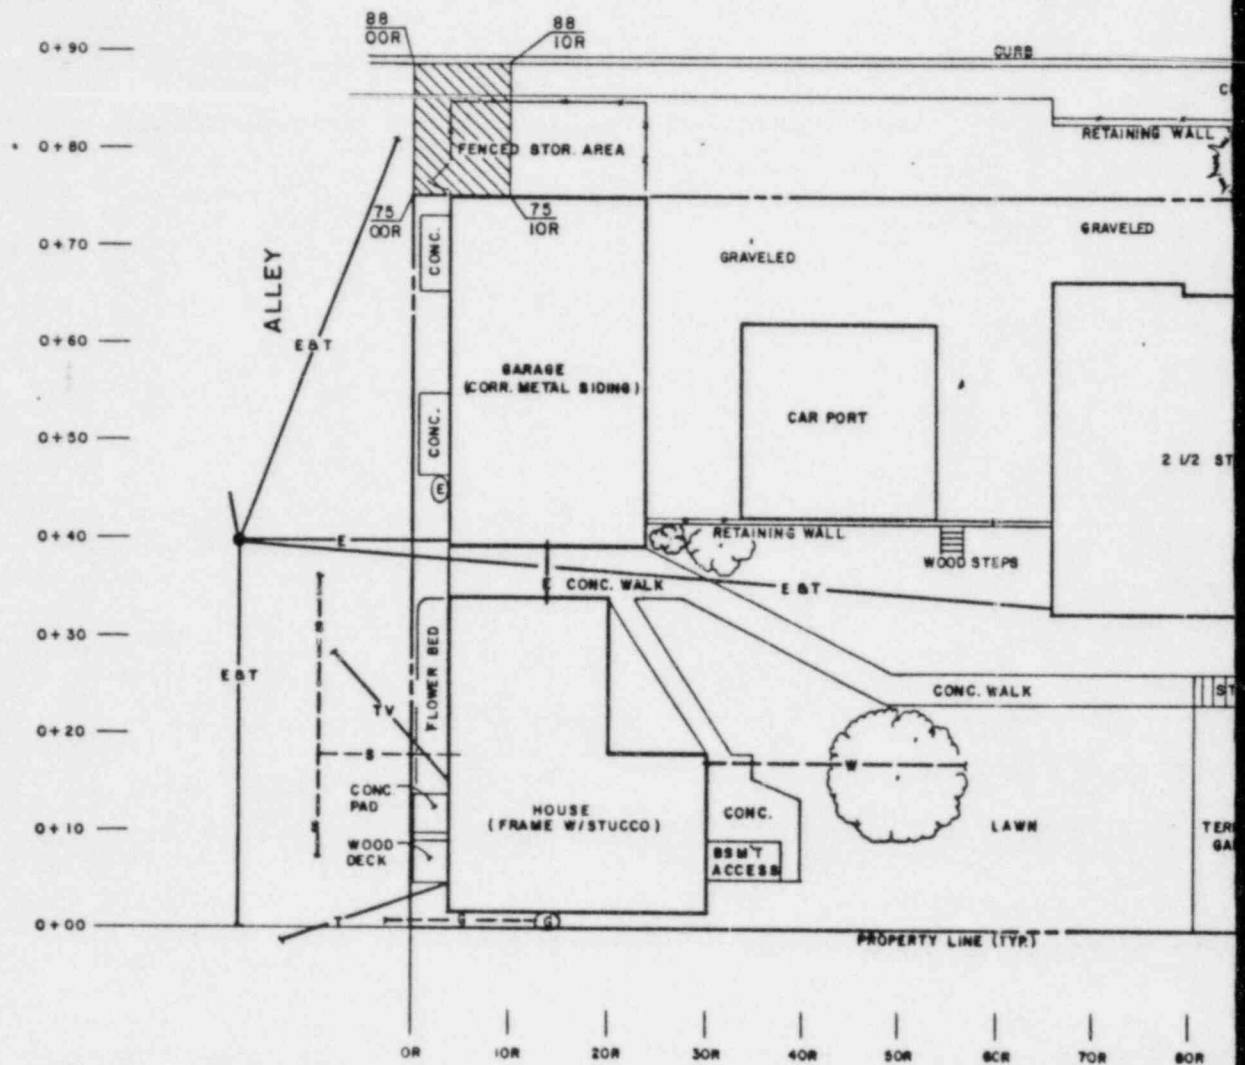
Contamination of this property is localized in the northwest corner of the property adjacent to the garage and is approximately eighteen to thirty inches in depth.

The remedial action for this property consists of the removal and salvage of the wooden fence, excavating the contaminated area to a depth of eighteen inches. Resurvey the area and excavate in six inch increments until the limits of contamination have been reached. Replace excavated material with clean backfill, reinstall wooden fence and clean up area.
