# **Draft Radiological and Engineering Assessment**

Vicinity Property No. DUR 202

THE RADIOLOGICAL AND ENGINEERING ASSESSMENT

DURANGO PROPERTY

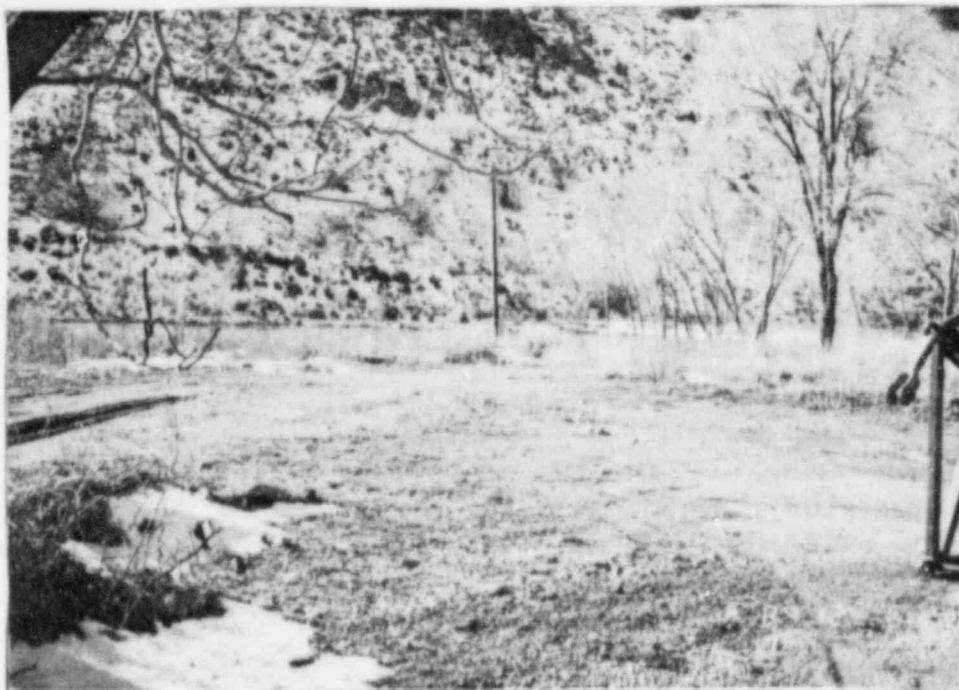
Park Area Looking Northwest

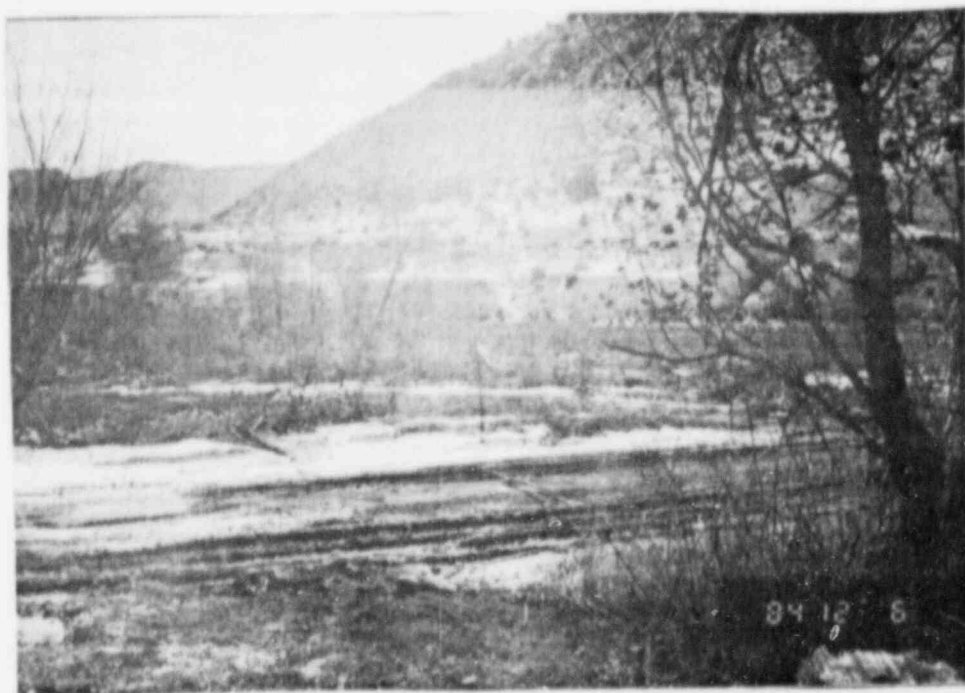
Park Area Looking West

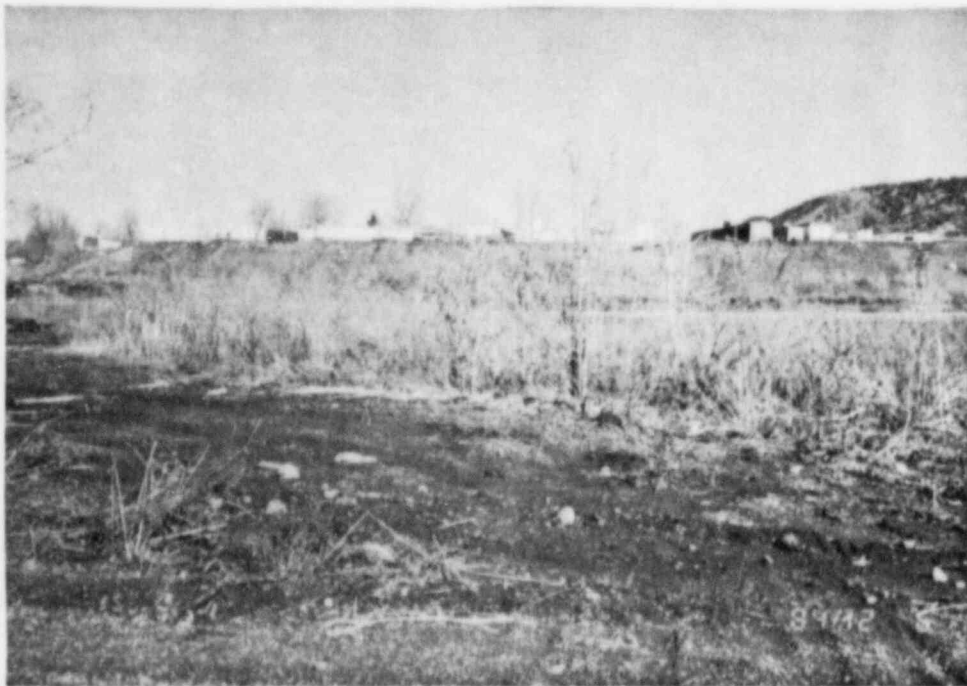
Park Area Looking East

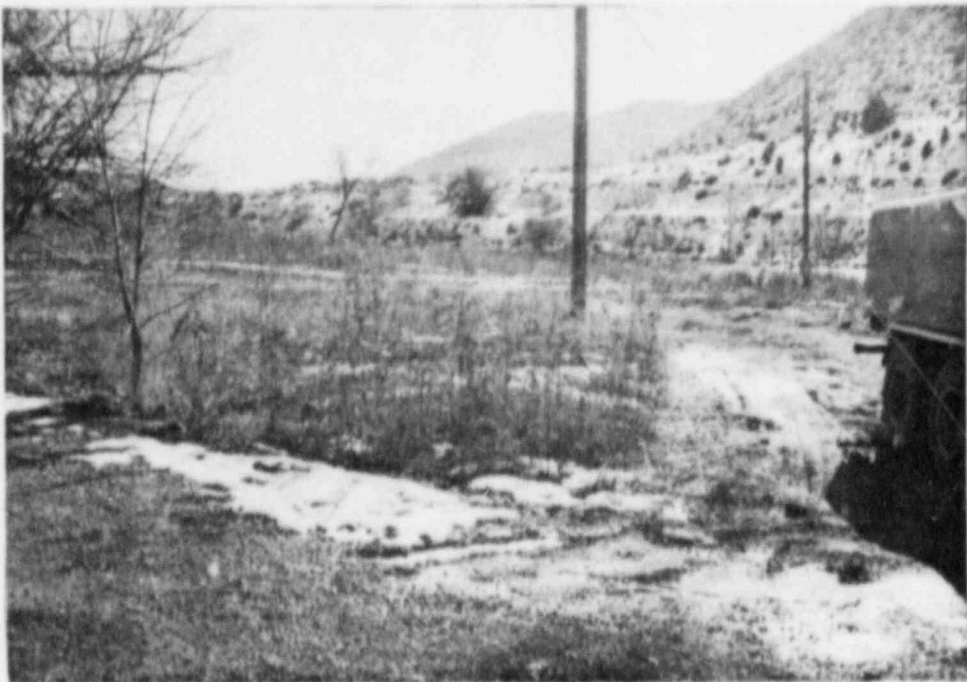
Park Area Looking South West

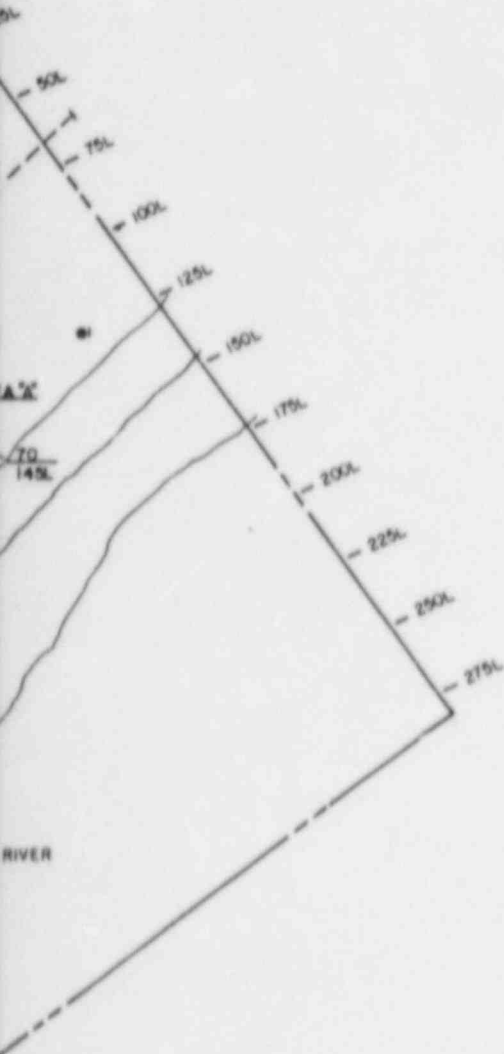
Surface gamma readings on the property, as shown in Figure 3.1, range from 15 to 35 micro R/hr. This may be compared with the background for the Durango site of about 12 micro R/hr.

Contamination was found in 9 of the 21 holes augered. The location and depth of the contamination is described in Table 3.1 and is shown in Figure 3.1.

Three distinct areas of contamination were identified in the survey. Area A has an estimated depth of contamination of 30 inches below the surface but it may be deeper closer to the river.

Area B has an estimated depth of 6 inches.

The largest of the three contaminated areas in the park region is Area C. The estimated depth of contamination in this Area is 12 inches, with possibly some pockets of contamination as deep as 24 inches.
