MILLSTONE NUCLEAR POWER STATION, UNIT NO. 3  
CONTAINMENT RECIRCULATION SPRAY (RSS)  
SYSTEM

TUBECO RADIOGRAPHY ISSUE

AUGUST 12, 1985

MILLSTONE UNIT NO. 3 CONTAINMENT RECIRCULATION  
SPRAY SYSTEM (RSS)  
REPORT

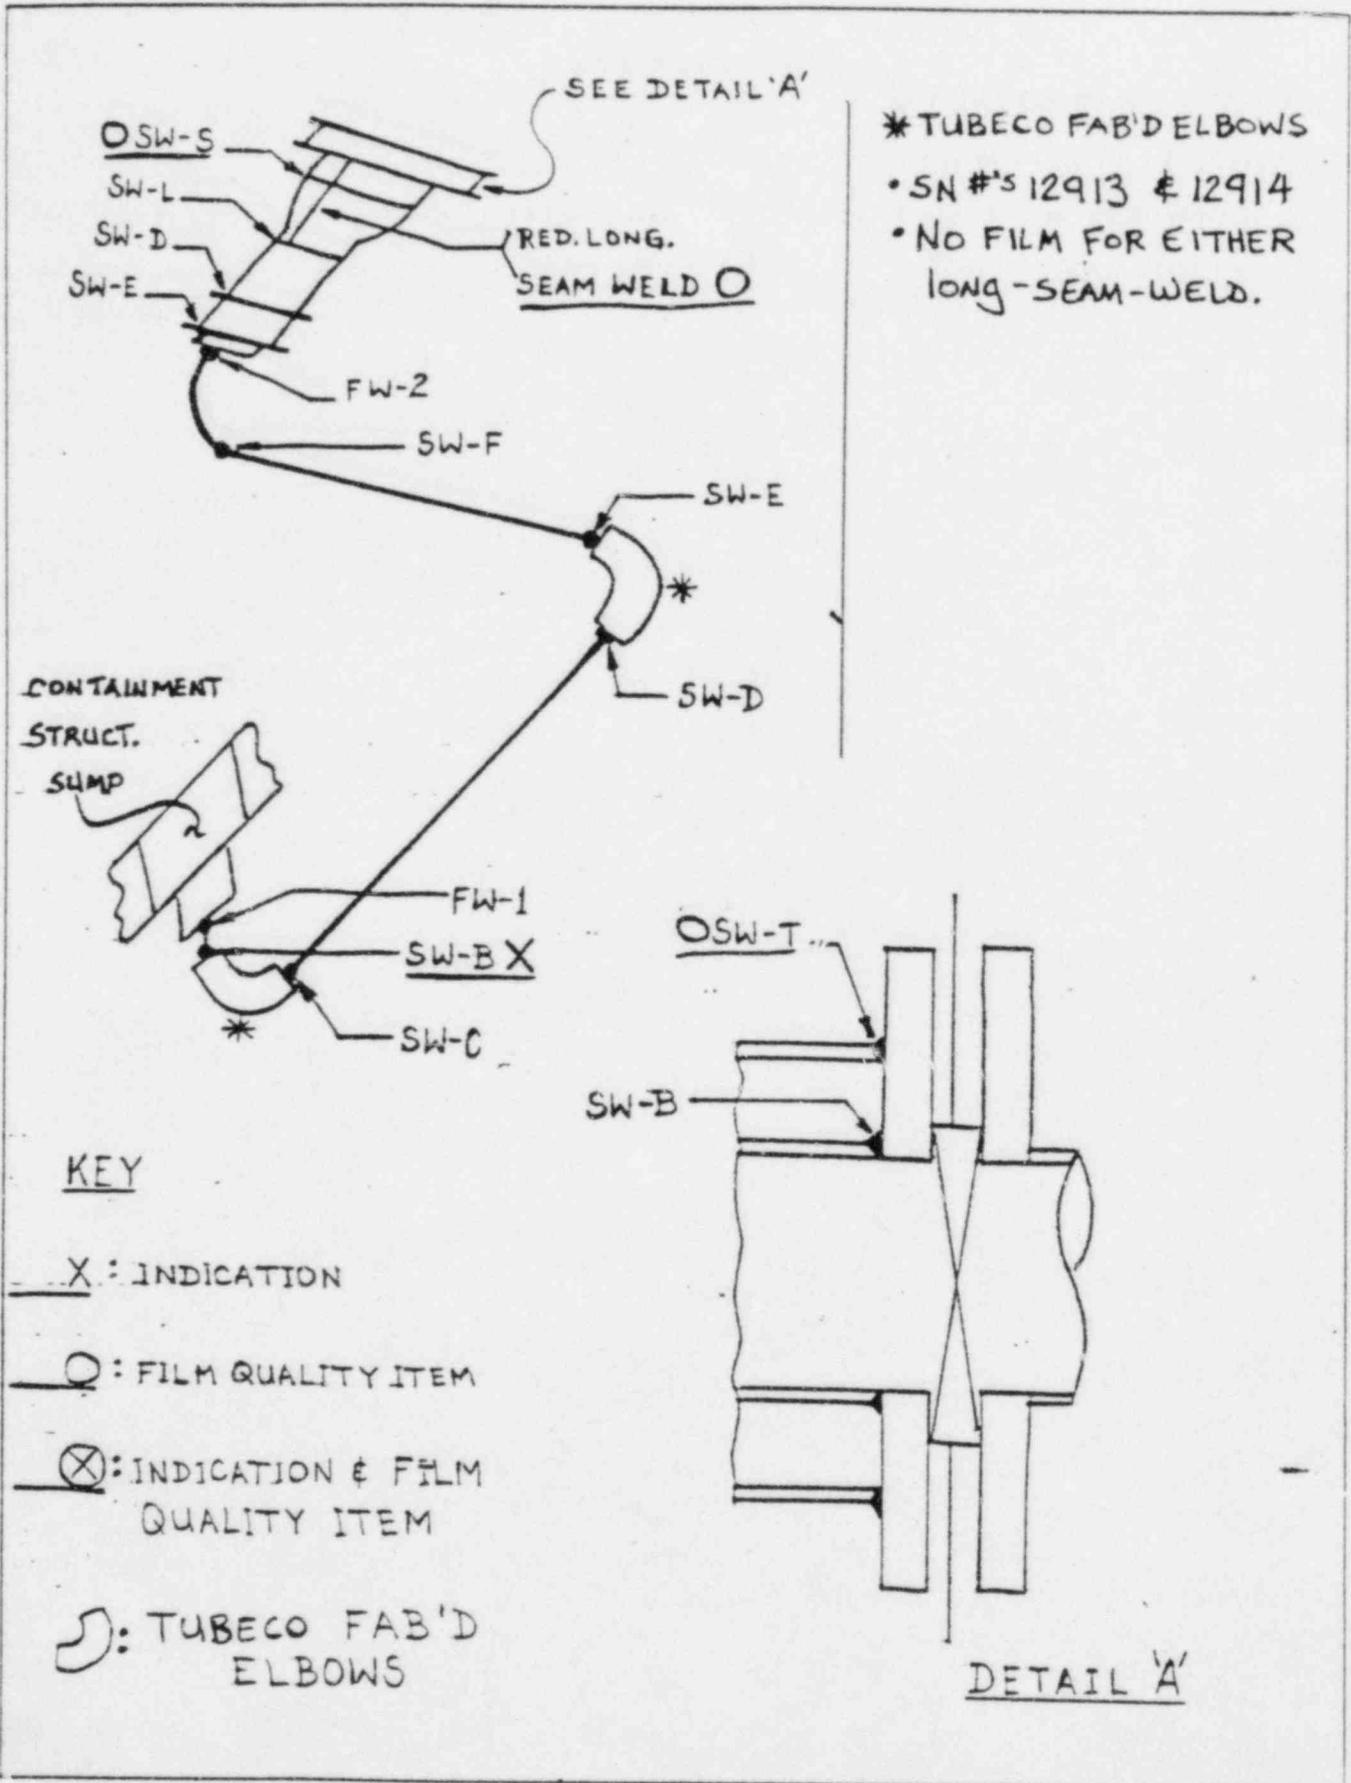
FIGURE 1

Visual examination was performed on SW-E, SW-D, SW-C, SW-B and the elbow long seams (S/N Nos. 12913 and 12914). No visible flaws were found in the areas inspected. The extrados long seam from SW-C to SW-B was partially obscured (approximately 10% of length) due to residual water and dirt film.

Weld radiograph SW-B had an indication at the intersect area of the circumferential weld to long seam. This was not detected on the pipe I.D. by visual examination. The remaining weld radiographs were acceptable; however, the radiographs of the long seam welds were misplaced and not available for review. Visual examination of these long seams revealed no apparent defects at the I.D. root area.

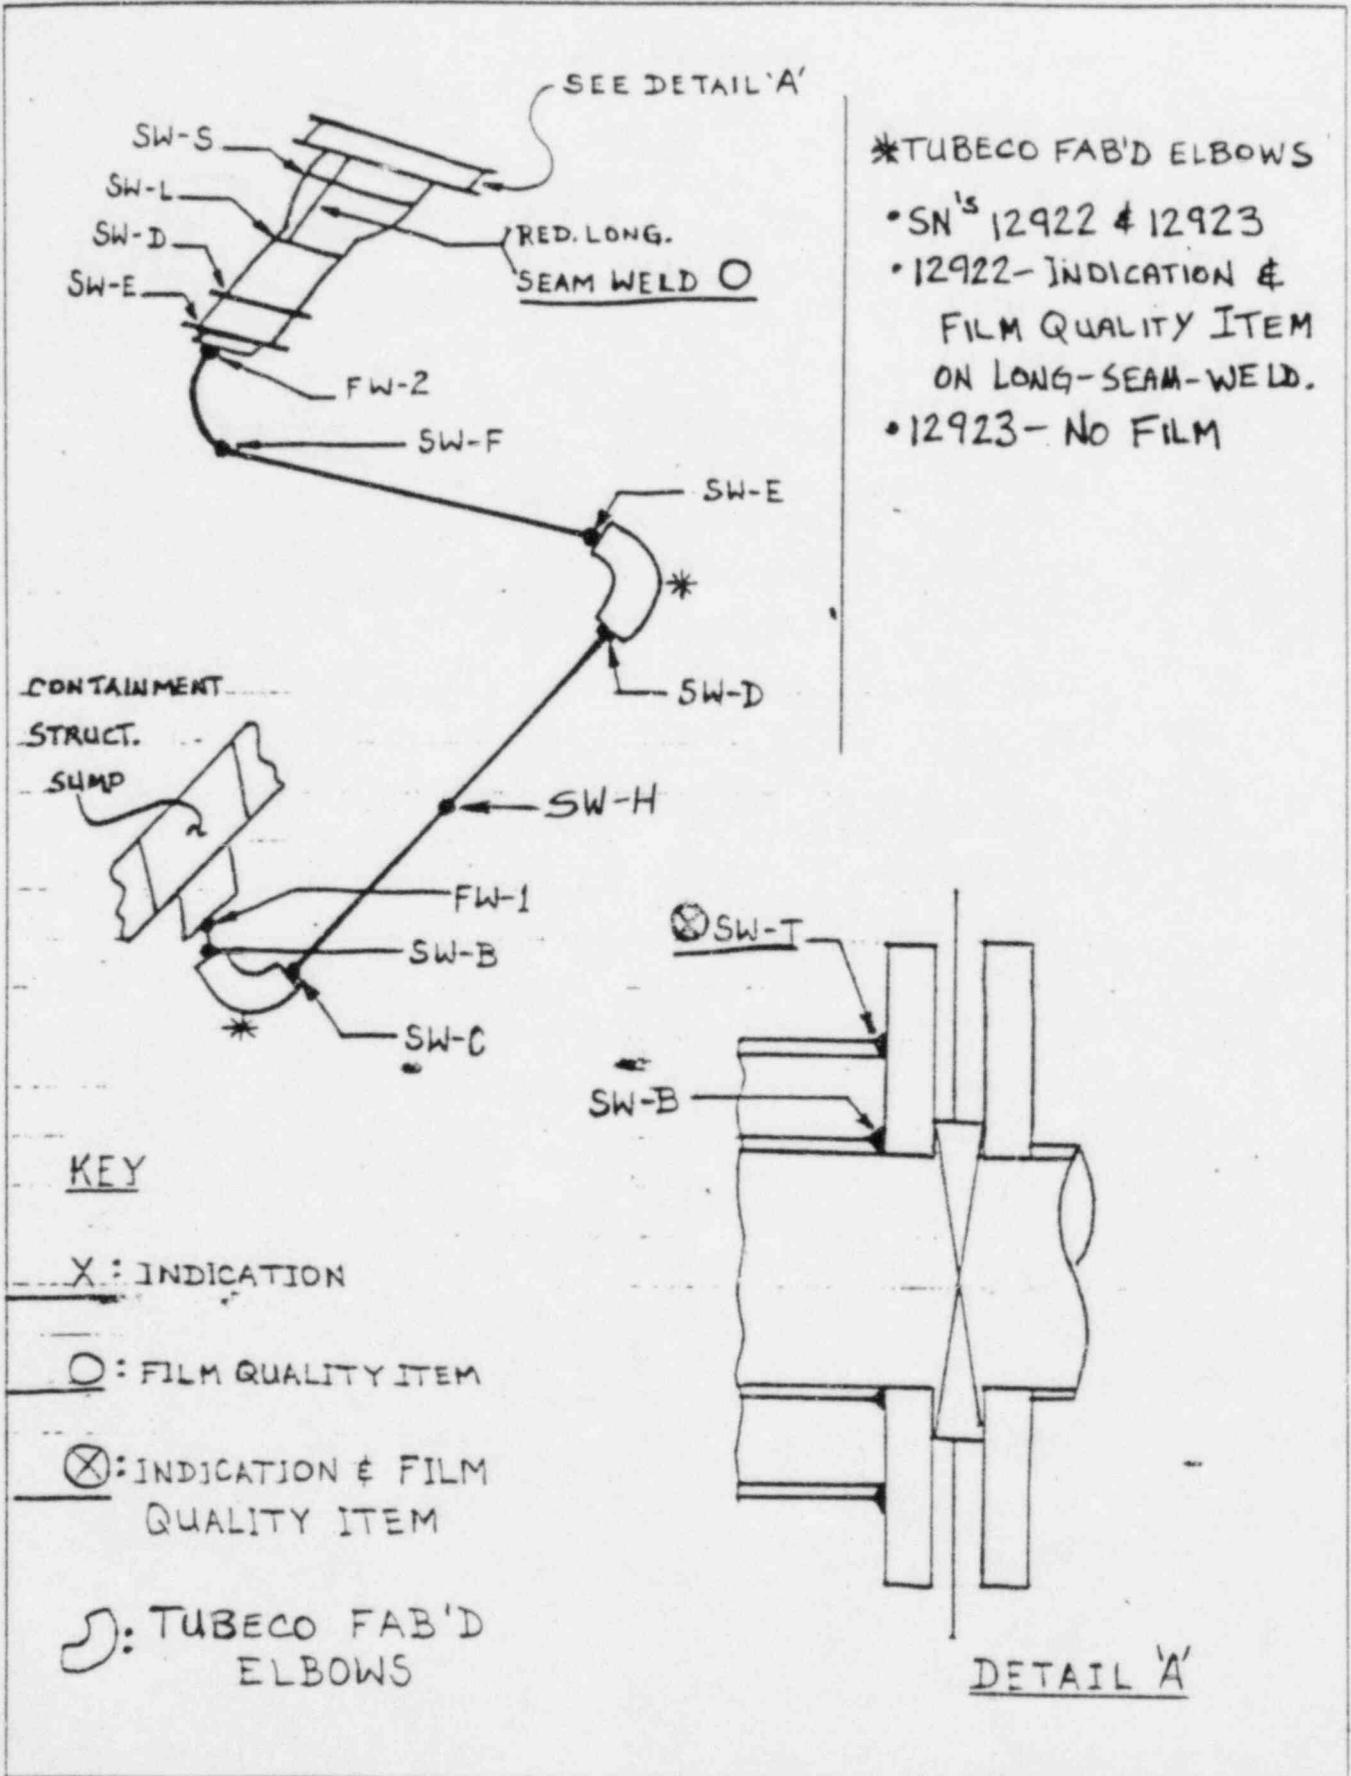
FIGURE 2

The radiograph review for this line identified no apparent defects. Film quality for radiographs taken of the elbow seams for elbow S/N 12922 were not acceptable to ASME standards. Radiographs of elbow seams S/N 12923 were misplaced and not reviewed. These radiographs were initially accepted.
