Edwin I. Hatch Nuclear Plant - Unit 1
Licensee Event Report
Incorrect Circuit Breaker Setting Results in
Emergency Diesel Generator Being Inoperable - Rev. 1

LICENSEE EVENT REPORT (LER)

Edwin I. Hatch Nuclear Plant - Unit 1

Incorrect Circuit Breaker Setting Results in Emergency Diesel Generator Being Inoperable - Rev. 1

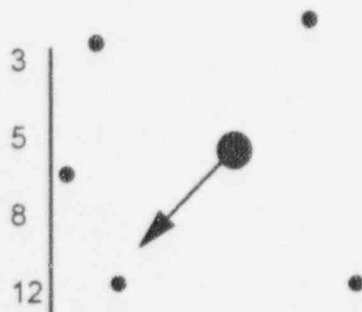
This event occurred as the result of a failure to incorporate information developed in a design calculation into the appropriate electrical single line drawing and plant maintenance procedure. A second error occurred due to a labeling problem which resulted in the installed trip device having a setting which differed even from the incorrect single line diagram.

In 1987, procedure 52PM-R24-002-0S, "Air Circuit Breaker Type LA-600 Maintenance" was developed to perform periodic maintenance on this breaker. The procedure writer appears to have relied on the erroneous technical information from the electrical single line diagram and listed the long time delay pickup as 300 amps and the instantaneous trip multiplier set at 12. In October 1988, the procedure was used to service the subject breaker and trip device. Per the maintenance work order, the breaker instantaneous trip setting was to have been set at 12. At this point, a labeling problem resulted in the individual who performed the work adjusting the setting to a multiplier of 8. The labels on the face of the trip device selector switch are misleading. An individual setting the trip device to point to the numeral 12 on the face of the selector switch would actually be setting it on a reference dot corresponding to 8x. Comparing Figure 1 with Figure 2 shows the labeling problem which led to the breaker trip device being set incorrectly.

Figure 1, Actual Appearance of Selector Switch Face

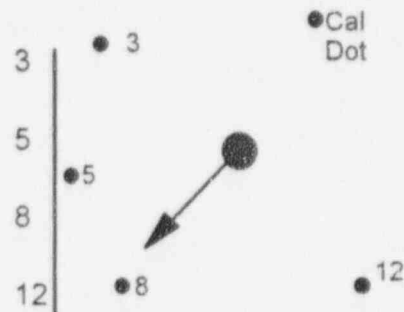
instantaneous trip on this trip device, described it "undesirable," and indicated that replacing the trip device with a different style was warranted. Based on this information, it now appears reasonable to conjecture that some work activity between 1985 and early 1987 changed the type of trip device which was installed to one which incorporated an instantaneous trip. No such change was authorized, nor was it documented. Thus as mentioned above, the design calculation was revised in May 1987 to accommodate the installed breaker and set it up to work in this MCC. However, settings for the new design were not correctly incorporated into the electrical single line diagram in that the long time delay pickup should have been 450 amps but was left at 300 amps on the electrical single line. The instantaneous trip was to have been set at 12 times the value of the long time delay pickup, termed "12x". The multiplier of 12 was correct in both the design calculation and the electrical single line.

Figure 2, Selector Switch with Numbers Added to Show What Each Dot Represents
