Subject: Arkansas Nuclear One - Units 1 and 2
Docket Nos. 50-313 and 50-368
License Nos. DPR-51 and NPF-6
Response To Inspection Report
50-313/96-06; 50-368/96-06

NOTICE OF VIOLATION

Response to Notice Of Violation 313/9606-01

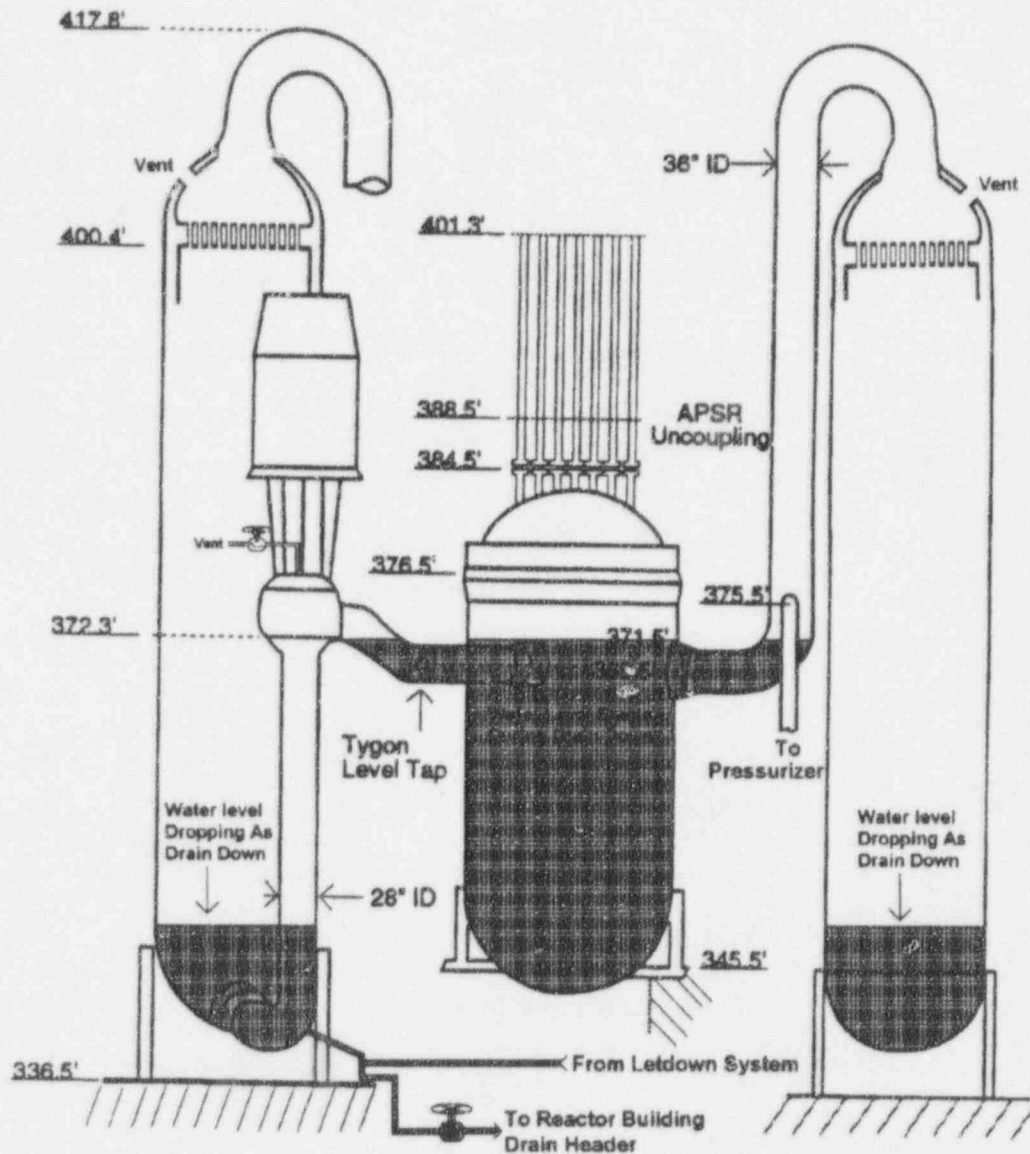
Drawing 1

Following a hot spot flush of the letdown coolers on September 18, 1996 Unit 1 operations personnel were draining the letdown line in preparation for a local leak rate test. During this evolution, Unit 1 was in reduced inventory with Reactor Coolant System (RCS) level steady at 371.5 feet and about 80% complete with the draining of the RCS cold legs. The core side of the RCS was no longer hydraulically coupled to the cold legs and, therefore, no longer hydraulically coupled to the reactor building drain header. The same drain was being used to remove water from the primary side of the Once Through Steam Generator (OTSG) and to remove water used in performing the previous hot spot flush of the letdown coolers. (See attached drawing 1)

Drain down in progress; water level stable in reactor core; cold leg level going down; cold leg drain water and letdown system flush water going to reactor building drain header.

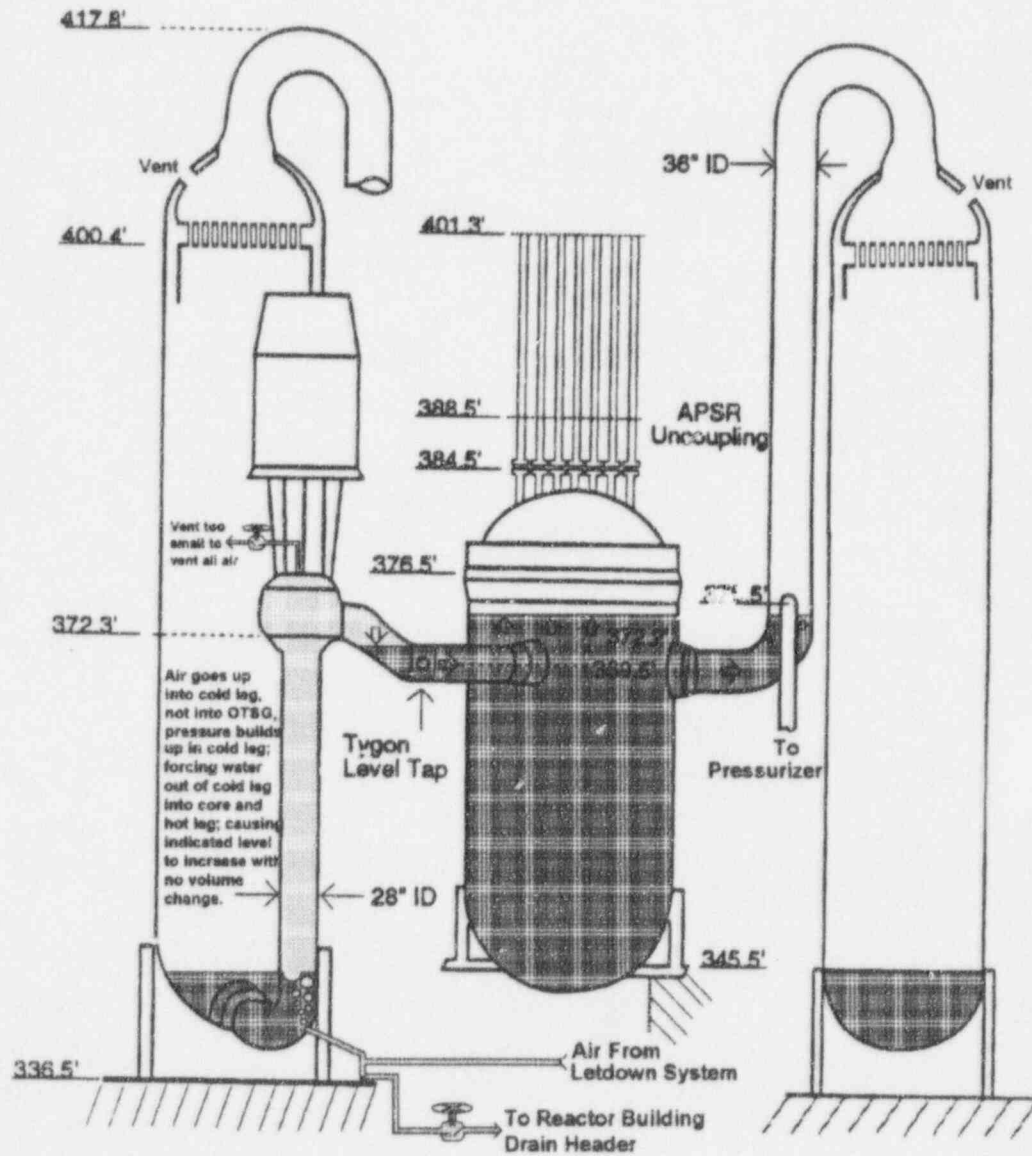
Drawing 2

In order to ensure complete venting and draining of the letdown penetration, pressurized service air was used as a motive force. During the evolution, control room operators observed an unexpected RCS level increase of approximately 0.7 feet. When the operations personnel draining the letdown line became aware of the RCS level increase, they immediately secured service air and informed the control room. The RCS level rise stopped when the service air was secured and quickly returned to its previous value. The elapsed time from the start of the RCS level rise to RCS level stable at its previous value of 371.5 feet was approximately ten minutes.

Air introduced into the cold leg from the letdown line collected in the air volume between the top of the water level and the Reactor Coolant Pump (RCP) seal. Water in the cold leg between the RCP and the reactor vessel acted as a seal between the RCP and the head vents. This allowed for venting of the introduced air to occur only from the RCP seal vent. The volume of air that this vent path could pass was insufficient in comparison to the amount of air being introduced into the system; therefore, the buildup of air pressure below the RCP seal vent displaced a small amount of water from the cold leg into the reactor vessel. This displaced water caused the reactor vessel level indication to increase approximately 0.7 feet. (See attached drawing 2)

The cause of this event was that an adequate assessment of the vent capabilities of the RCS cold legs in association with the high volumes of service air being introduced into the RCS via the letdown system was not performed. Additionally, the lack of a procedure for draining systems connected to the RCS contributed to this event.

Drain down in progress; air assisted draining of letdown system in progress; air goes into cold leg RCP area; RCP seal vent can not vent all the air, and pressure builds up in this area; water level rises in reactor core to 372.2'.

Service air was secured immediately upon identification of it as the cause of the RCS level increase.

A procedure for draining systems that are or may be interconnected to the RCS will be developed by February 28, 1998.
