Arizona Nuclear Power Project

Subject: Final Report - DER 85-23
A 50.55(e) Evaluation Relating To Diesel Generator
Start Failure Due To Mechanical Valve Failure
File: 85-019-026; D.4.33.2

FINAL REPORT - DER 85-23
DEFICIENCY EVALUATION 50.55(e)
ARIZONA NUCLEAR POWER PROJECT (ANPP)
PVNGS UNITS 1, 2, 3

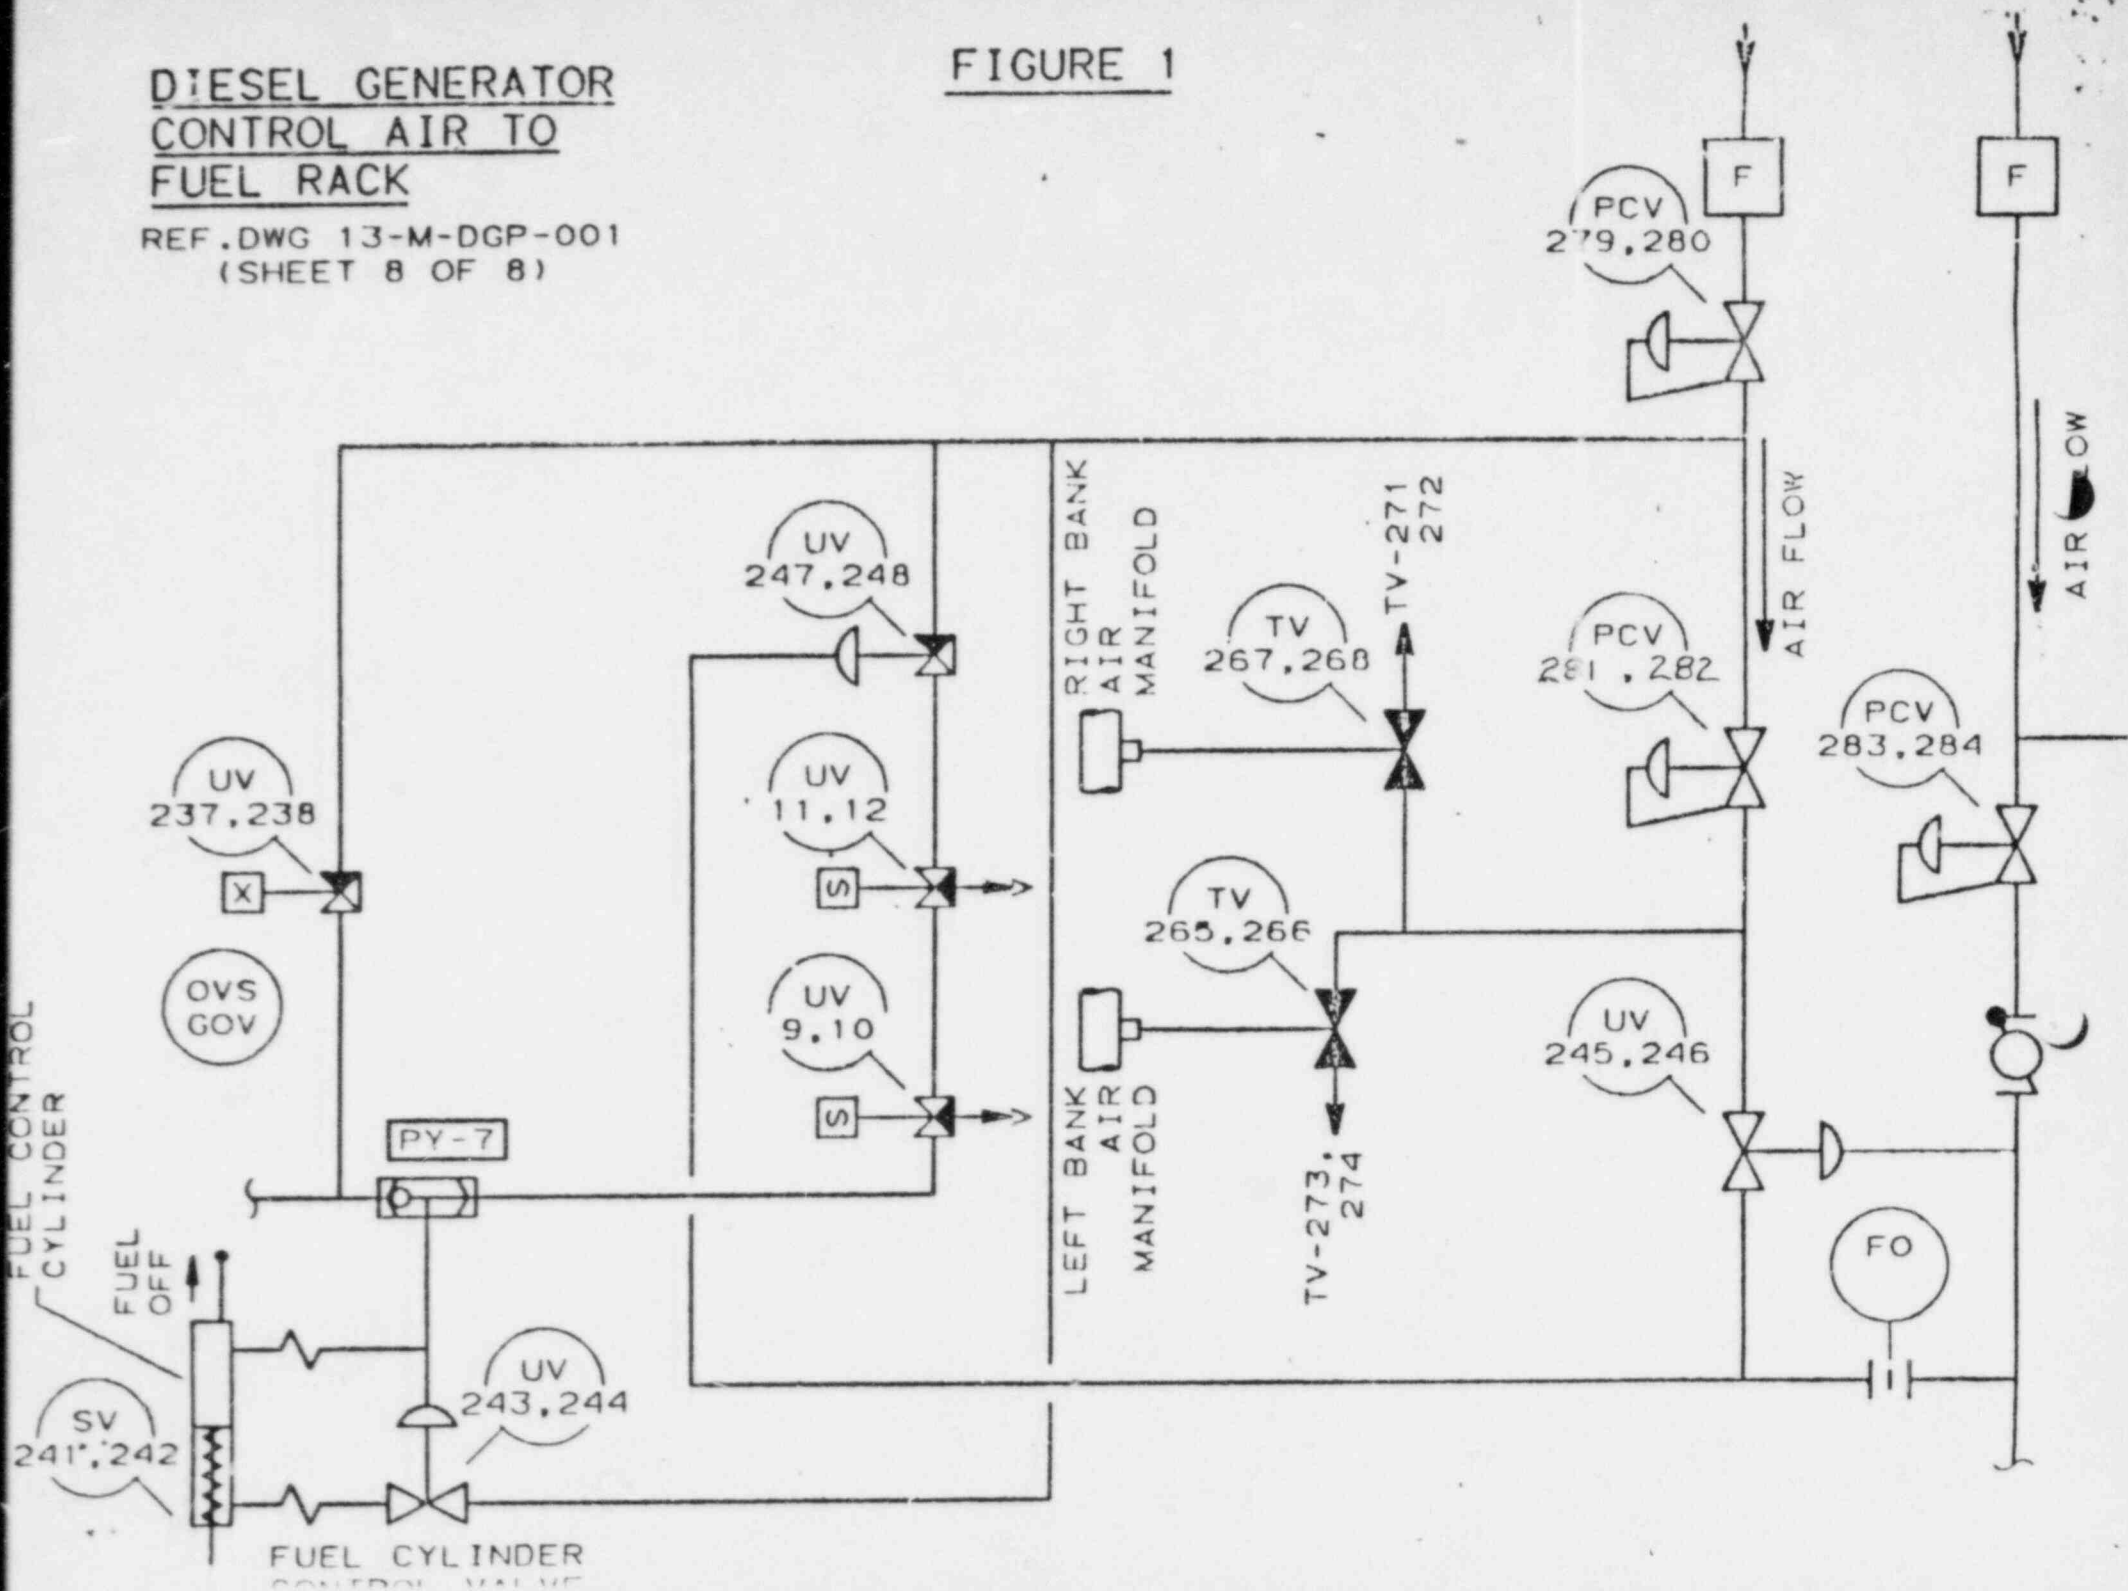
FIGURE 1

Air to the temperature control valves is taken off the control air system header. (See attached sketch, Figure 1.) The valves bleed air, thus reducing air pressure in the control air header. When a diesel start signal (test mode) is initiated, reduced air pressure in the air header is not sufficient to fully actuate the pneumatic valve that vents air from the fuel cylinder control valve pneumatic actuator and the fuel control cylinder (UV-248 and SV-242, respectively, Figure 1). Air is not vented from the "OFF" side and admitted to the "ON" side of the fuel control cylinder fast enough to enable the diesel generator to start in 10 seconds.

The installed valves are the valve port overlap type which bleed continuously. This was determined by dismantling and inspecting the valve internals. Valve port overlap valves have two grooves in the spool as did the PVNGS valves (Reference 1). The root cause of the failure of the temperature control valves to operate properly is that the valves now installed do not have the correct internals. Per Cooper Energy Services letter, Reference 2, the proper valves for the system are center dead spot valves which do not bleed air during actuation. These valves perform a non-safety-related function and are designated, and were procured, as a non-"Q" component.

Replace the existing valves TV-265, TV-266, TV-267, and TV-268 with center dead spot valves Amot Corporation model number 4021C11C7. The work will be performed under Work Request number 108529 for Unit 1, Work Request number 108530 for Unit 2, and a subsequently issued DCP for Unit 3. Work is expected to be completed prior to fuel load for Units 2 and 3 and during the first outage for Unit 1.
