UNITED STATES OF AMERICA  
NUCLEAR REGULATORY COMMISSION

Briefing on Davis Besse

Docket No. 50-346

Location: Washington, D. C.  
Date: Wednesday, July 24, 1985

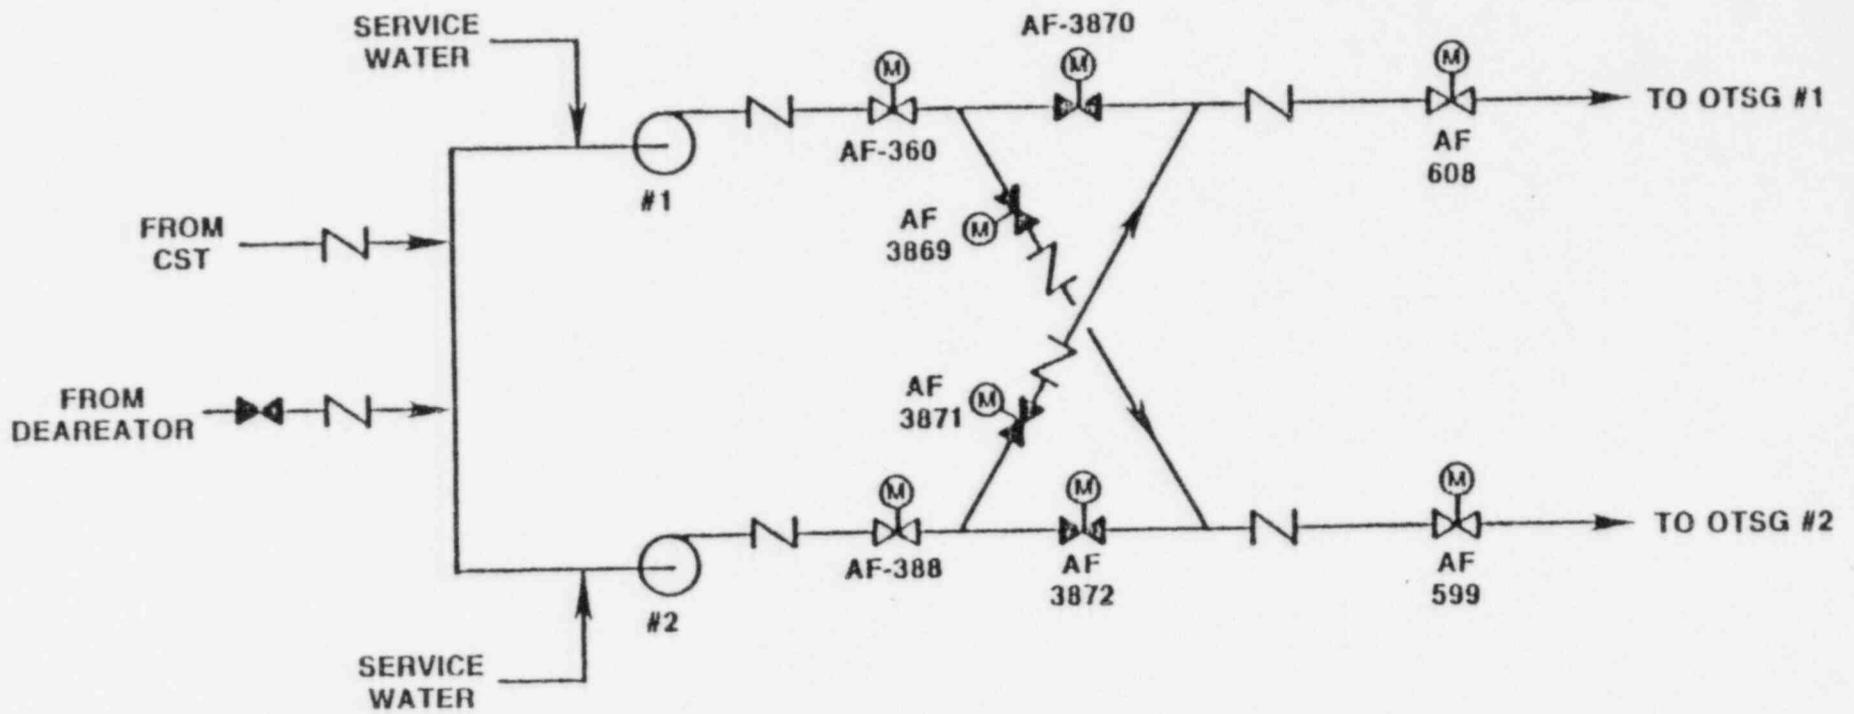
Figure 4.4 Auxillary Feedwater System

21           However, the auxiliary feedwater valves failed to  
22 reopen. These are the valves that are shown in the next  
23 Vu-graph. Why don't you put that next Vu-graph up.

15 Before we left the site, Toledo Edison had done  
16 testing of the valves with differential pressure across them,  
17 and they had been able to reproduce the failures with that  
18 differential pressure across the valves. They reproduced the  
19 failures that occurred on June 9th when you had the  
20 differential pressure, and when you didn't have the  
21 differential pressure, the valves worked.

22 So that one, they have probably found the root  
23 cause.

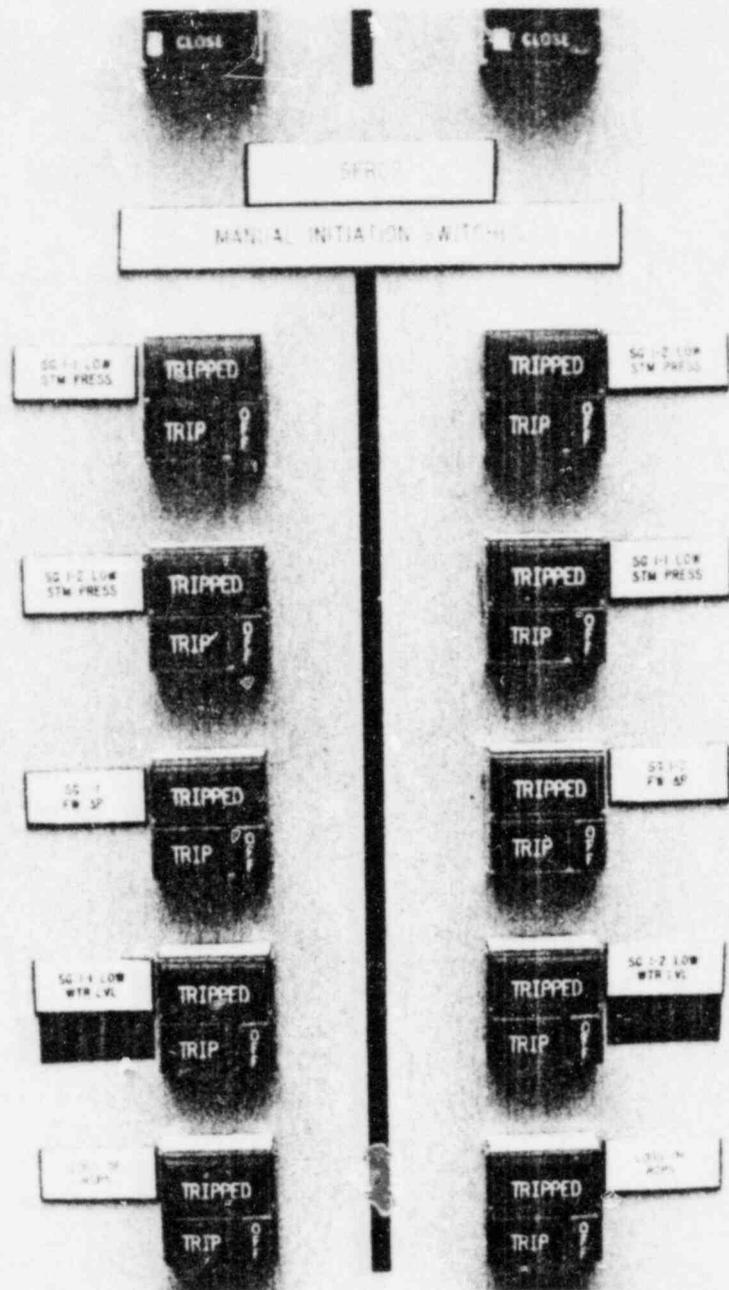
Figure 3.6 Manual Initiation Switches for SFRCS

12 This Vu-graph shows the steam and feedwater rupture  
13 control system switches that the operator used. The low  
14 pressure actuation switches which were actually initiated are  
15 the two top buttons. It's the top one in each column. These  
16 switches are not frequently used. The correct buttons that  
17 the operator should have initiated are four buttons down on  
18 each column, so he should have initiated the fourth button  
19 down on each of the two columns.

20 Had low pressure actuation actually been the  
21 intended operator action, because of what is considered to be  
22 a human factors deficiency in the layout of these buttons,  
23 actuated the steam and feedwater rupture control system on low  
24 pressure would have required pushing the buttons on a  
25 diagonal.

1           For example, the operator would have had to push the  
2 first button in one column and the second button down in  
3 another column in order to correctly actuate it on low steam  
4 line pressure. Again, what he actually did was he pushed the  
5 top two, which was in error, which basically indicated to the  
6 system that both steam generators had a steam line rupture and  
7 it shut off the auxiliary feed to the two steam generators.

5 MR. ROSSI: Our report and our evaluation did look  
6 at some of the human factors considerations coming out of the  
7 event. There is, of course, the question of the operator  
8 pushing the wrong steam feedwater rupture control system  
9 buttons early on in the transient, and that has to do  
10 primarily with the arrangement of the buttons, which I already  
11 discussed, the poor labeling of the buttons.

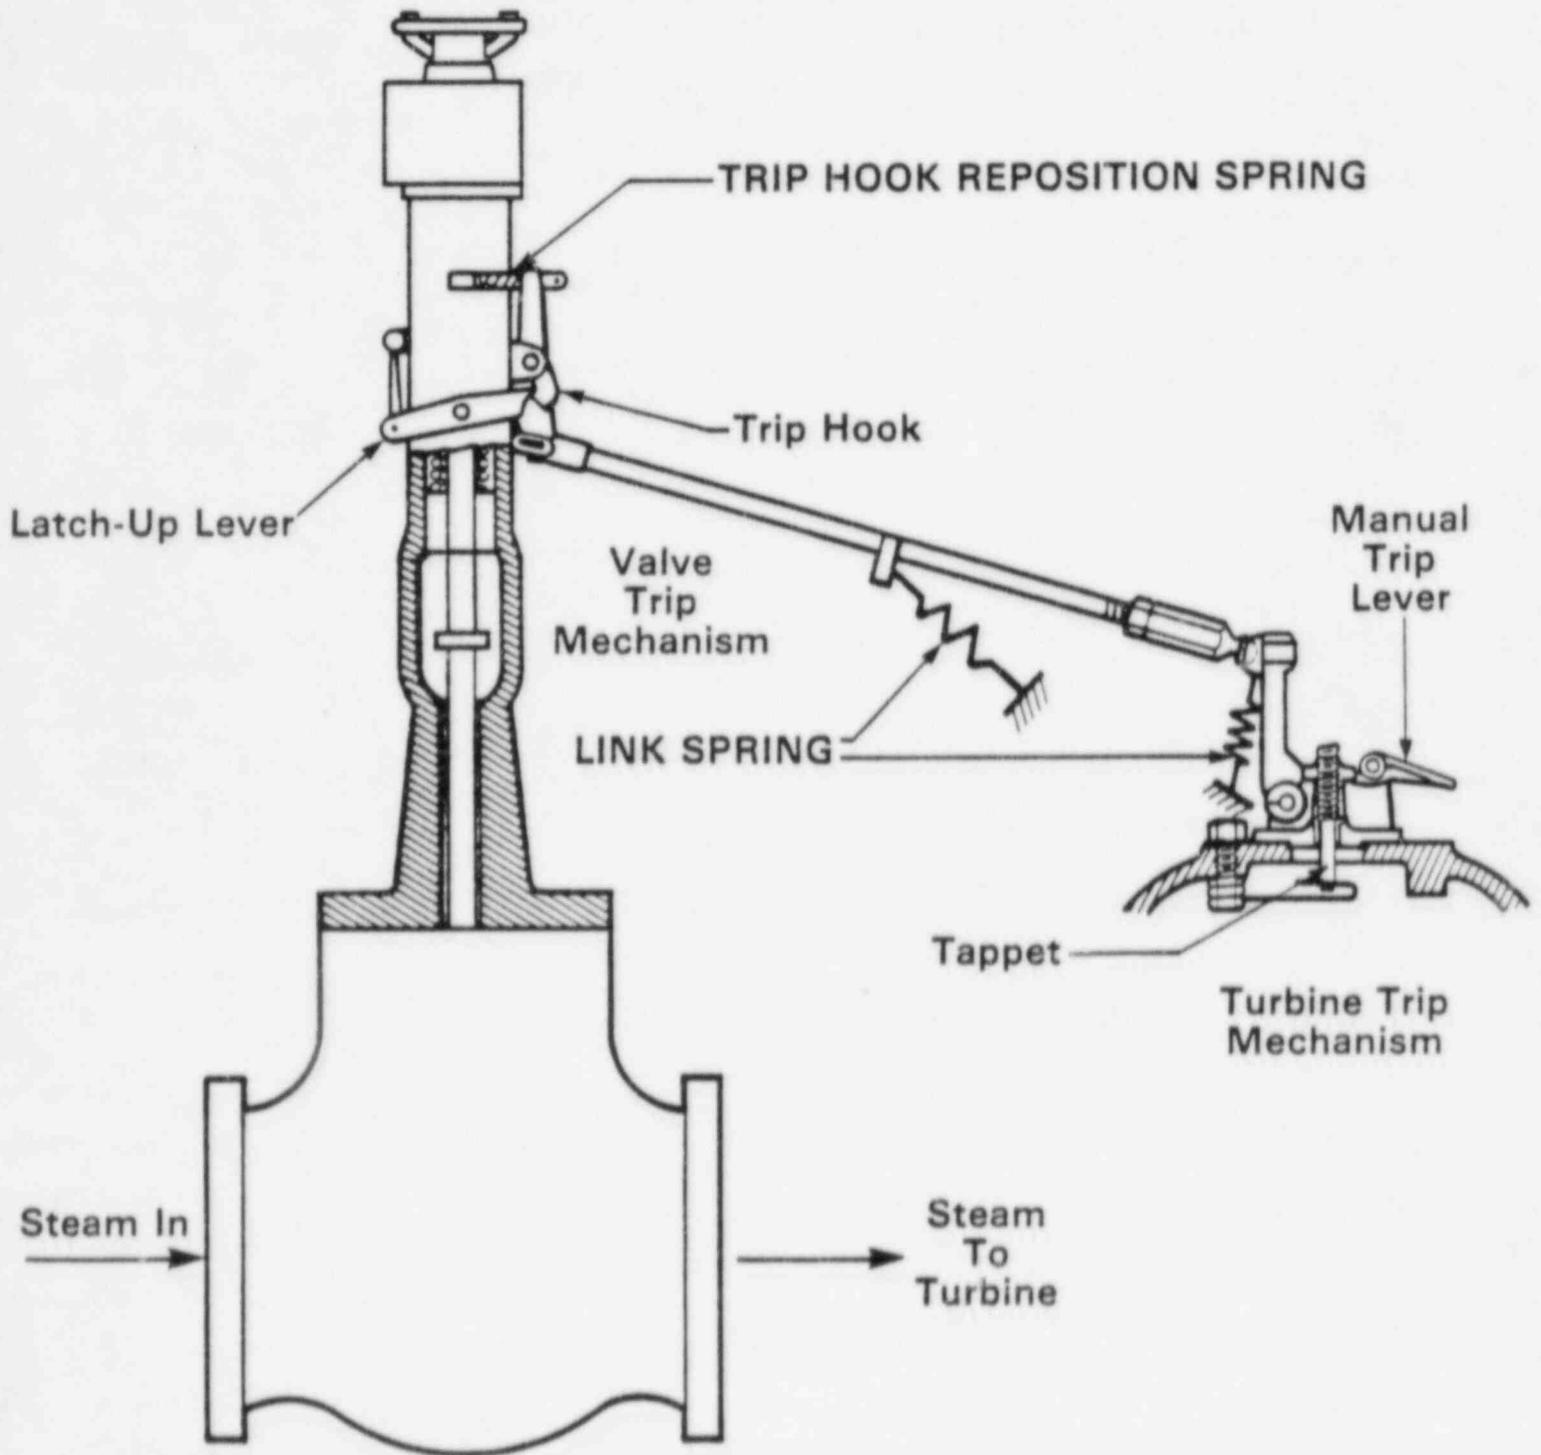
Figure 5.1 AFPT Trip-Throttle Valve

16           And Toledo Edison's hypothesis of the cause of the  
17 tripping of the turbines is that when the steam came through  
18 these lines that were not used very often, the lines were cold  
19 and condensate was formed and they got slugs of hot condensate  
20 going through the pump turbines at the time they were trying  
21 to start up the turbine, and that that hot condensate imparted  
22 more energy into the turbine because it was masses of water  
23 that was hot and it flashed in the turbine, and that caused  
24 both of the turbines to overspeed.

1 it with the turbine vendor. The turbine vendor believes that  
2 that is a likely thing, but this is one that they have not --  
3 you know, they feel very confident that that is the cause of  
4 the problem, but the only way you are going to be able to know  
5 for sure is you have to go up with the plant hot and try it  
6 over again and see if it does, indeed, happen when you open  
7 the lines that were used on June 9th.
