KG&E MANAGEMENT PLAN

MANAGEMENT PLAN FOR THE RESOLUTION OF CAR-19

STRUCTURAL STEEL WELDING
PRESENTATION

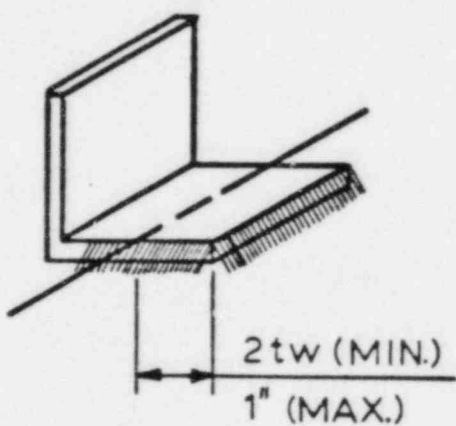
OVERRUN

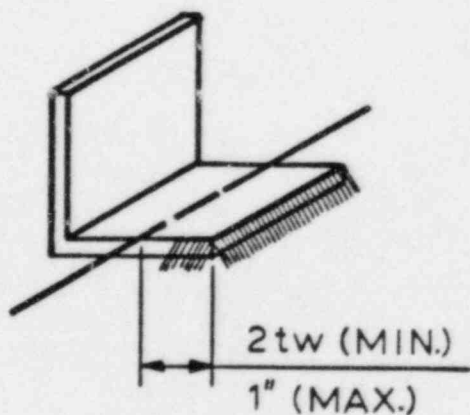
UNDERRUN

tw = REQUIRED WELD LEG

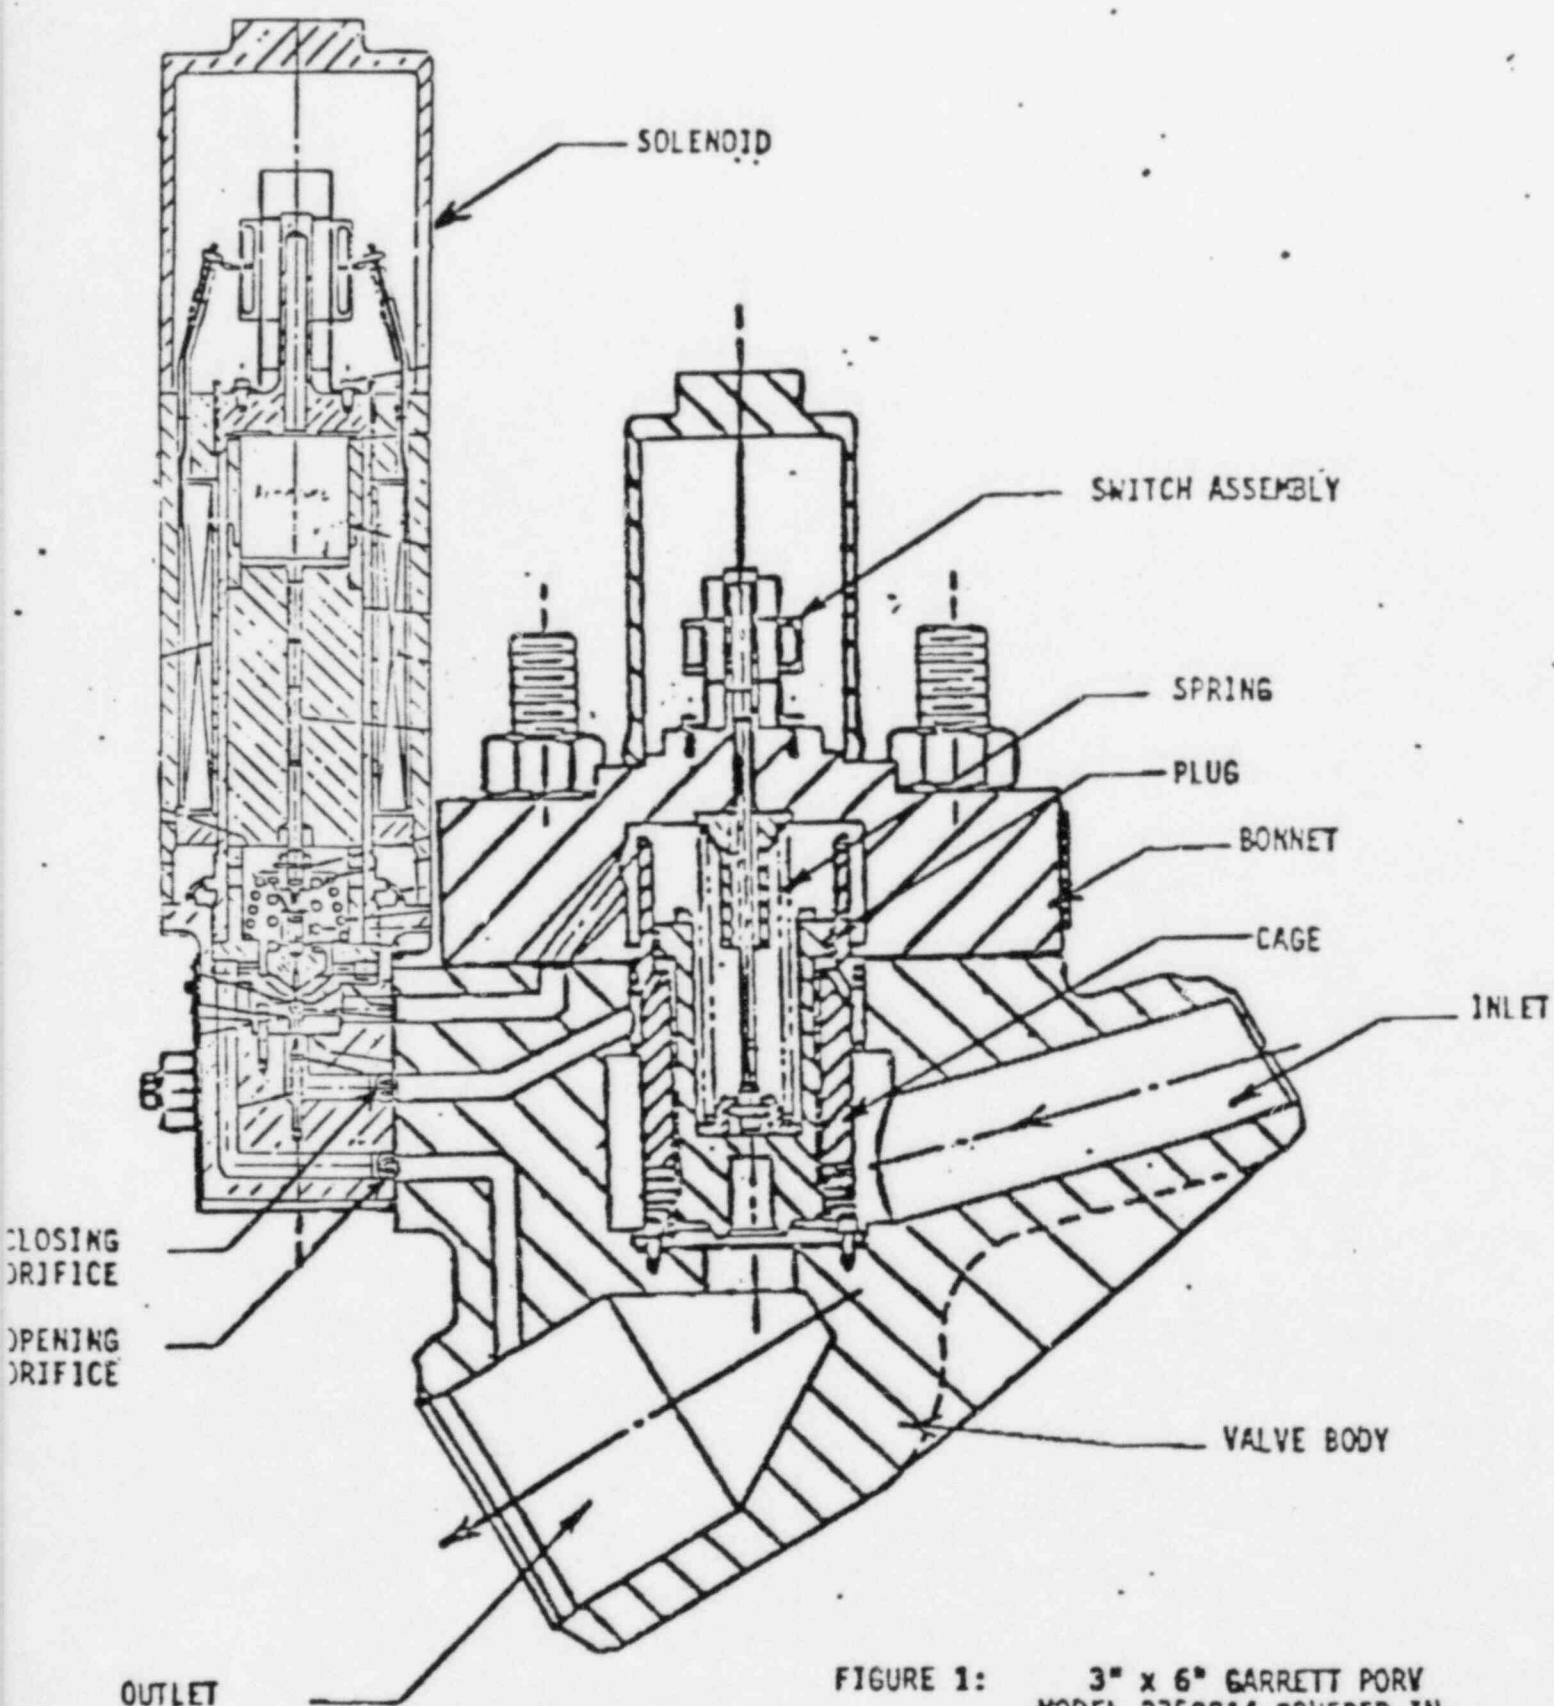
FIGURE 1:

THE WOLF CREEK PRESSURIZER PROVS FAILED TO CLOSE AFTER A DISCHARGE OF WATER FOLLOWED BY STEAM WHICH WAS CONDUCTED MANUALLY FOR AN EXTENDED PERIOD OF

TIME. THE CAUSE OF THIS MALFUNCTION WAS DETERMINED TO BE DIFFERENTIAL THERMAL EXPANSION (VALVE BODY TO CAGE) RESULTING IN A RESTRICTION OF AN ESSENTIAL FLUID FLOW PATH TO THE VALVE ACTUATOR HEAD ASSEMBLY. IDENTIFICATION OF THE CAUSE OF THE MALFUNCTION IS SUPPORTED BY TESTING IN OTHER OPERATING MODES, SUCCESSFULLY REPEATING THE FAILED TEST WITH REDUCED DIFFERENTIAL TEMPERATURES, AND A DETAILED ENGINEERING ANALYSIS.

3" x 6" GARRETT PORV
 MODEL 3750014 COVERED IN
 SPECIFICATION G-955245, REV. 0

A VALVE MODIFICATION, SPECIFIED BY WESTINGHOUSE AND CONCURRED WITH BY GARRETT (THE VALVE DESIGNER/MANUFACTURER) HAS BEEN MADE WHICH CORRECTS THE MALFUNCTION WITHOUT HAVING ANY DELETERIOUS EFFECTS ON VALVE FUNCTION.

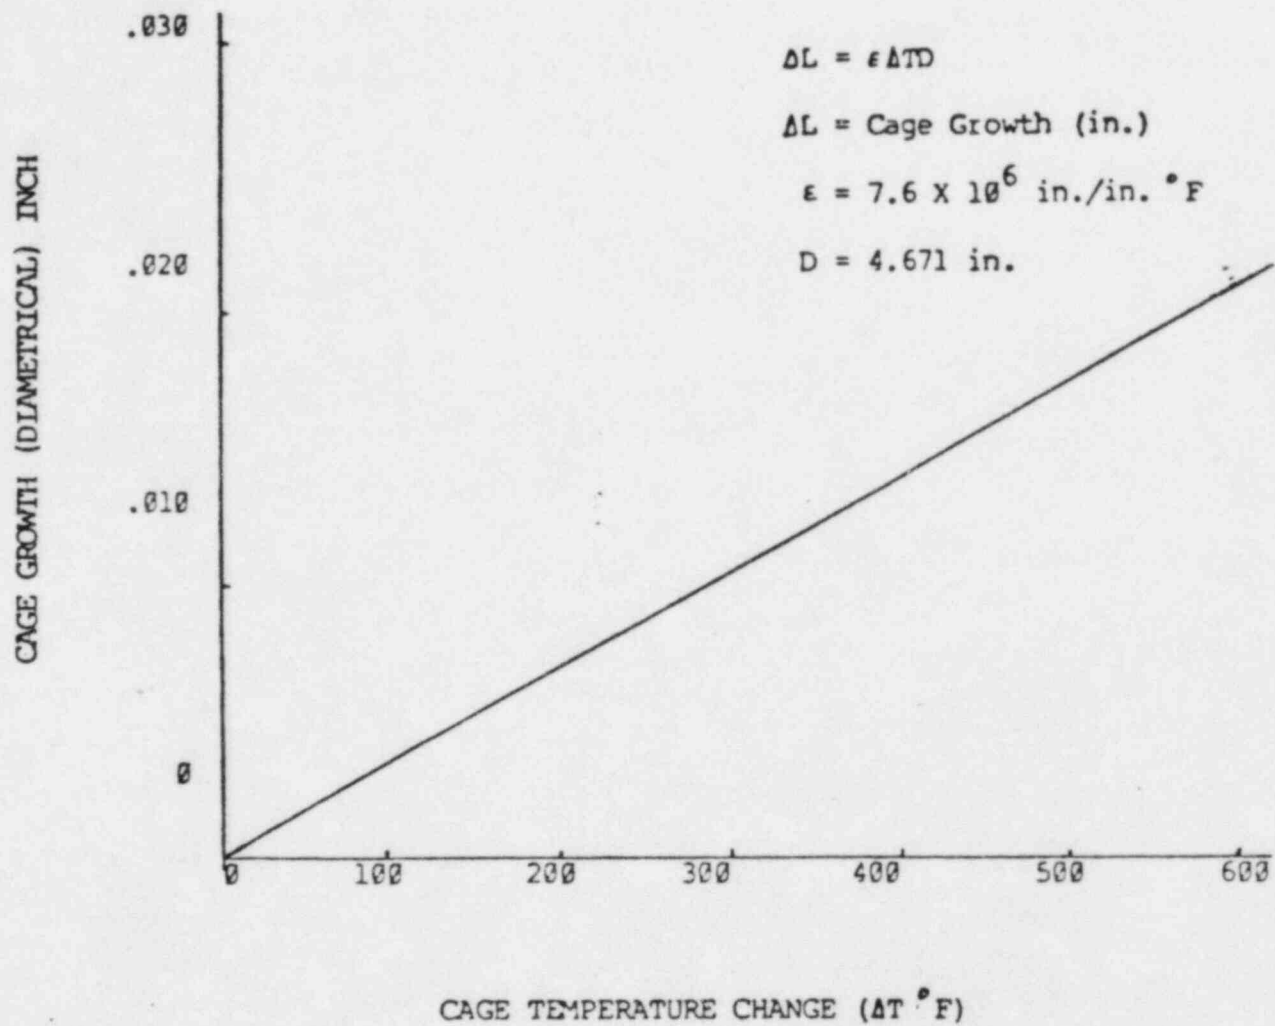
FIGURE 2

THIS PHENOMENON WAS THEN ANALYZED TO DETERMINE THE EFFECTS OF GAP CLOSURE ON FLUID FLOW WITH A HOMOGENEOUS FLOW MODEL. THE RESULTS SUBSTANTIATE THE HEATED TEST RESULTS AND THE DIFFERENTIAL EXPANSION PREMISE. SPECIFICALLY, FOR ALL RELIEF CONDITIONS, THE MINIMUM ANNULAR DIAMETRAL GAP BETWEEN THE BODY AND THE CAGE NECESSARY FOR THE PORV TO FUNCTION PROPERLY IS 1.12 MILS. WITH THE VALVE STARTING COLD (90 DEGREES FAHRENHEIT) AND SUDDENLY EXPOSED TO HIGH PRESSURE STEAM (650 DEGREES FAHRENHEIT) IT WILL TAKE 5.75 SECONDS FOR THE ANNULAR ORIFICE GAP TO BE REDUCED FROM 15 MILS TO 1.12 MILS. IN

CAGE GROWTH VS. CAGE ΔT °F
