U.S. NUCLEAR REGULATORY COMMISSION
REGION I

Report No. 50-293/85-22

Facility Name: Pilgrim Nuclear Power Station

Inspection Conducted: August 19-23, 1985

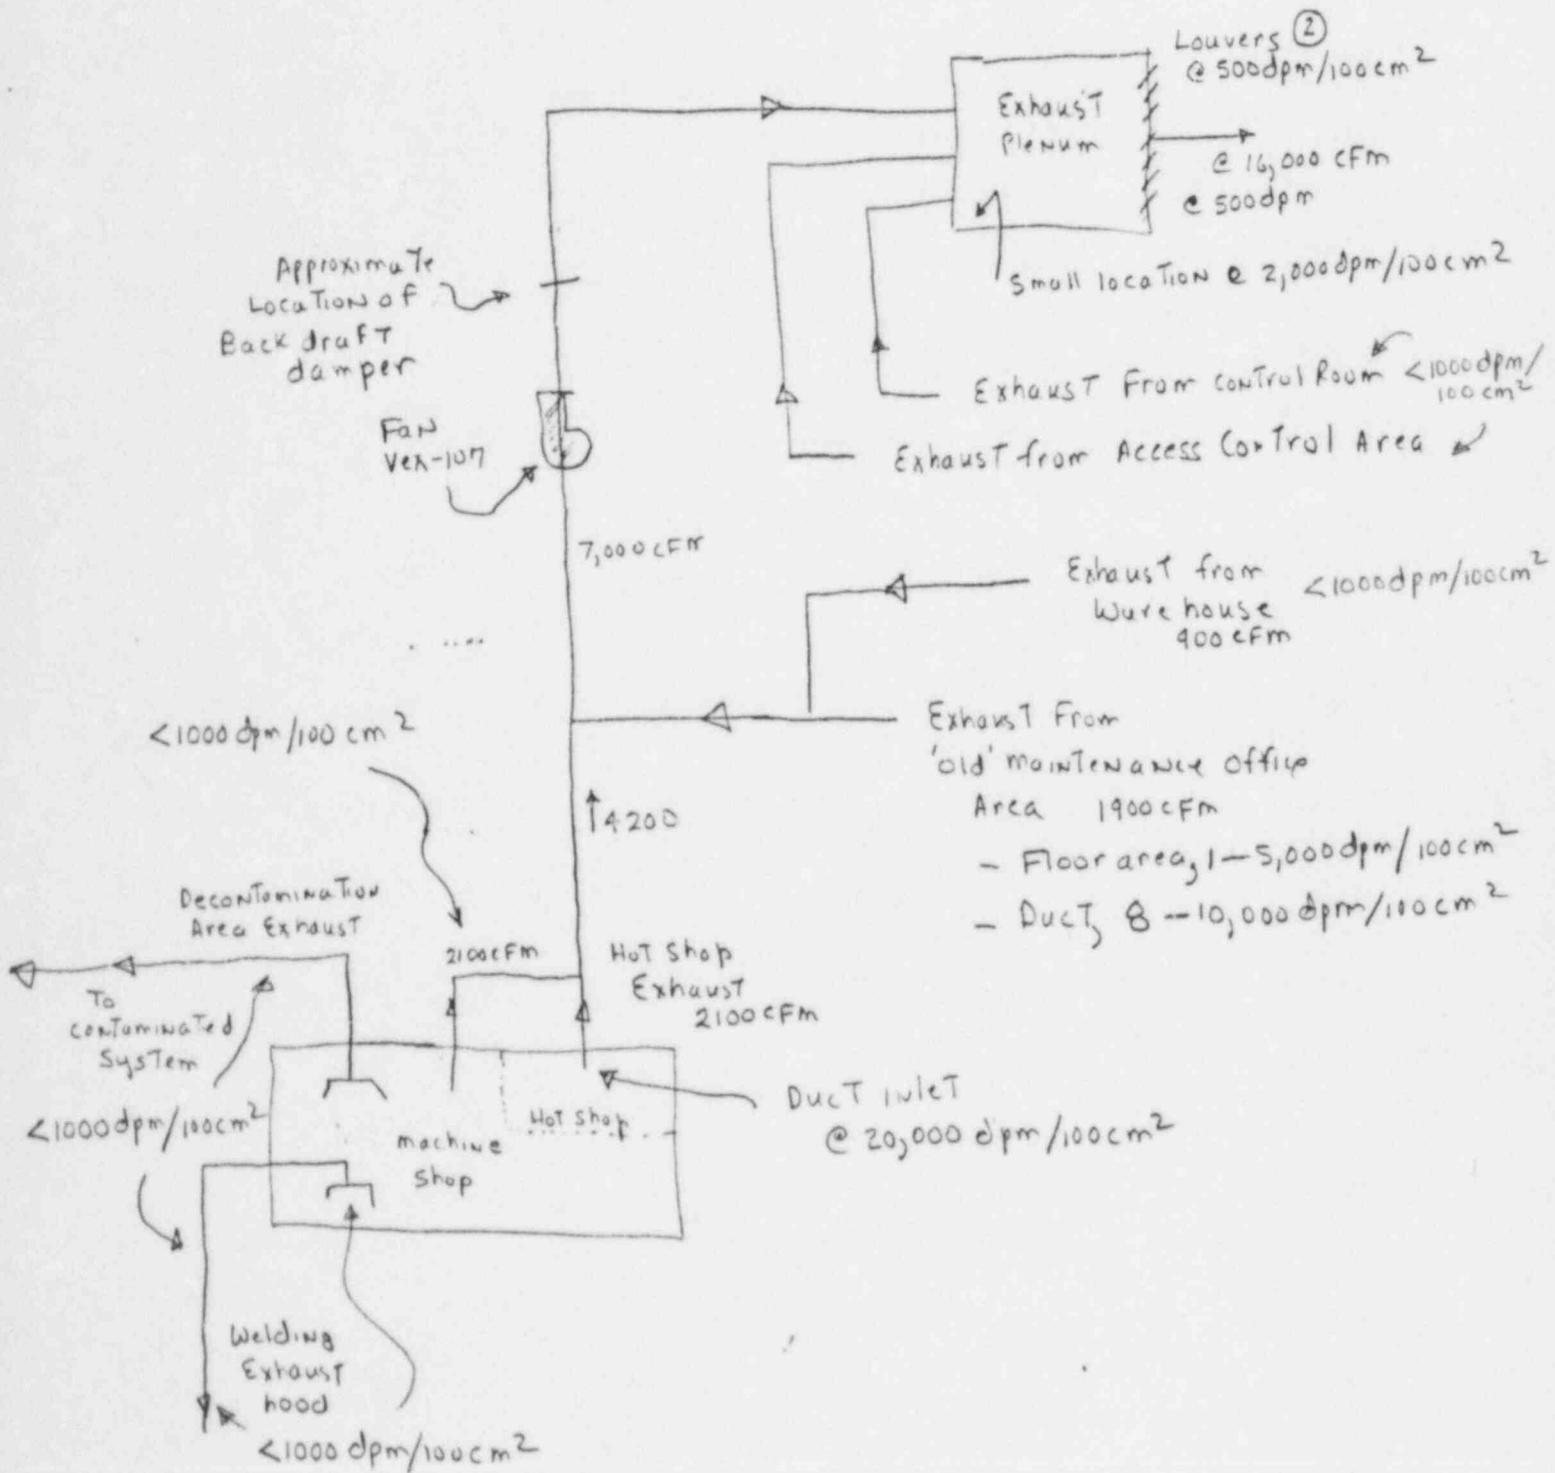
Figure 1
Hot Shop Ventilation
Flow Path ①

On July 30, 1985, a contamination survey of the "Old Maintenance Office" floor area identified low level floor contamination (1000-2000 disintegration per minute per 100 centimeters squared [dpm/100 cm²]). An investigation as to the source of the contamination indicated it apparently was emanating from exhaust duct work in the area. Further investigation indicated the local exhaust duct work tied into exhaust duct work from the "Hot" Machine Shop. This former duct work eventually exhausted its contents to the atmosphere outside the Turbine building. (See Figure 1)

- On or about July 30, 1985, a determination was made that a "backdraft damper" down stream of VEX-107 was found to be failed open. Note: This allowed contaminated air to be "blown back" into other duct work (i.e. Maintenance Area).

- The plenum and louvers from which air from the Hot Machine Shop was ultimately exhausted to the environment exhibited low levels of contamination. No significant source term was identified based on the extent of contamination present.

- The cause of the unmonitored release path was due to insufficient review when this area of the station was converted to a "Hot" machine shop.
- Licensee Procedure 3.02, "Preparation, Review Verification, Approval and Revision of Design Documents for Plant Design Changes", dated December 10, 1984, provides guidance for review of design changes by radiological control personnel. However, inspector review of this procedure indicated the procedure does not appear to clearly show how a similar event could not occur. i.e., (Conversion of a normally clean room to a contaminated area and subsequent offsite release.)

① General Path
 Based on discussion
 with licensee
 personnel

② Contamination
 level of @ 500 dpm/100 cm²
 used for release
 calculations

- On August 7, 1985, the back draft damper was repaired and fan VEX-107 was inspected, found to be operable, and placed in service. Note: Radiation Protection Personnel were unaware of the restarting of this fan.

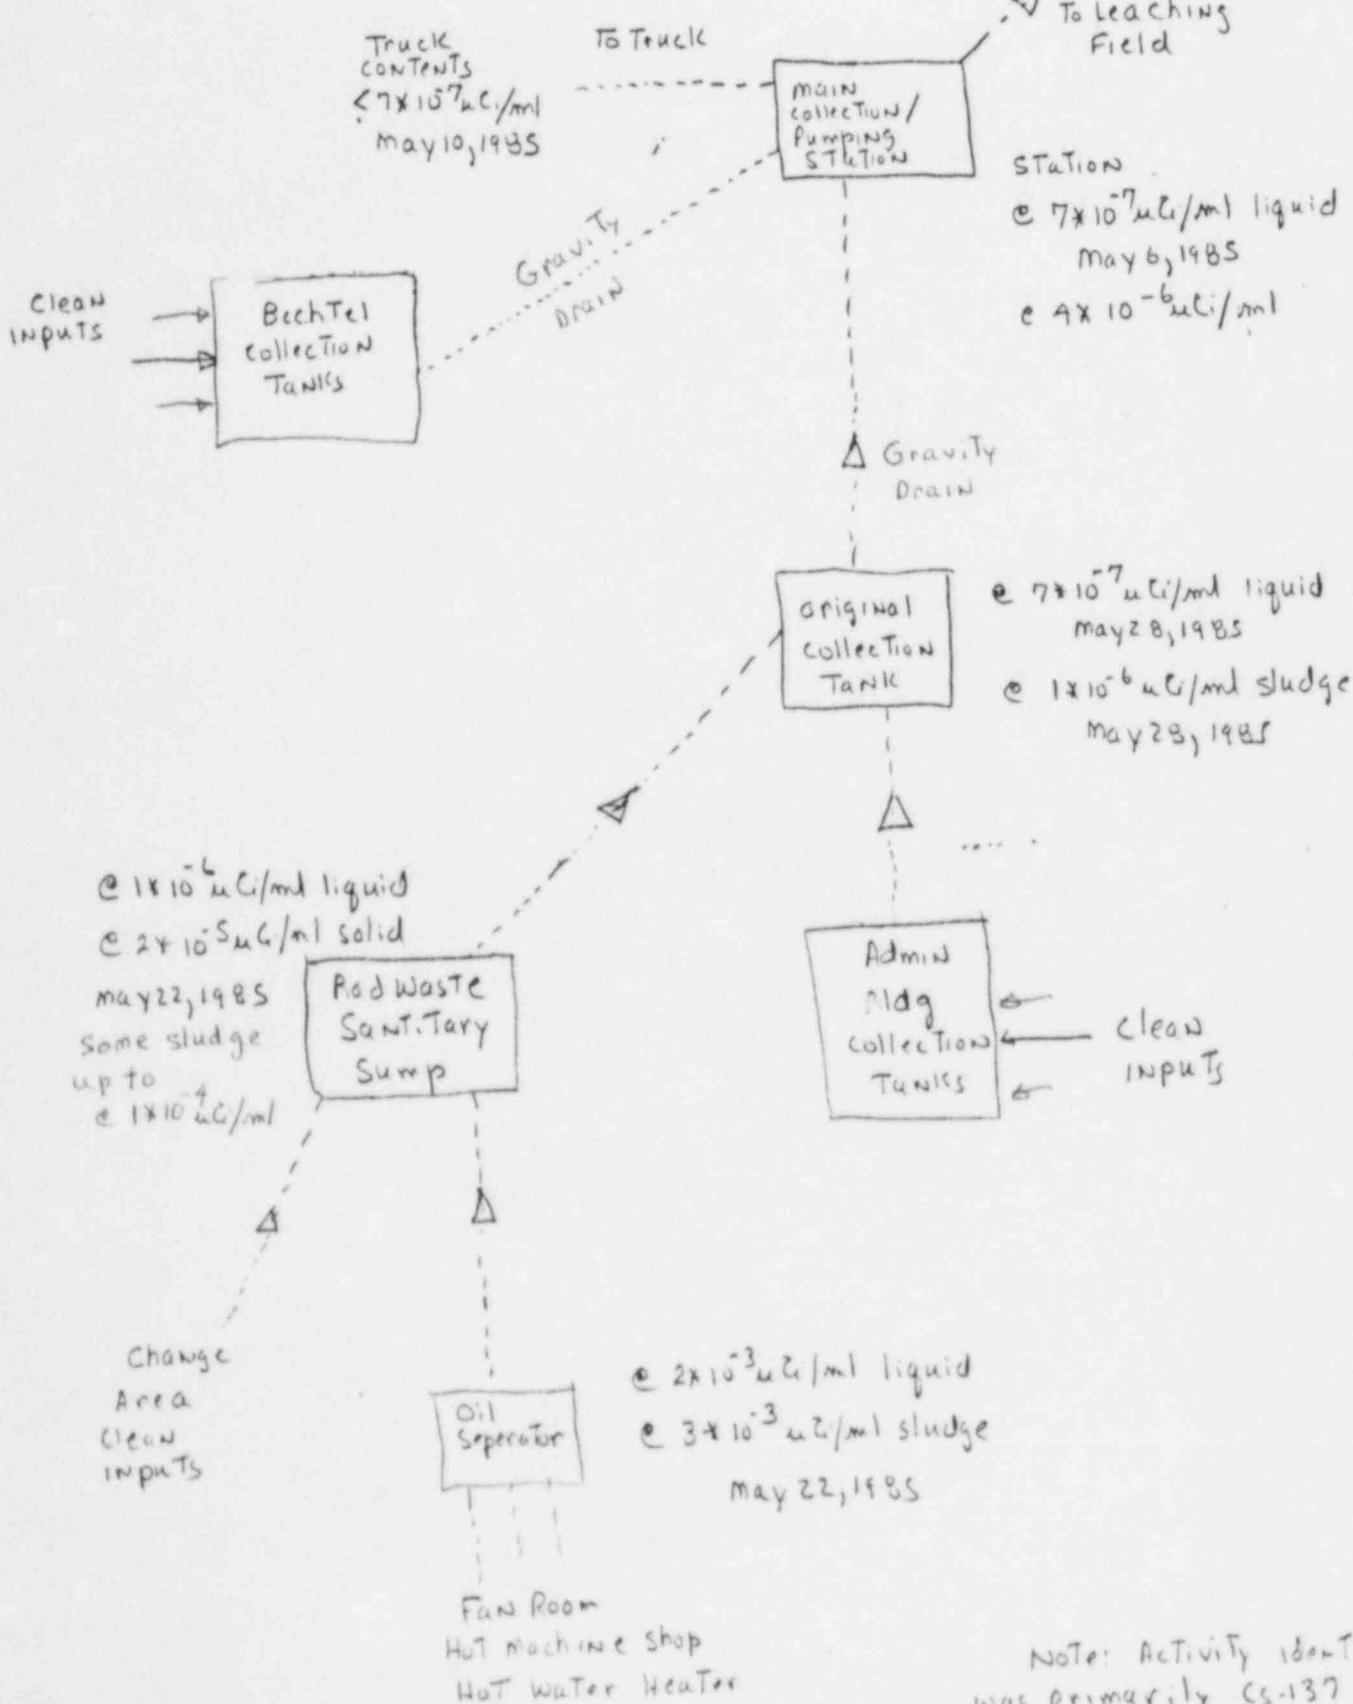
Pilgrim Sewage System*

On May 3, 1985, a drain in the licensee's "Hot Machine Shop" (23' elevation) was identified as apparently backing up. A Radiological Occurrence Report was written at that time. Since this drain was plugged and located in a contaminated area, an investigation was initiated to determine the ultimate disposal point of the drain. The licensee's investigation indicated that liquid in the drain may be directed to the Main Sewage Pumping Station. Since the effluent from this pumping station is directed to an onsite leaching field and the pumping station effluent is periodically pumped out and sent to the Plymouth Sewage Disposal facility, the Main Pumping Station potentially represented an unmonitored effluent release path. The sewage flow path is shown in Figure 2. The licensee notified the resident inspector of this finding on May 10, 1985. This matter was reviewed in part during inspection 50-293/85-13. (Conducted May 20-24, 1985). At that time it was determined that the licensee had failed to implement a noncontaminated system sampling program consistent with the requirements of IE Bulletin 80-10, "Contamination of Nonradioactive System and Resulting Potential for Unmonitored/Uncontrolled Release to the Environment." The NRC took enforcement action on this matter at that time. The licensee initiated a comprehensive review of the facility design with respect to IE Bulletin 80-10 in order to identify other problems in this area. The licensee took the following actions when the backed up drain was identified:

- On April 15-20, 1985, action was initiated to pump out the main sewage holdup tanks.
- On May 6, 1985, a sample of effluent from the main sewage holdup tank was collected, analyzed and found to be contaminated.

Note: Activity identified was primarily Cs-137 and Co-60. No alpha emitters were indicated.

- During the period April 8 - May 10, 1985, action was taken to isolate all potential radioactive inputs to the sewage collection system. All identified inputs were rerouted to radwaste. (e.g. Hot Machine Shop floor drains, Radwaste Oil Separator)
