#### NOTICE OF VIOLATION AND PROPOSED IMPOSITION OF CIVIL PENALTIES

Tennessee Valley Authority Sequoyah Nuclear Plant Units 1 and 2 Docket Nos. 50-327 and 50-328 License Nos. DPR-77 and DPR-79 EA 96-414

Predecisional Enforcement Conference

October 11 Unit 2 Shutdown Equipment Problems and Unit 2 Reactor Trip Breaker Issues

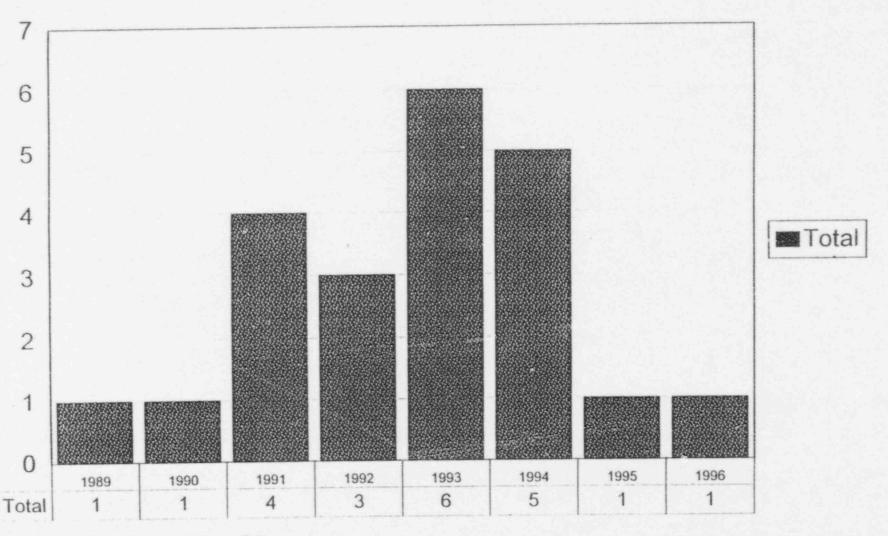
# CONDUIT WORK ORDERS FOR MFIV's

- B. The licensee failed to take adequate corrective actions to prevent additional flexible conduit damage. The work request history indicated that the flexible conduits, on the Unit 2 main feed water isolation valves, were damaged approximately 20 times since 1989, with 8 occurrences of damage on the flexible conduits for 2-MVOP-003-0100-B alone.

- · Instances of broken flex conduit in the steam valve vaults
- Breaks licensee-identified through PM program
- Attainment of zero break goal is limited by physical congestion in the work area

From 1989 till 1996

TOTAL Work orders = 22

- · As part of September 1990 FWIV failure corrective actions,
  - Evaluated and determined 26 valves are susceptible to this damage
  - Initiated two PMs to check these valves for conduit damage after outages before plant returns to service
  - Number of breaks successfully reduced by employee training (1 in '95, 1 in '96)
  - PM successfully repairs remaining breaks
- TVA does not agree with the apparent violation
  - Failure rate has been reduced
  - PM repairs effective
