River Bend Station - Unit 1
Docket No. 50-458

Enclosed for your review is Gulf States Utilities Company (GSU) supplemental response to the request for additional information dated June 13, 1984 from the Nuclear Regulatory Commission (NRC) Staff regarding the status of corrective action on five recent 10CFR21 notices issued by Transamerica Delaval, Inc. (TDI). Enclosure 1 summarizes each GSU Deficiency Report (DR) while the attachments contain copies of the GSU responses previously provided.

GSU Deficiency Report (DR) No. 298, "Air Start Check Valves"

DR-298/AIR START CHECK VALVES

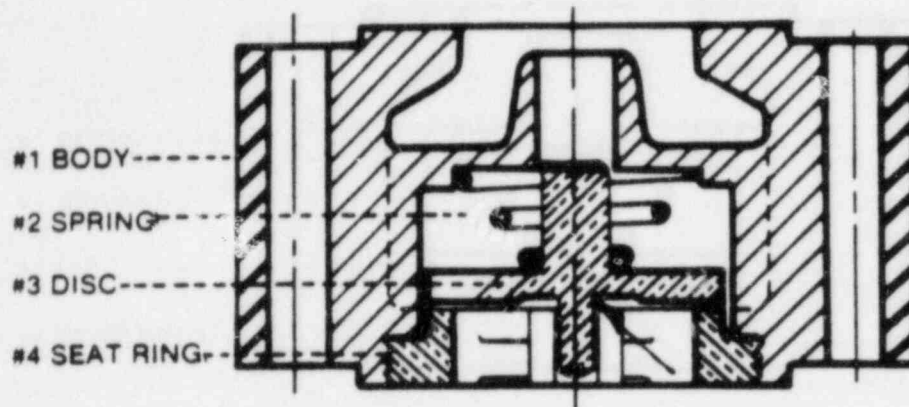
At Grand Gulf on March 11, during operational testing on Engine 74033, flames were noticed coming out of a flexible coupling on the Air Start Header Assembly. The Engine was shutdown and number 6 right bank Air Start Valve was removed. A 3/8 diameter, 7/8 long non-magnetic piece was observed lying on top of the Piston. This resulted in further examination, and it is felt that this piece broke off of a Starting Air Check Valve Disk. This Disk has a top and a bottom guide. It appears this piece broke off of the bottom guide. There are 4 of these Valves on the RV 16 Engine. Grand Gulf checked the other 3. One of these was cracked and the other 2 were ok. LPI was used to check these valves.

In the mean time, our recommendation for corrective action is to disassemble the Check Valves on the Engine and inspect the Disk Guide for cracks (LPI). Attached is a copy of the assembly drawing of this Valve showing the area of concern.
