LICENSEE EVENT REPORT (LER) TEXT CONTINUATION

Peach Bottom Atomic Power
Station - Unit 2

SUBJECT: Licensee Event Report
Peach Bottom Atomic Power Station - Unit 2

This LER concerns two separate events involving the failure of the 'A' loop residual heat removal system outboard injection valve MO-2-10-154A.

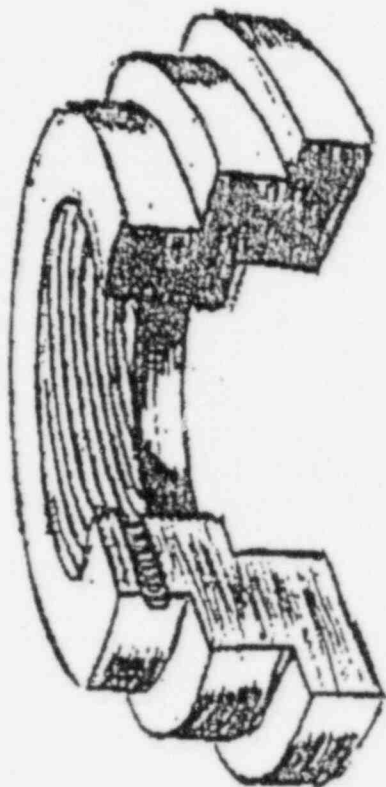
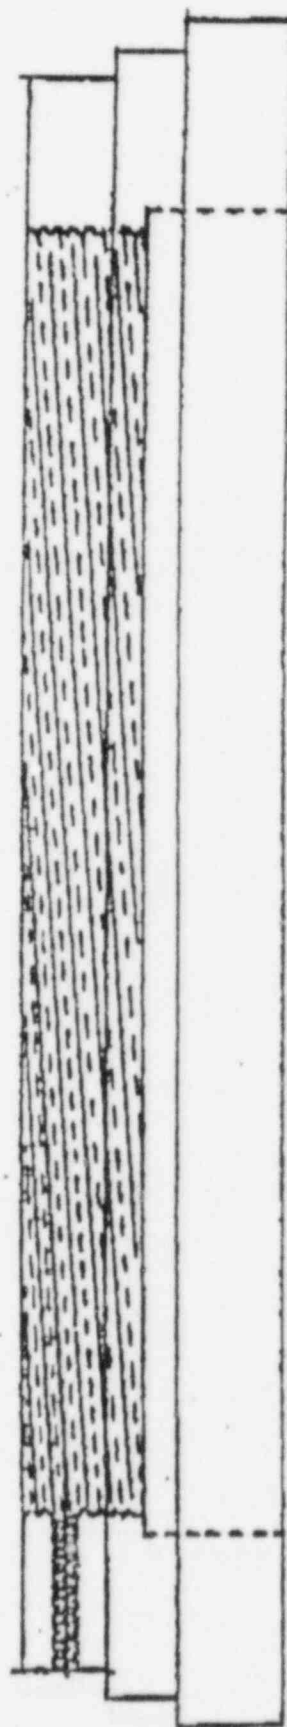
LER 2-85-13
Attachment 1

The upper roller bearing operates between a shoulder in the topside of the valve yoke and locknut which is threaded onto the yoke nut. The locknut is provided with two setscrews, located 90 degrees apart in the locknut, which are tightened against the yoke nut external threads to prevent its rotation on the yoke nut. These components of the thrust assembly are under load during valve opening.

When the Limitorque operator was removed from the valve yoke on August 13, 1985, the locknut was observed to be disengaged from the external yoke nut thread. The yoke nut was found to have rotated down the valve stem until the yoke nut drive key had jammed between the top of its slot in the yoke nut and the top surface of the locknut. This prevented further rotation of the yoke nut and the valve from being opened.

It was observed that the locknut had been deformed such that the bottom shoulder of the O-ring recess had been bent upward along approximately 45 degrees of the locknut outer circumference. This was the result of non-uniform load distribution between the locknut and the upper surface of the upper bearing inner race. Locknut deformation caused by the yoke nut key extended over the inner circumference of the upper face over a 90 degree section. The greatest depth of key-caused damage was at the innermost diameter and on the same side of the locknut as the O-ring shoulder damage. The pinching effect caused the locknut to become dished upward over approximately 120 degrees of its perimeter. There was no observed damage to the locknut threads other than the distortion caused by the yoke nut key. It has been concluded from the described damages that the locknut had become cocked in the yoke bore after disengaging from the yoke nut external threading.

Upon further disassembly, the upper bearing cone was found to be fractured. A crack through the inner race was terminated at one end with a small 'V'-shaped chip (approximately 1/16" wide and 1/16" deep) at the upper surface outer circumference of the race. At the other end of the crack, a large chip (approximately 1" wide and 1/2" deep) was removed from the lower inside diameter of the race. It is believed that this damage was caused by high localized forces attributed to the locknut becoming cocked. The upper bearing cup and lower roller bearing assembly were undamaged.

Both yoke nut and locknut threads were rolled over at the thread crests. This is indicative of minor thread stripping as a result of an incomplete thread mesh between the yoke nut and locknut.

The yoke nut external threading had two areas where the threads were completely removed by the locknut setscrews. These areas were in the shape of an inverted 'T' with its bottom approximately 4"-5" in length and parallel with the yoke nut external threading. The vertical portion of the inverted 'T' was perpendicular to the yoke nut external threading. These markings, made by the setscrews, indicate that the locknut had rotated back and forth before it was stripped up and off of the yoke nut threading.

To use the remaining spare yoke nut and compensate for the critical dimensional variations, a representative from Alloyco, Inc. (the current N-stamp holder for Walworth Co.) recommended manufacturing a locknut of increased thickness to provide the necessary constant contact between the load bearing surfaces of the thrust assembly while maintaining the full 1.5" of thread engagement with the yoke nut.

Because the material specified by the valve manufacturer (AISI-1015) was not available, an alternate (ASME SA-515, Gr. 70) was suggested to Alloyco, Inc. It was available in the necessary thickness at PECO Stores and was purchased under the Nuclear Quality Assurance Program. Alloyco, Inc. considered ASME SA-515, Gr. 70 acceptable, assuming the yield strength was a minimum of 45 KSI, for use in machining both the new locknut and yoke nut key. The Certified Material Test Report for the 2" x 48" x 96" plate of ASME SA-515, Gr. 70 from which the locknut and key were machined listed a yield strength of 49.5 KSI and tensile strength of 82.3 KSI.

To provide an accurate thread fit between the locknut and yoke nut, the machinist measured the yoke nut thread major diameter using a micrometer. The pre-threading bore diameter of the locknut was then machined to obtain a Class 2A fit which should assure a 90% thread engagement with the yoke nut external threading.

After application of the proper pre-load on the thrust assembly as recommended by Timken Co., self-locking setscrews were inserted through the locknut after application of "Lok tite" and properly tightened.

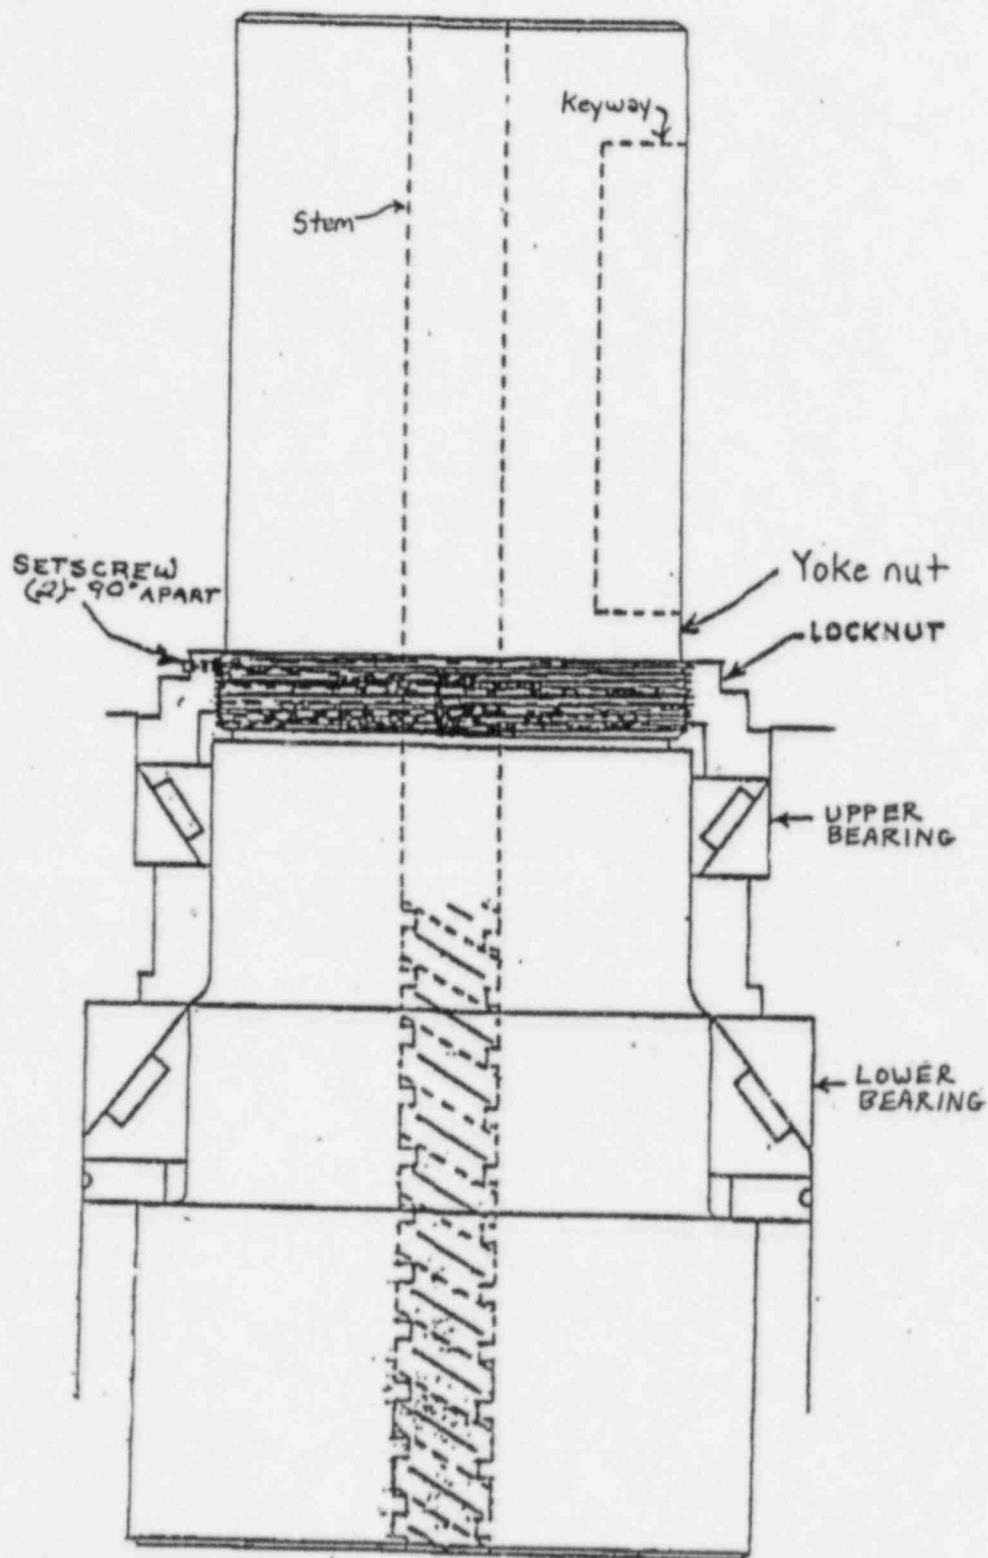
LER 2-85-13
Attachment 2

valve stem threaded through the yoke nut in a vertical orientation (See Attachment 2).

The lower roller bearing operates between a shoulder in the underside of the valve yoke and a bearing support plate that rests on a protruding rim at the base of the yoke nut. These components of the thrust assembly are under load during valve closing.

O-rings installed in the lower bearing support plate and locknut are in continuous contact with these components' respective bores in the valve yoke. The O-rings provide a dynamic seal preventing the entry of dirt to, and the exit of grease from the thrust assembly.

The yoke nut has an internal triple-lead, left-hand acme thread which mates to the threading on the valve stem. The external yoke nut threading which mates with the locknut is right-hand with twelve threads per inch. When the yoke nut is rotated counter-clockwise (top view) the valve stem rises, opening the valve.
