OMAHA PUBLIC POWER DISTRICT
FORT CALHOUN STATION

Steam Generator Tube Rupture Incident
Final Report

June 1984

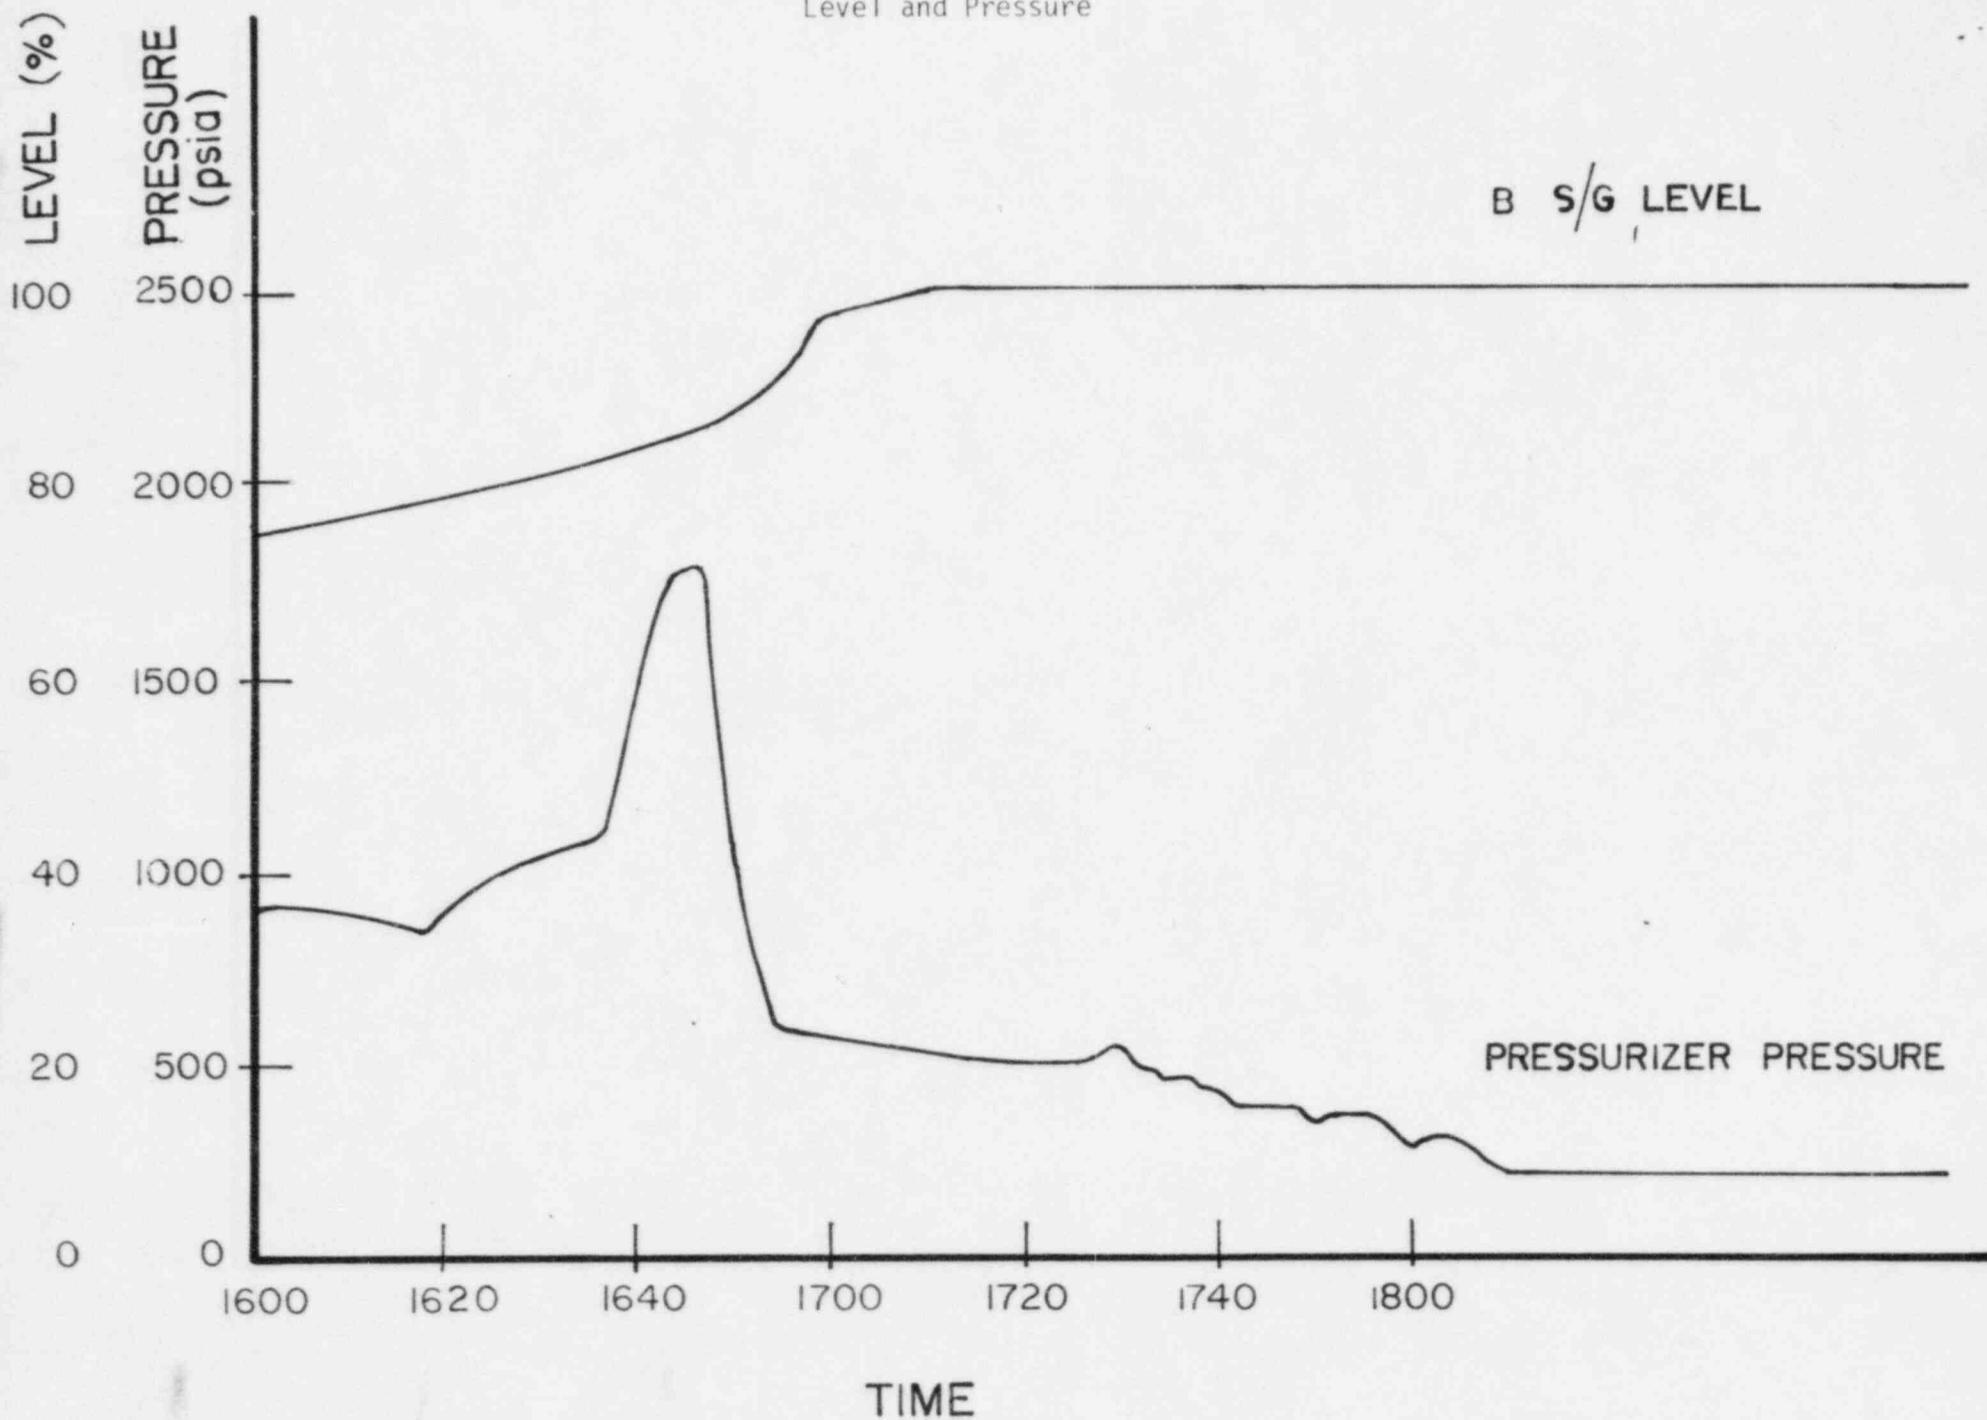
Figure 1: Time Sequence Relating to Steam Generator Level and Pressure

The following is the sequence of events for the steam generator tube rupture (SGTR) of May 16, 1984.

<u>Time</u>	<u>Event</u>
1618	Operator noted that pressurizer level was no longer increasing with single charging pump in operation; pressurizer pressure decreasing slowly; started other two charging pumps.
1636	Pressurizer pressure and level slowly increasing; however, charging flow rate only approximately 50 gpm versus expected flow rate of 120 gpm (probably due to inadequate NPSH with existing SIRWT level and three charging pumps); operator switched charging to VCT, flow rate increased to 120 gpm.
1639	PPLS reset at 1700 psia (automatic).
1641	Pressurizer solid; pressurizer pressure = 1800 psia and slowly increasing

Time	Event
*1642	Operator isolated letdown. Operator noted level increasing above setpoint in RC-2B, thought to be leakage through HCV-1106, operator closed block valve HCV-1385.
1645	VCT level approaching 0% despite blended makeup in progress; operator secured two charging pumps; pressurizer pressure = 1850 psia.
1646	PPLS blocked at 1700 psia (operator action).
1648	Pressurizer pressure dropping rapidly.
*1650	Operator noted continuing increase in RC-2B level; auxiliary FW pump FW-6 secured.
1654	Pressurizer pressure = 560 psia; RCS solid; operator opened letdown valve to draw pressurizer bubble.
1658	MSIV from RC-2B, HCV-1042A, closed by operator.
1659	Cooldown of RCS initiated using steam generator RC-2A and atmospheric dump valve HCV-1040.
1700	Reactor coolant pump RC-3C secured.
1701	Reactor coolant pump RC-3B secured.
1711	Notification of unusual event declared.
1717	NRC notified via red phone.

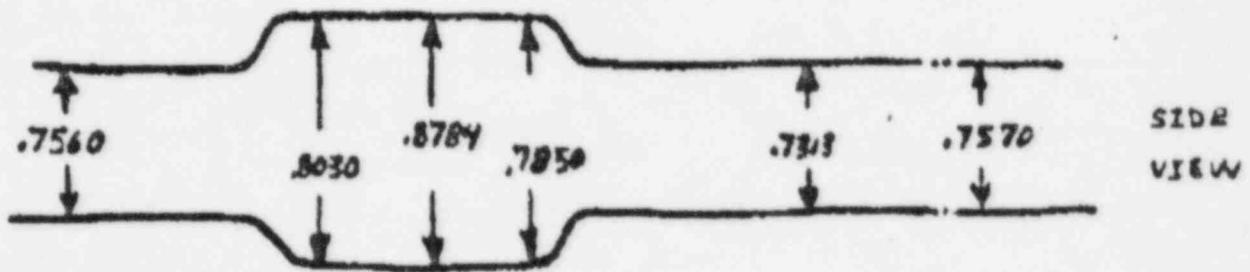
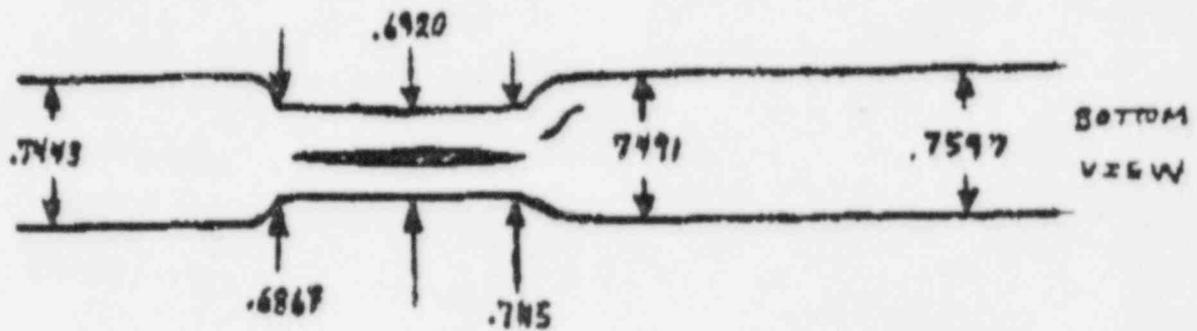
FIGURE 2. Dimensional Measurements of Tube L29R84

Figure 2 illustrates the dimensional measurements around the defect region. These measurements were taken before descaling and, as such, include the thickness of residual deposits. The measurement data indicate that the tube was ovalized. The major axis (6-12 o'clock) was elongated by 0.046-0.122 inch, while the minor axis (3-9 o'clock) was compressed by 0.045-0.070 inch diametrically.

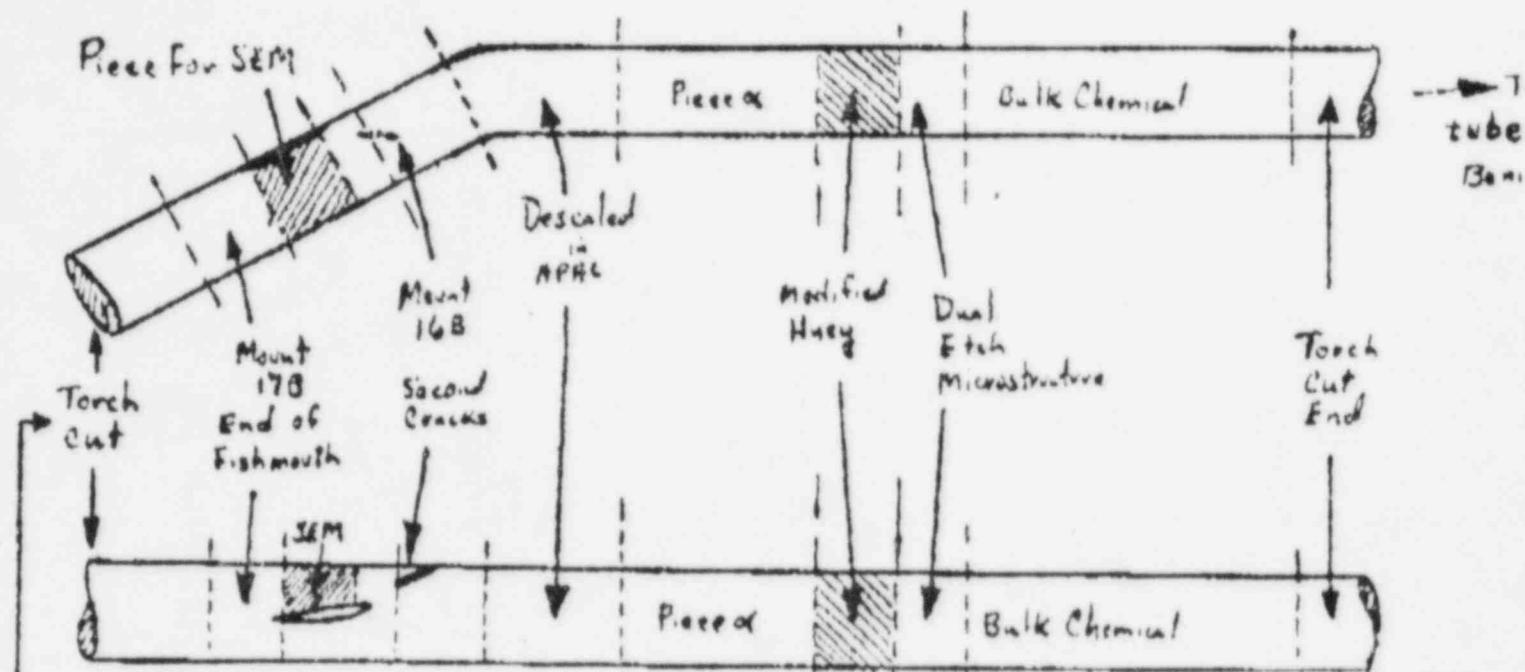
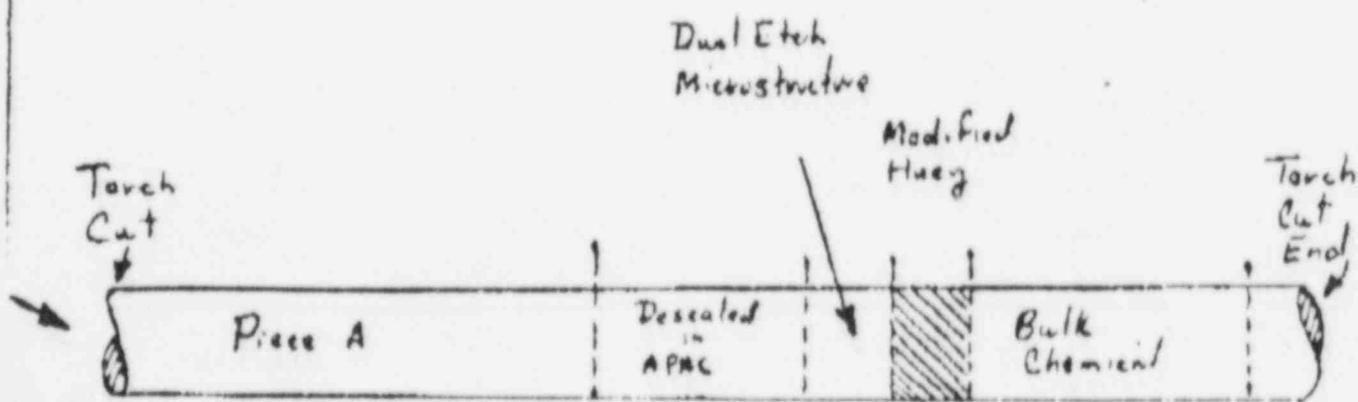
FIGURE 3. Sectioning Diagram of Tube L29R84

Upon receipt at the CE lab, the two tube specimens labeled 23B and 23C were visually inspected. Two cracks were observed on piece 23B. The first was a large, axial (1-1/4") "fishmouth" type crack, while the second was a series of small (approximately 1/4") length fissures which made an acute angle (45°) relative to the axis of the tube. One end from each tube section was removed to allow the eddy current probes to pass. Tube section 23B was the length of steam generator tube L29R84 from inboard of the first vertical tube support to outboard of the hot leg batwing tube support. The tube section labeled 23C was the length of the same tube from inboard of the first vertical tube support to outboard of the middle vertical tube support.

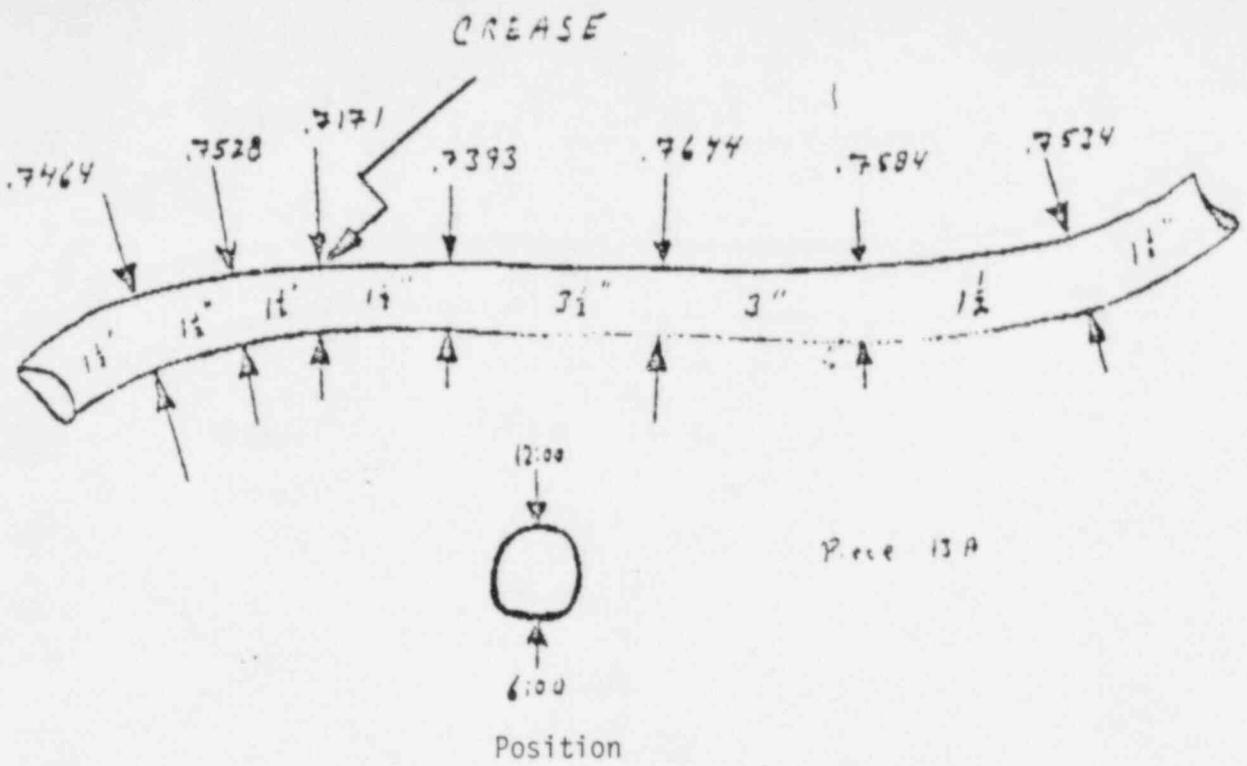
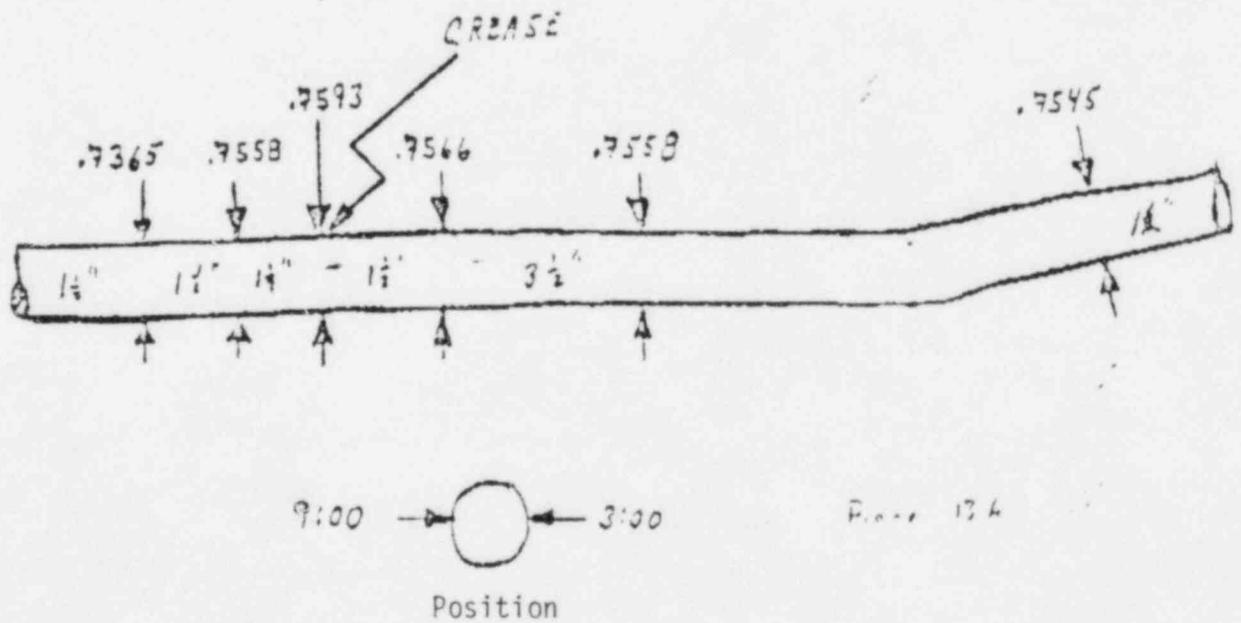
Figure 4 - Dimensional Measurements of Tube L29R86, Section 13A

Two small defect signals were detected on section 13A during the receipt inspection. However, tube deformations from the removal operations created interferences which made it impossible to accurately assess the nature of these two defects. The best interpretation of the data was that there were one or more kinks (creases) in the tube section as a result of deformation during the removal operation. (This was subsequently confirmed during the destructive examination).
